Issue Report

Keller 20-13, 125-07340

Report created on September 22, 2020

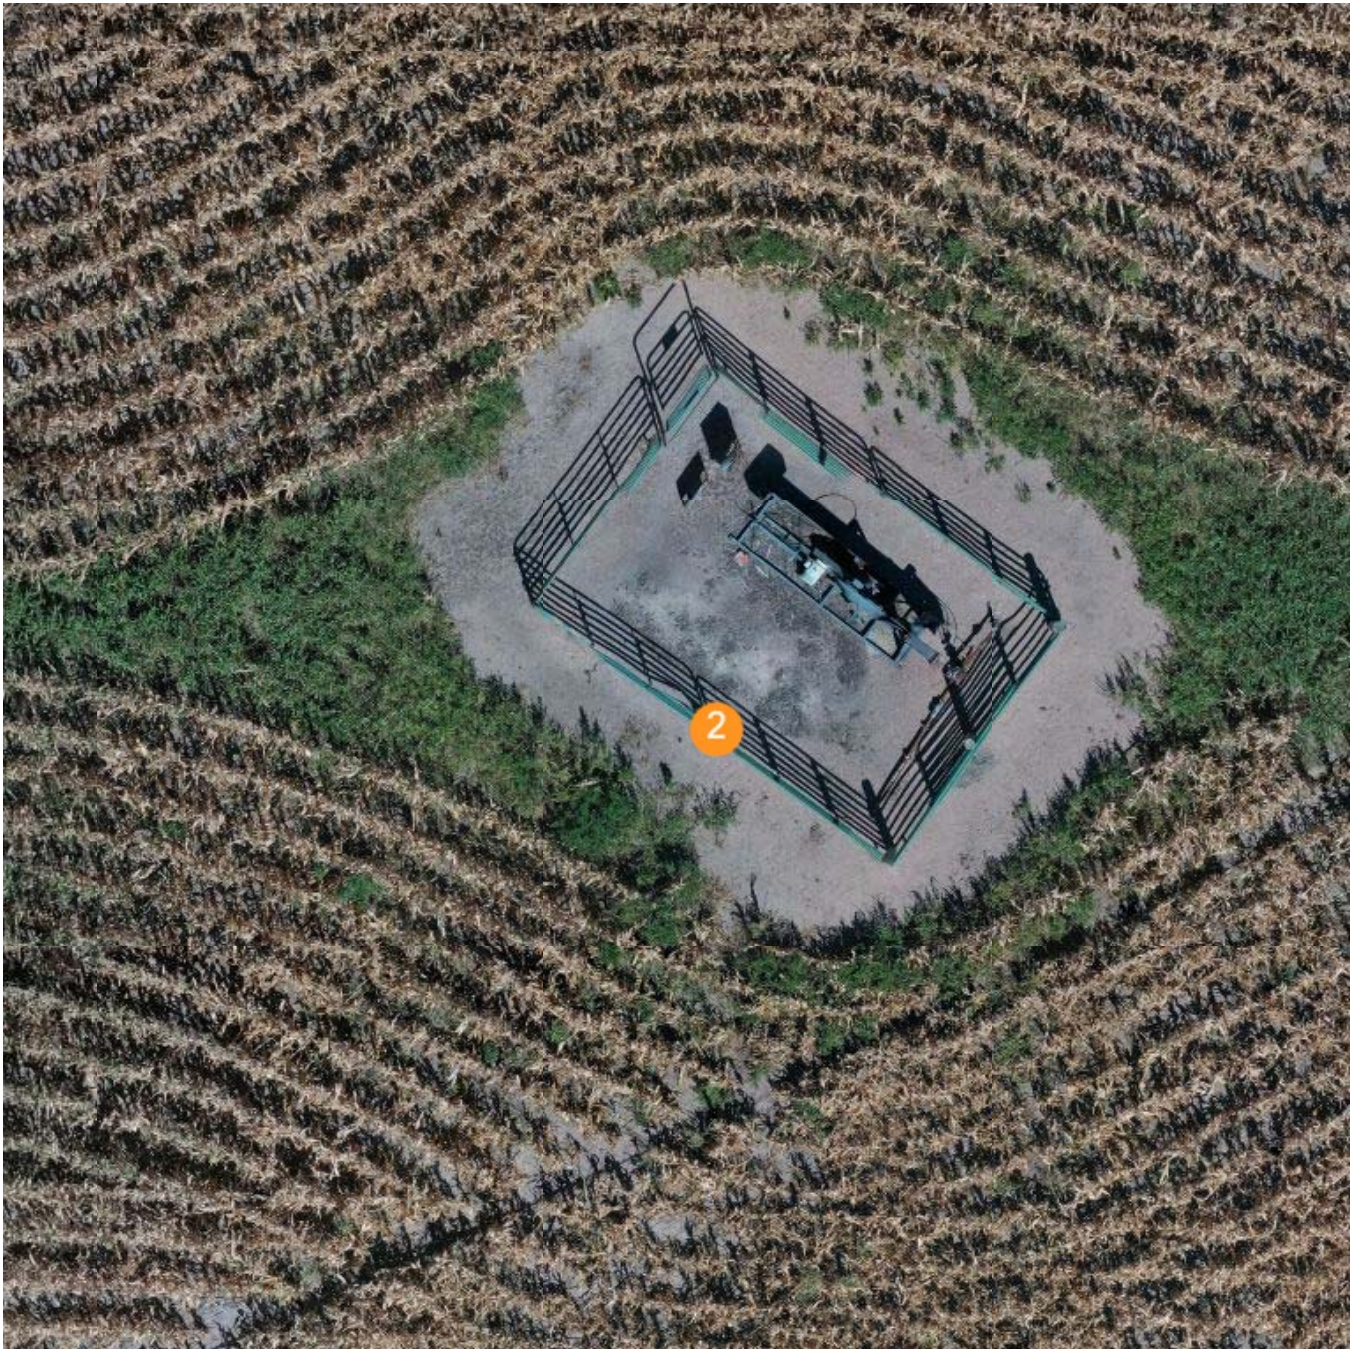
No. 2 OPEN**Captured:** Sep 2, 2020 at 12:02pm

No.	Summary	Created	Status
2	No access, seasonal inspection.	Sep 22, 2020 at 2:40 PM	Open

**Type**
Missing Part**Lat/Long**
39.88014, -102.48155**Summary**
No access, seasonal inspection.**Created**
Sep 22, 2020 at 2:40pm by Craig Quint

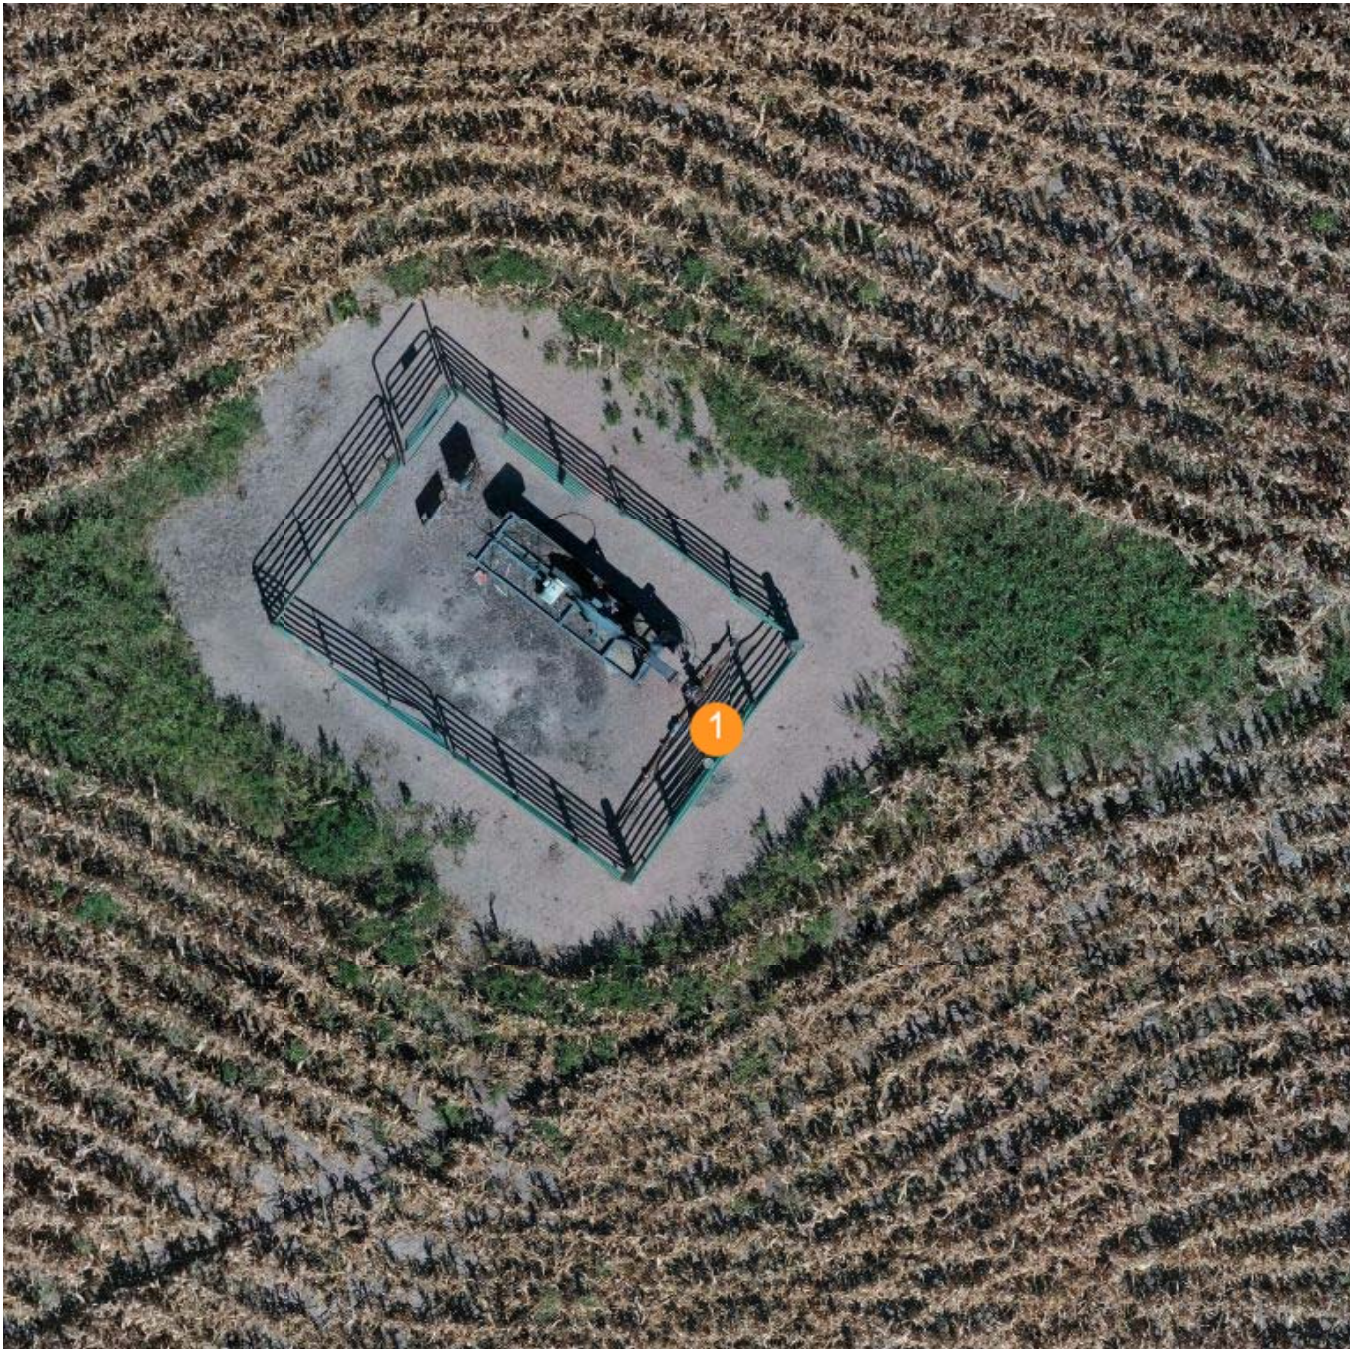
No. 1 OPEN*Captured: Sep 2, 2020 at 12:02pm*

No.	Summary	Created	Status
1	Pumping unit fenced with steel panels in corn field.	Sep 22, 2020 at 2:38 PM	Open

**Type**
Other**Lat/Long**
39.88014, -102.48150**Summary**
Pumping unit fenced with steel panels in corn field.**Created**
Sep 22, 2020 at 2:38pm by Craig Quint
