Inspection Photos

Operator: Crescent Point Energy
API: 113-06220
Date: 10/20/2020

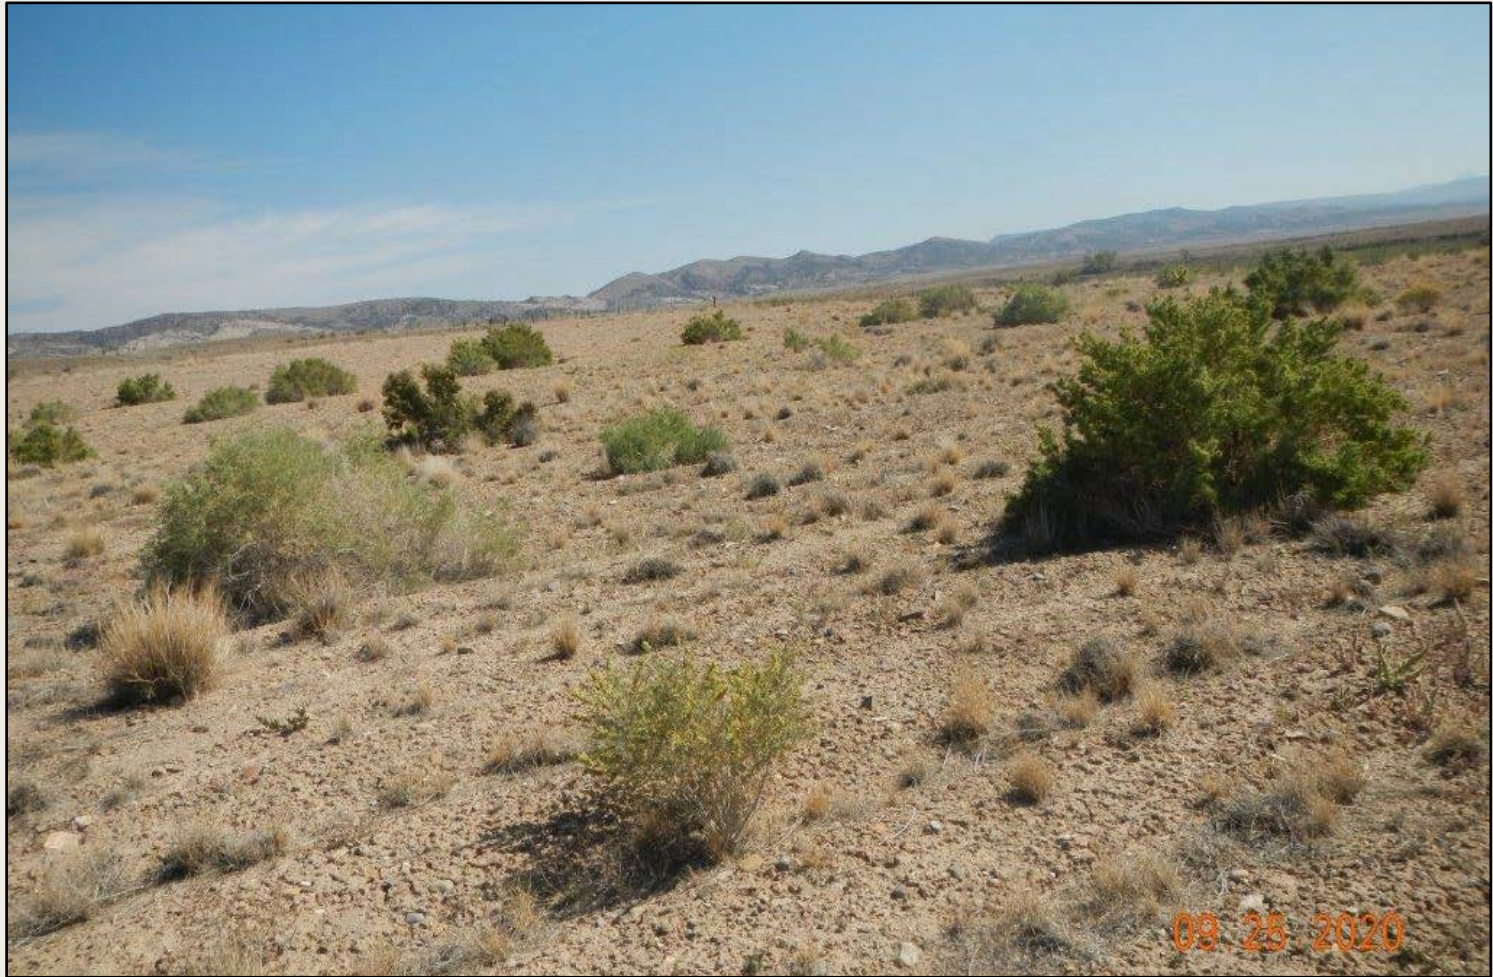
Photo 1. View of the project area from the southwestern corner facing center.

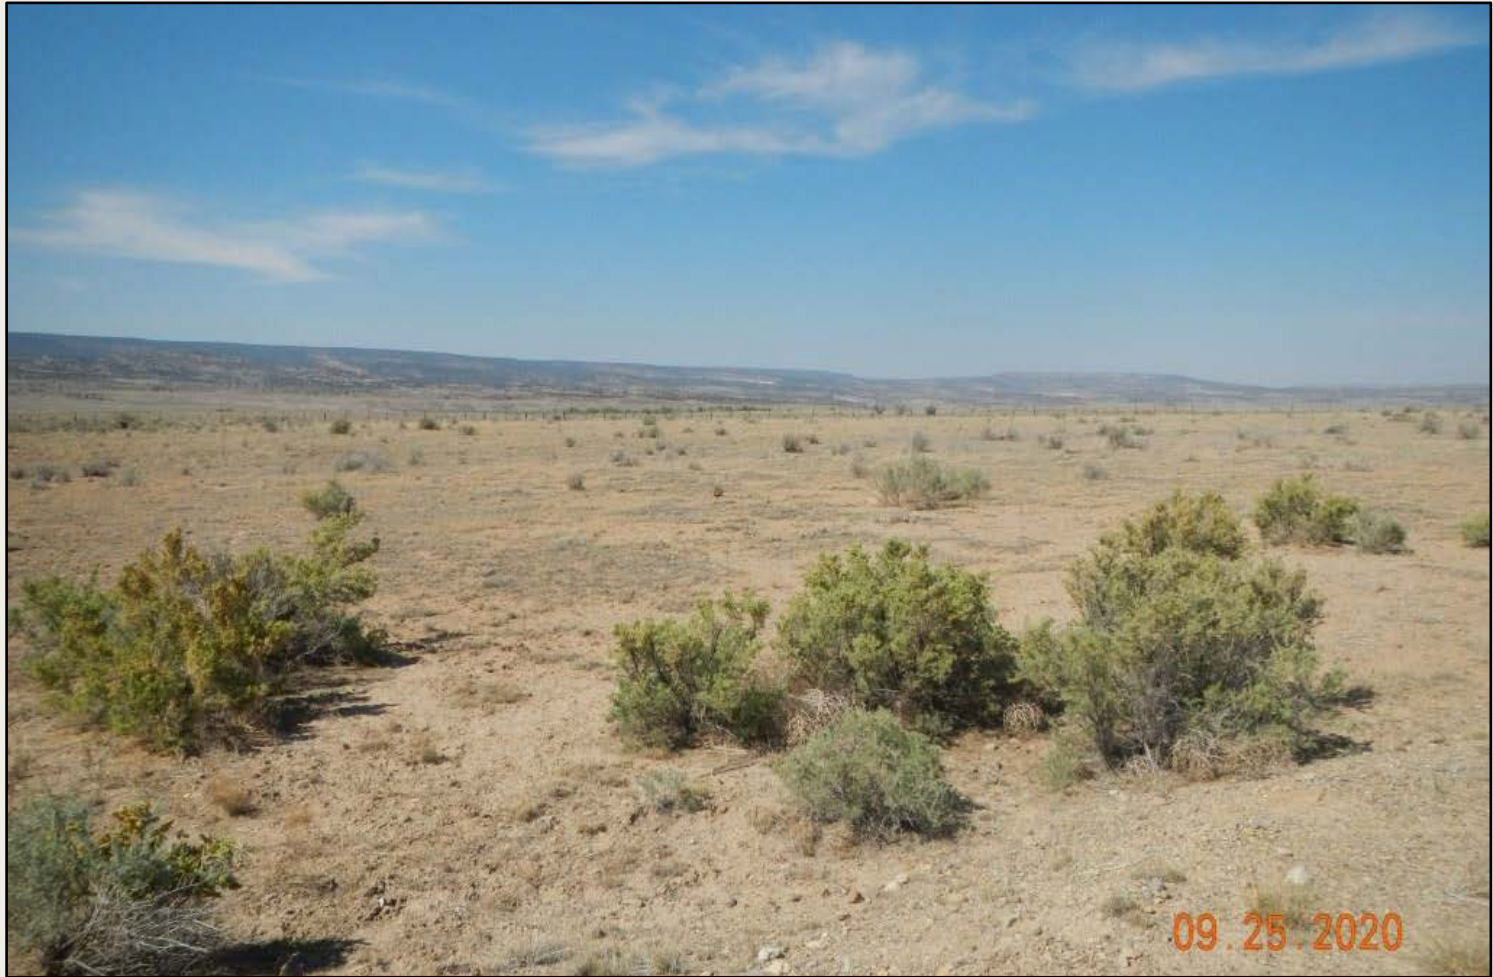
Photo 4. View of reference area vegetation comprised of greasewood and sagebrush shrubland with blue grama, prickly pear, and *Chaetopappa* spp.
