Inspection Photos

Operator: WPX

API: 067-07066

Date: 1/6/2021

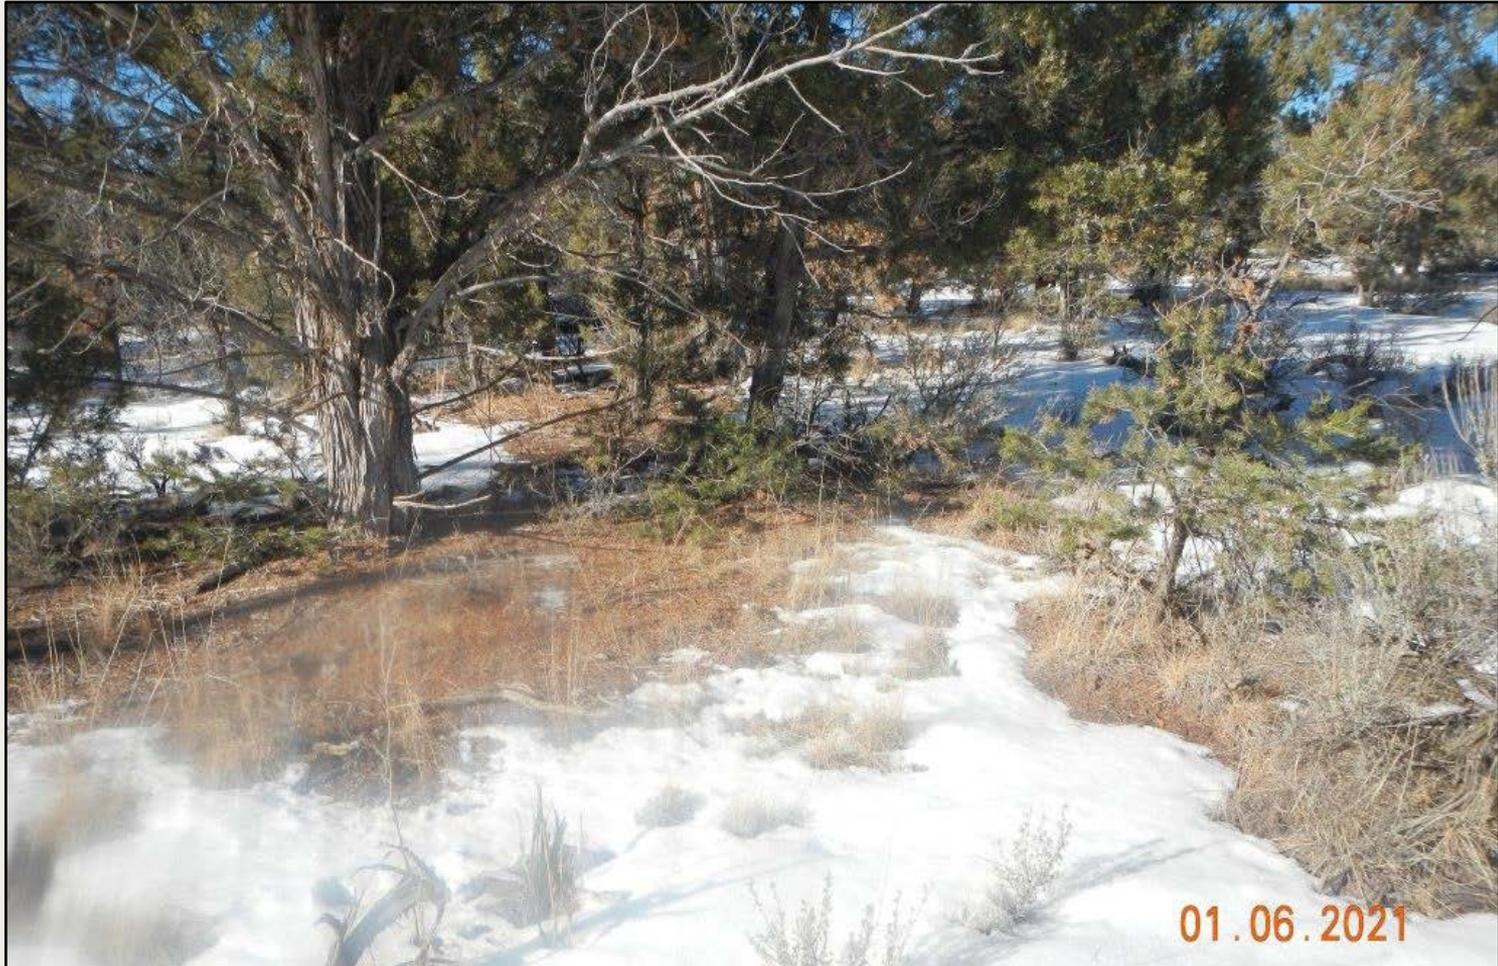
Photo 5. View of reference area comprised of pinyon and juniper woodland with sagebrush, squirreltail, and narrow leaf penstemon.
