Inspection Photos
Operator: Simcoe
API: 067-06679
Date: 5/24/2021

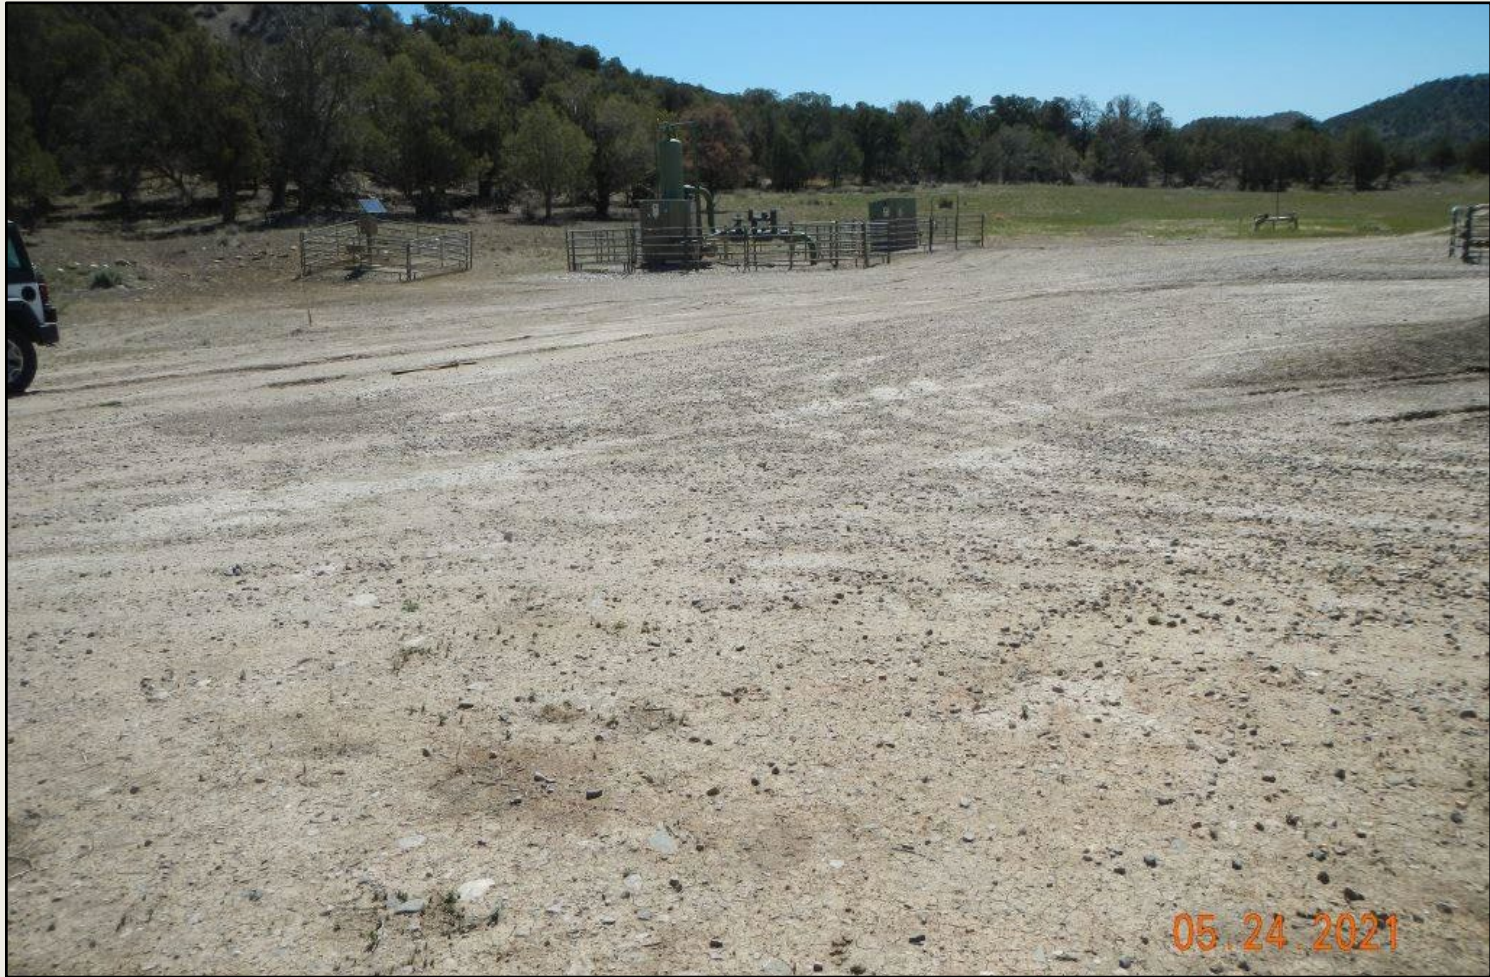
Photo 1. View of project area from the northwestern corner facing center.

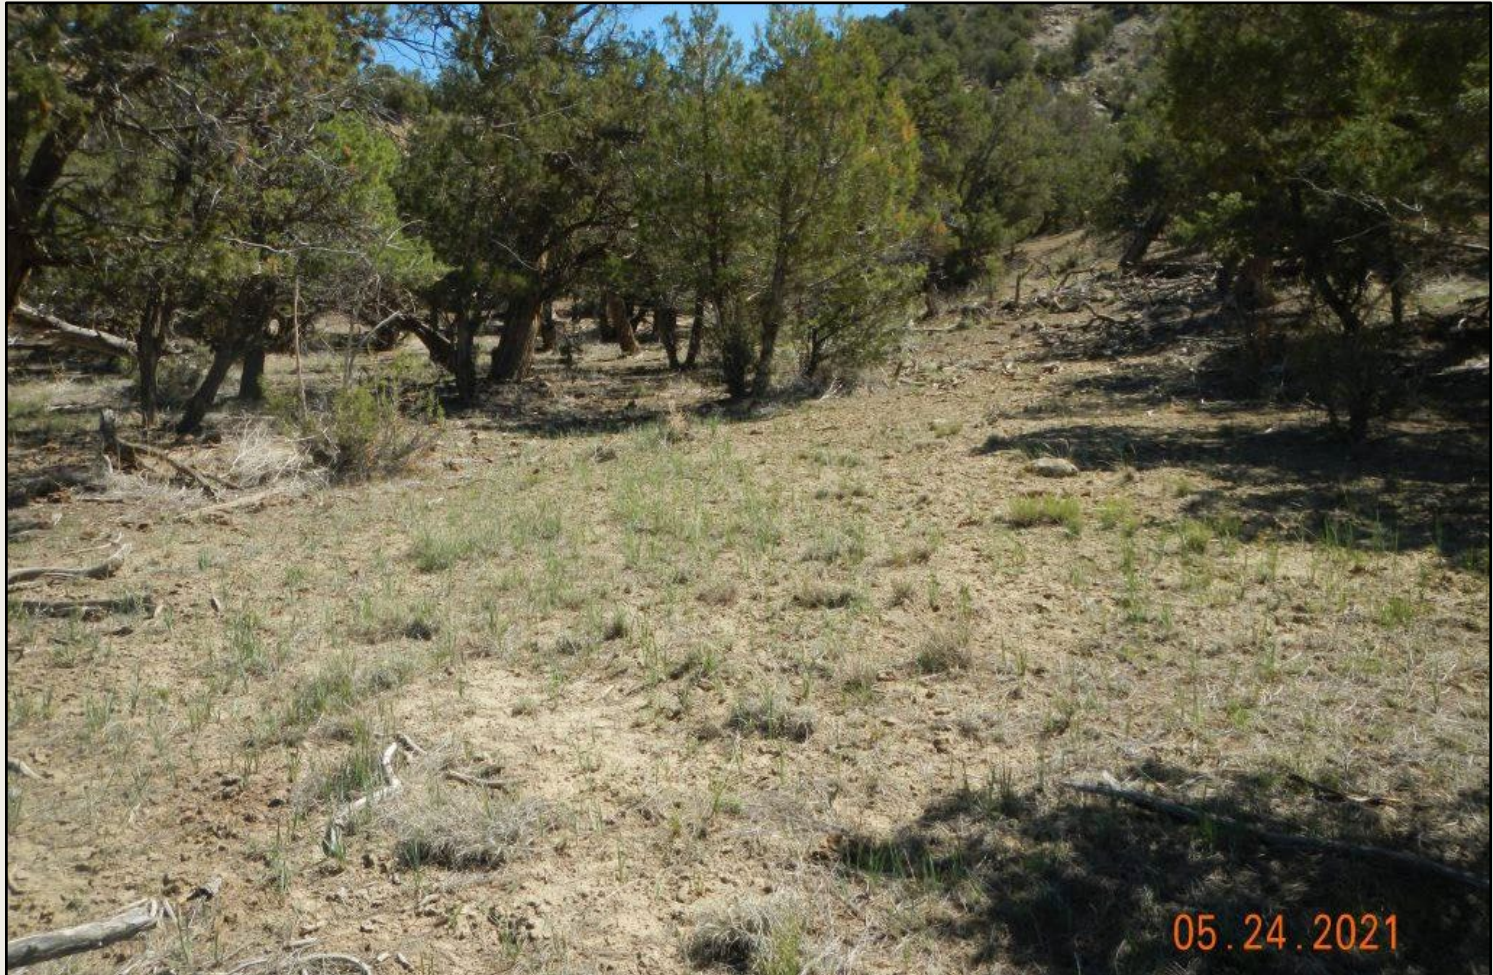
Photo 5. View of reference area comprised of pinyon and juniper woodland with western wheatgrass, pricklypear, phlox, and blue grama in the understory.
