Inspection Photos
spill doc 402679961
Spill #479949

Inspection Date: 5/6/2021
All Photos taken by Kris Neidel

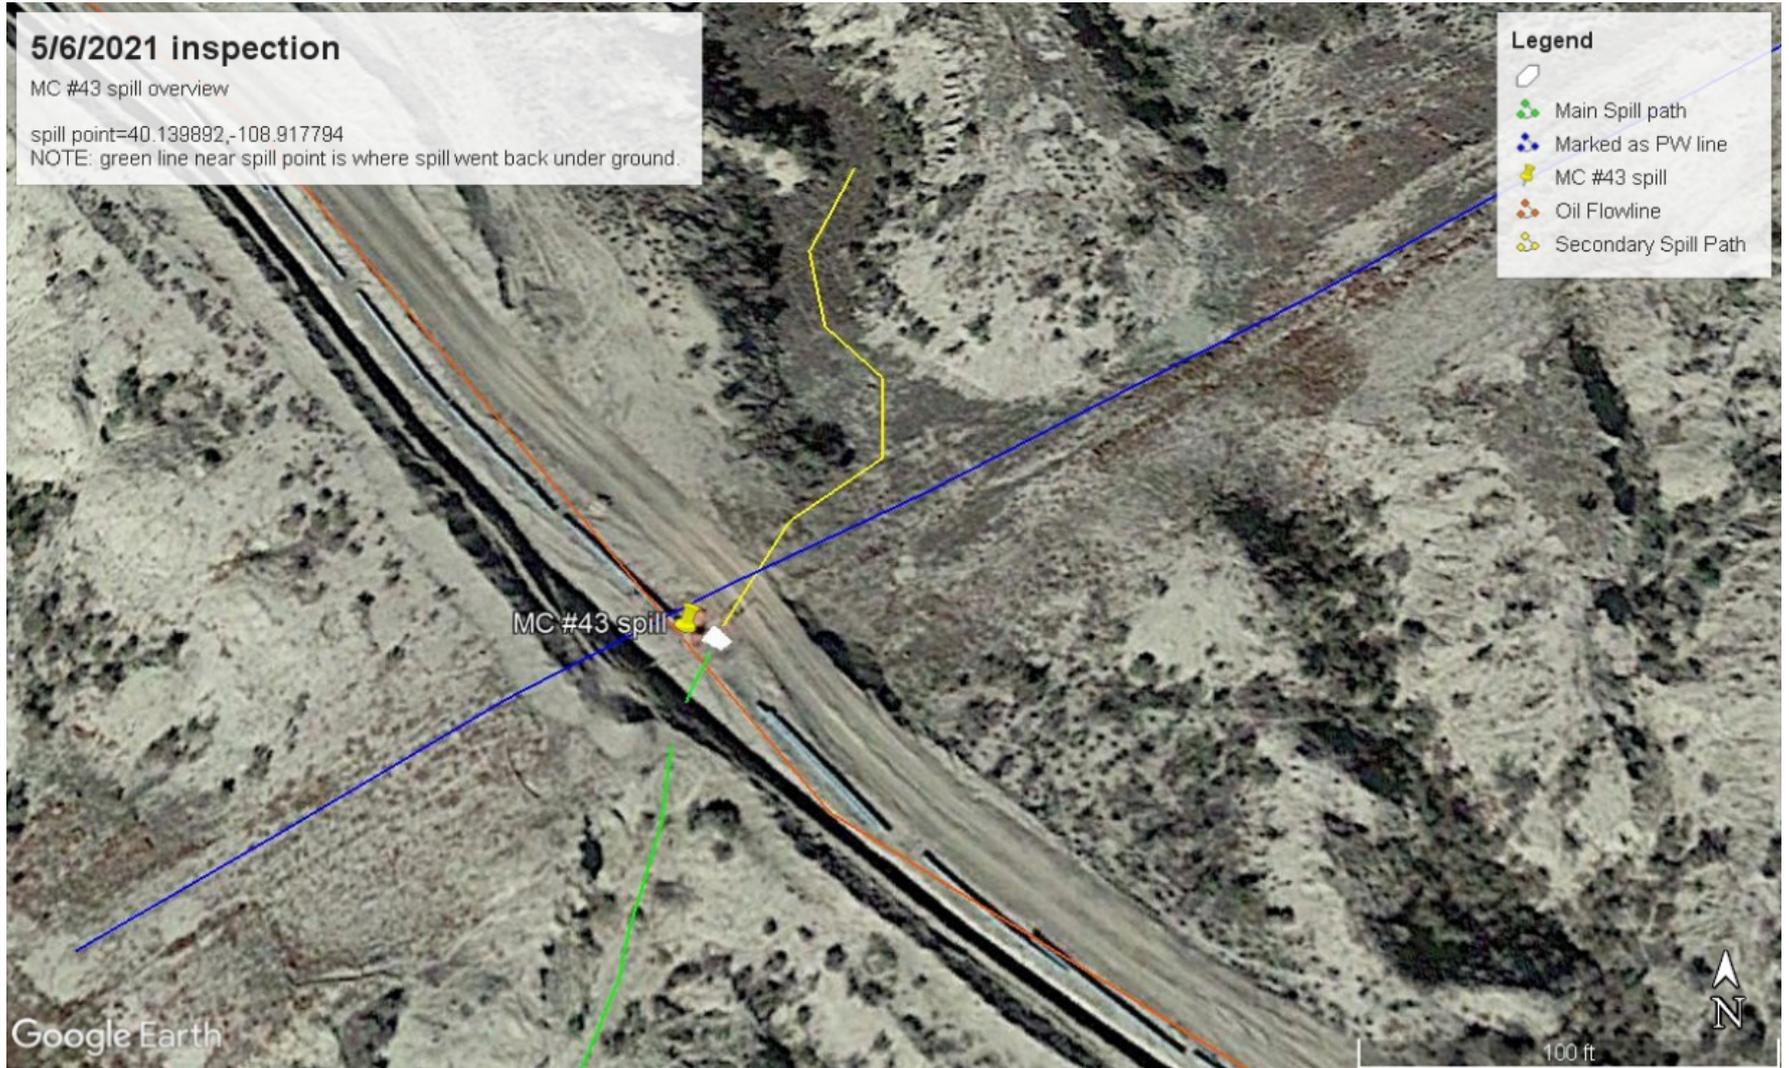
Figure #1

5/6/2021 inspection

MC #43 spill overview

spill point=40.139892,-108.917794

NOTE: green line near spill point is where spill went back under ground.
