Inspection Photos
Operator: Arkoma/Catamount
API: 067-05412
Date: 8/6/2021

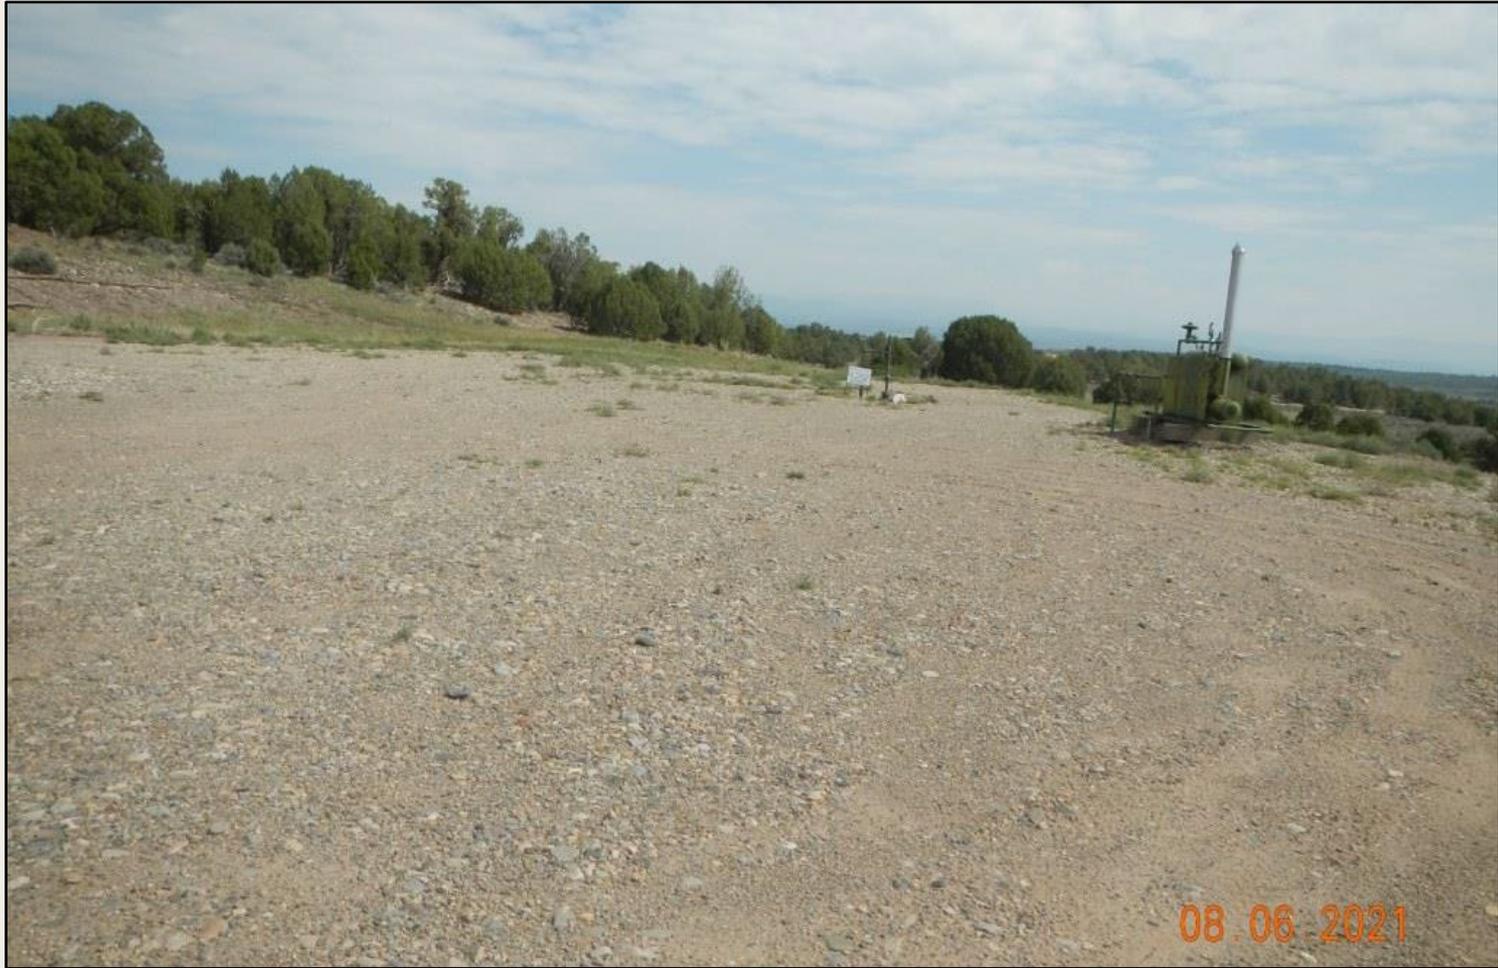
Photo 1. View of the project area from the well pad entrance facing center.

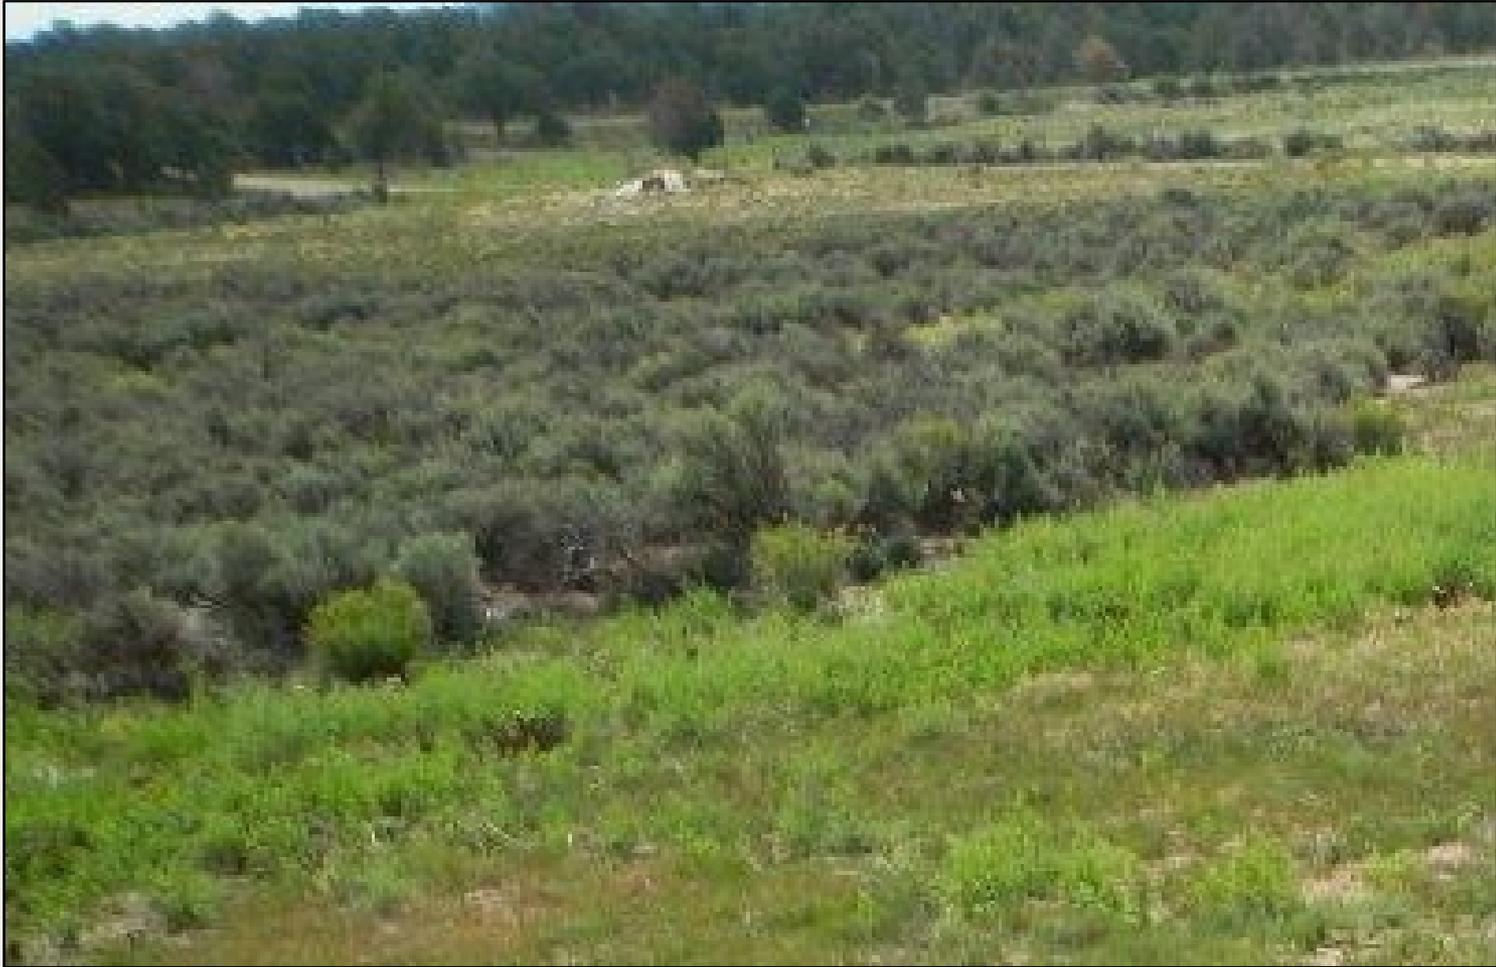
Photo 5. View of reference area comprised of sagebrush shrubland, open grass field, and pinyon and juniper woodland mosaic, with grasses and forbs such as western wheatgrass, James galleta, matt penstemon, and goldenaster.
