Stormwater Inspection Report

Operator:	Laramie Energy, LLC
Project:	Cascade Creek
Location:	Cascade Creek 604-41-32 Pad
Date:	Friday, May 7, 2021
Weather:	Mostly Sunny, Windy, 77°, Lo 41°

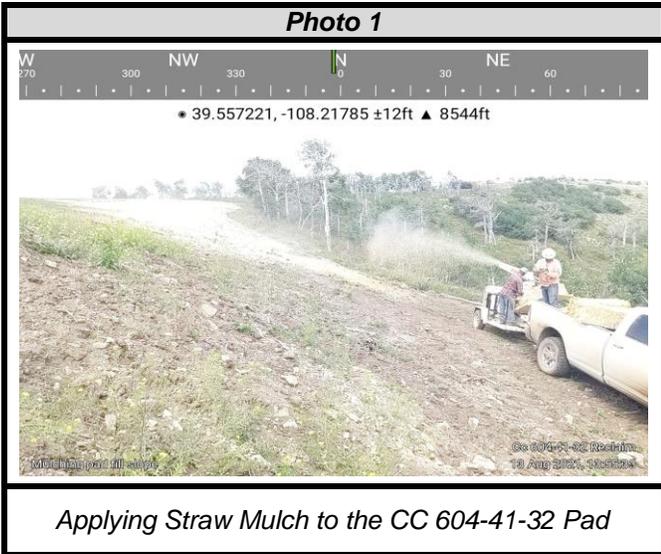
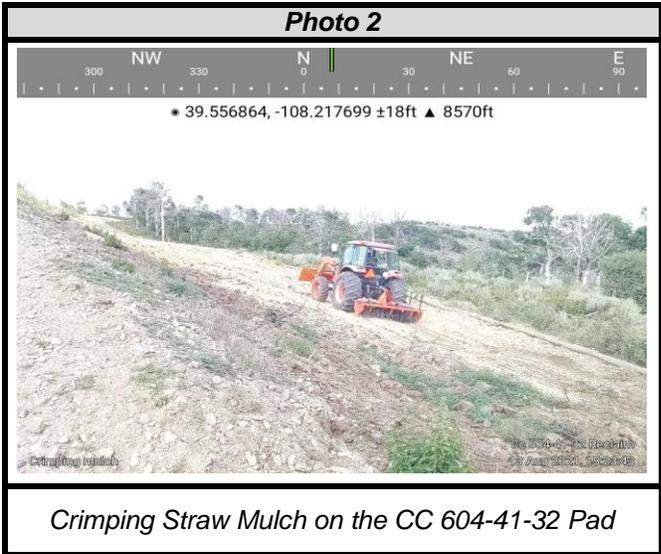
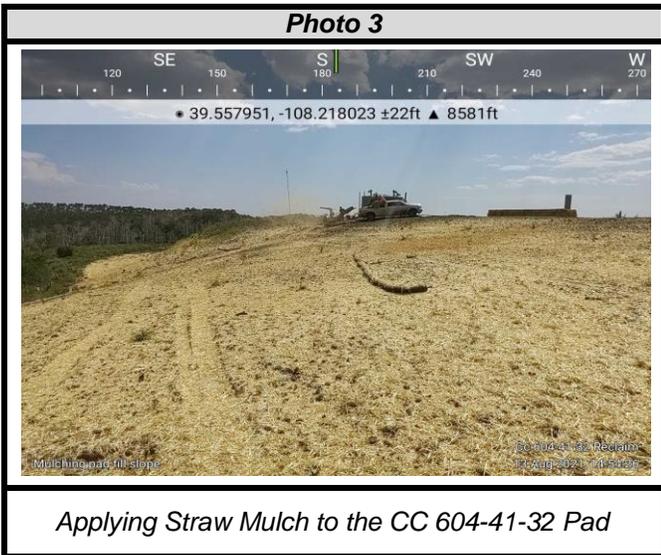
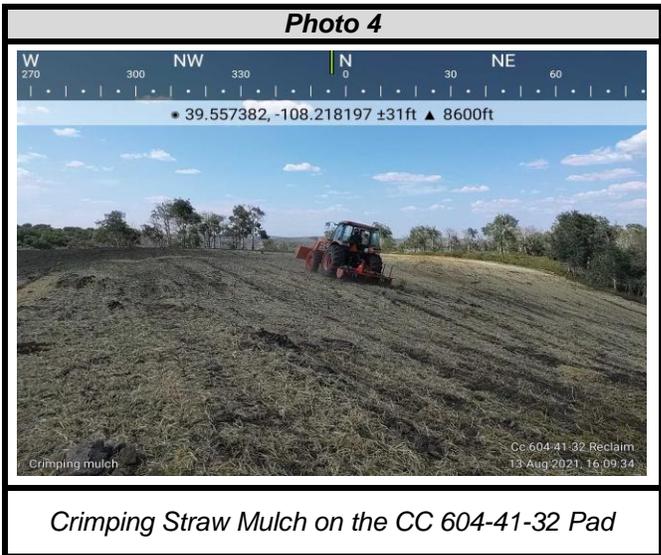
Comments / Descriptions / Explanations
<p>One BMP crew began mulching operations on the Cascade Creek 604-41-32 pad in response to issues identified in COGCC Document #696202681. Mulching operations were unable to be conducted sooner due to the lack of certified, weed-free straw bales available. This year's straw bales have just recently become available for purchase. The crew mobilized bales and equipment to the site and began mulching on the east side of the location.</p> <p>The crew used a mulch blower to apply 100 bales over the reclaimed portions of the CC 604-41-32 pad. Mulch was physically crimped with a tractor and crimping implement which binds straw into the soil. Mulching operations will resume and likely completed on Monday.</p>
