Inspection Photos
Location Name: Federal Wildhorse #15-31
Location ID: 322954

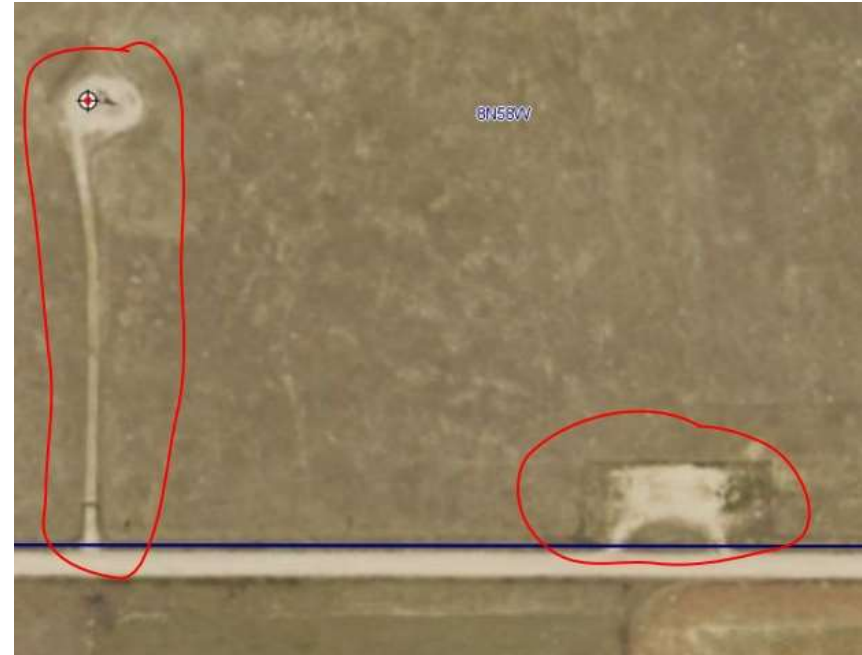
Photo 8 – 2019 aerial imagery using COGCC GISOnline illustrates the well location and the associated offsite tank battery location.
