Site Inspection Report

Site: MOSER 1A
04/22/2022

SITE/LOCATION	DATE	TIME	INSPECTOR
MOSER 1A	04/22/2022	12:44 PM	COGCC Subcontractor
Comments			
Work Activity Notes			
Changes since previous inspection?	No	Drive by inspection	No
Actively being worked?	No		
Fieldwork Oversight Performed?	No	Oversite Type	N/A
Were Oversight Samples Collected?	N/A	Sample Details	N/A

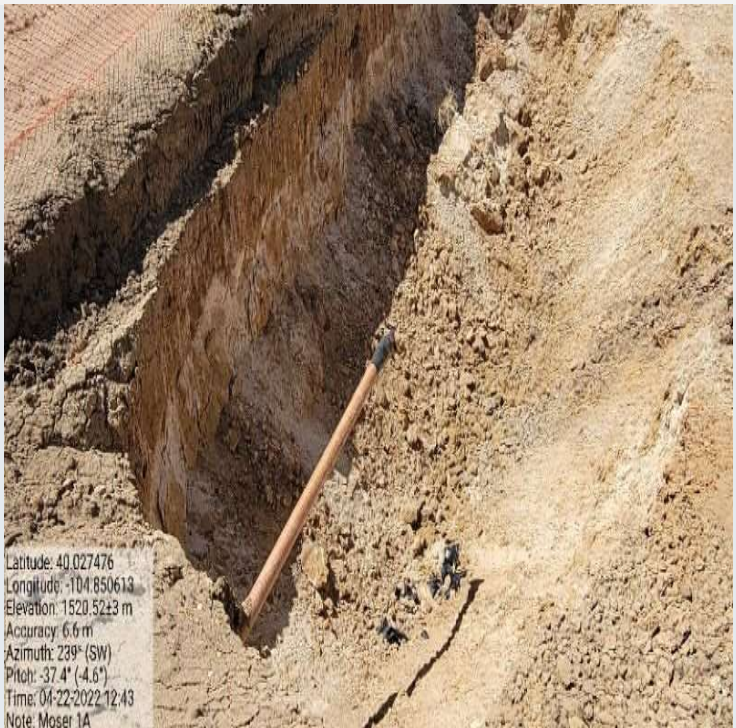
<p>Latitude: 40.027533 Longitude: -104.850465 Elevation: 1516.95±2 m Accuracy: 4.3 m Azimuth: 245° (SW) Pitch: -7.8° Time: 04-22-2022 12:43 Note: Moser 1A</p>
<p>Question: Exposed buried/underground flowlines? Response: Yes Notes:</p>	<p>No Photo</p>
<p>Question: If flowlines are exposed are they properly capped (bullnose plug, etc.)? Response: Yes Notes:</p>
