Inspection Photos  
Operator: Enduring  
API: 067-07514  
Date: 4/29/2022

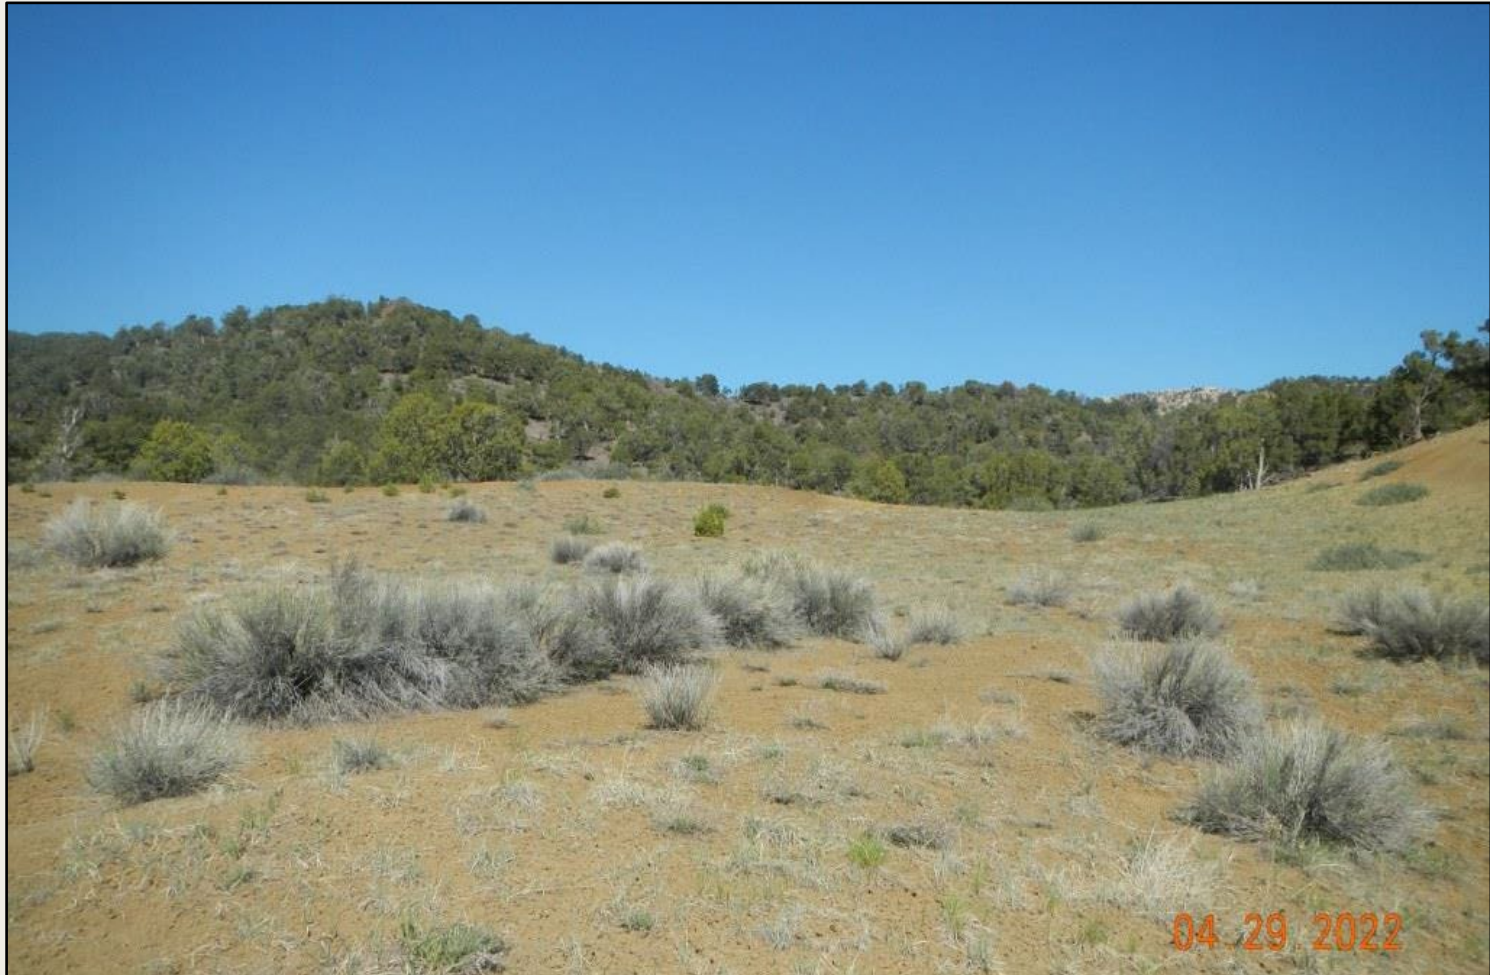
Photo 1. View of the project area from the well pad entrance facing center.

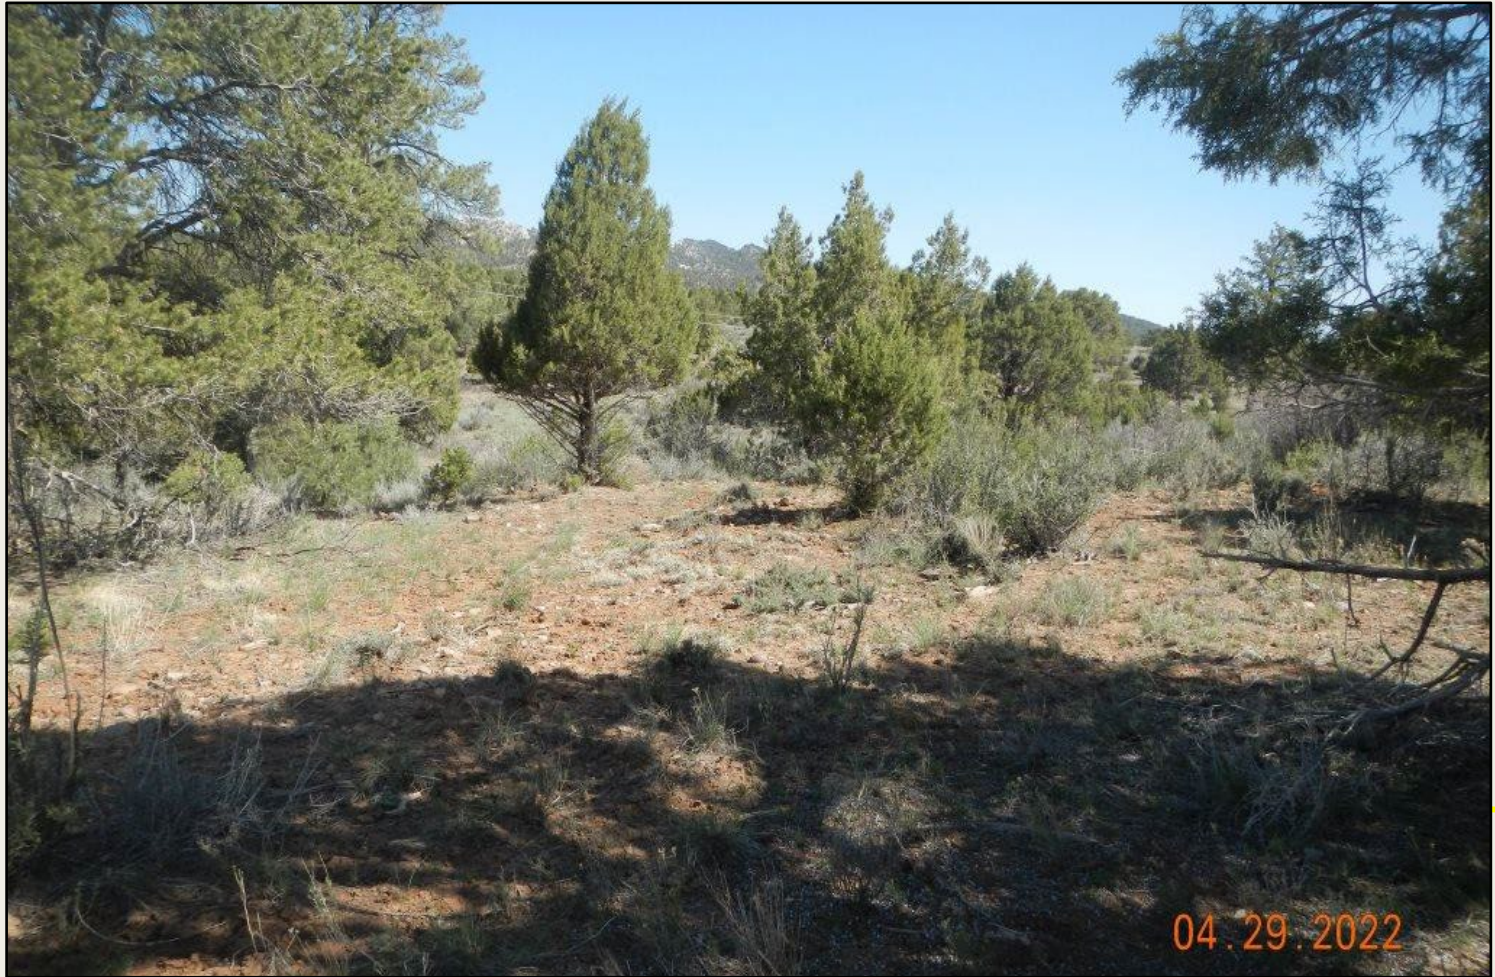
Photo 6. View of the reference area comprised of pinyon and juniper woodland with antelope bitterbrush, sagebrush, gambel oak, western wheatgrass, Indian ricegrass, and Navajo tea.
