## **ATTACHMENT B**

## TANK BATTERY DECOMMISSIONING FORM

<b>SITE NAME:</b> Brant HZ Facility							<b>DATE:</b> 6/2/2022	<b>REM. PROJECT #:</b>	<b>WEATHER:</b> Sunny 70's
<b>SITE DIRECTIONS:</b> From HWY 7 and Riverdale Road travel south 3/10 of a mile to location							<b>CLIENT:</b> PDC - Cheyenne		
<b>LEGALS AND LAT/LONG:</b>							<b>TASMAN PERSONNEL:</b> Sam Anderson		
<b>SOIL TYPES:</b> Clayey Sand - SC							<b>SURFACE GRADIENT:</b> Southeast		
SOIL SAMPLING							FACILITY INFRASTRUCTURE		
Date/Time	Soil Sample ID	PID (ppm)	Visual	Olfactory	Photo?	Grab or Lab Sample?	EQUIPMENT		Quantity
							Above Ground Storage Tank (AST)		
6/2/2022 10:40	GS01 @ 0-6"	3.4	HC Staining	Slight HC Odor	Yes	Grab	Buried or Partially Buried Vessel		
6/2/2022 10:42	GS02 @ 0-6"	0.8	No Staining	No Odor	Yes	Grab	Separator		
6/2/2022 10:44	GS03 @ 0-6"	11.5	HC Staining	Slight HC Odor	Yes	Grab	Emission Control Device (ECD)		
6/2/2022 10:46	GS04 @ 0-6"	0.4	No Staining	No Odor	Yes	Grab	Dump Line

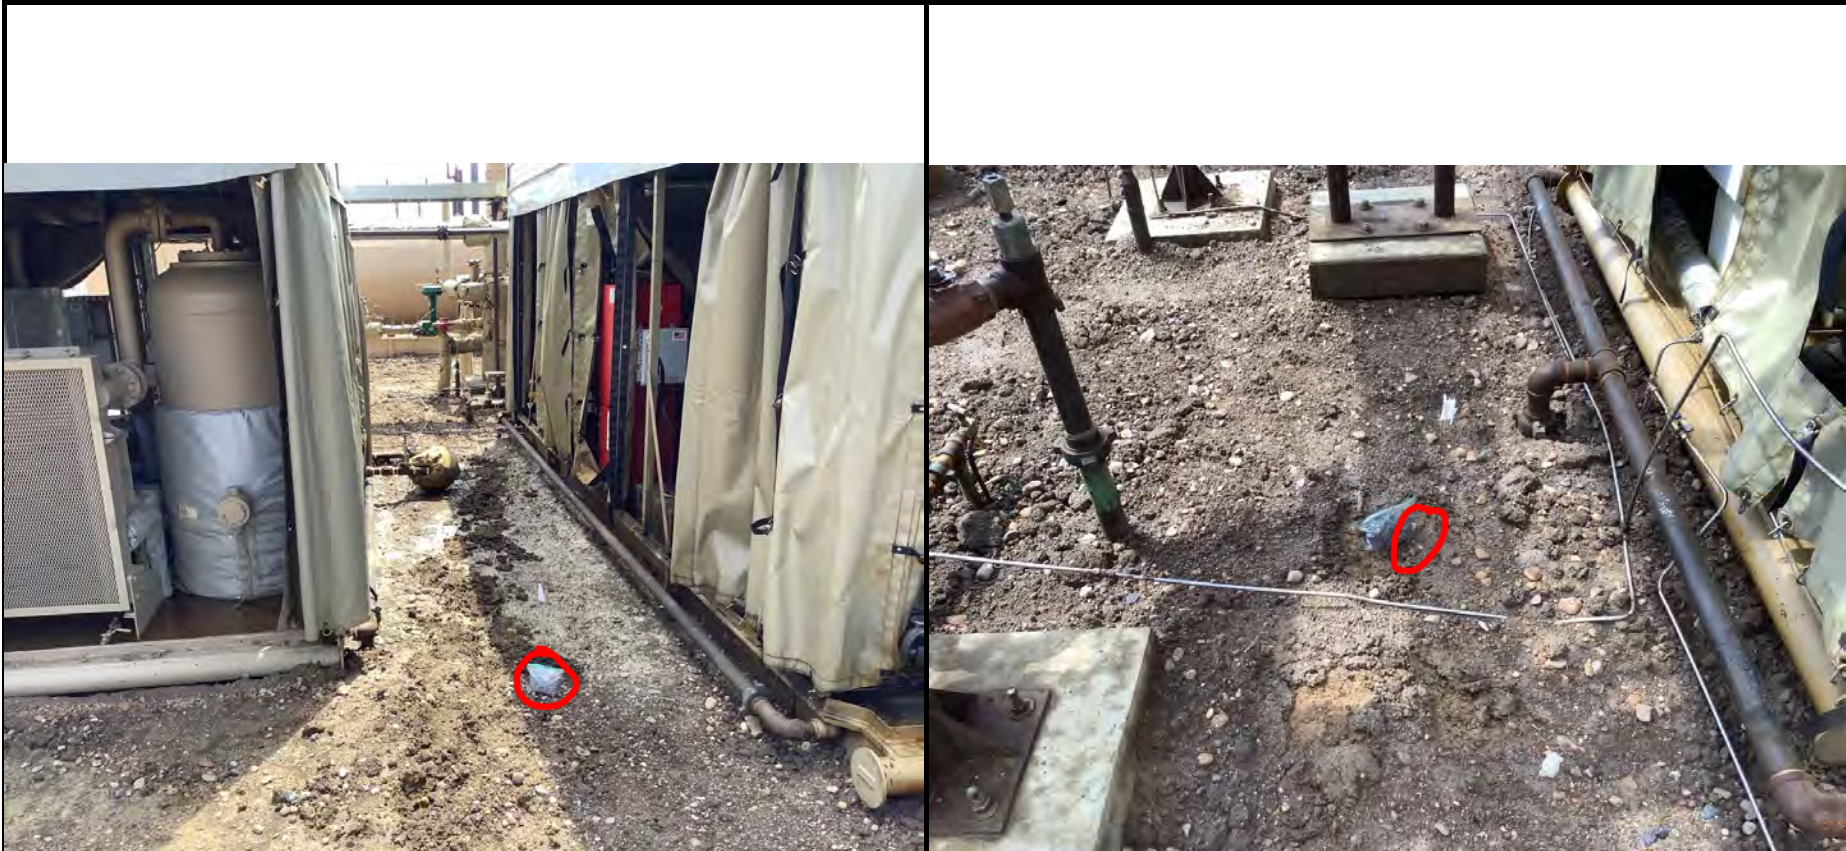
<b>Equipment ID:</b> GS06		<b>Equipment Type:</b>			<b>Equipment ID:</b> GS07		<b>Equipment Type:</b>		
<b>Material:</b>	<b>Volume:</b>	<b>Contents:</b>			<b>Material:</b>	<b>Volume:</b>	<b>Contents:</b>		
<b>Notes/Conditions:</b>					<b>Notes/Conditions:</b>

6/2/2022 10:48	GS05 @ 0-6"	14.9	HC Staining	Slight HC Odor	Yes	Grab	Wellhead		
6/2/2022 11:00	GS06@0-6"	1.4	No Staining	Slight HC Odor	Yes	Grab	Flowline		
6/2/2022 11:02	GS07@0-6"	224.7	HC Staining	HC Odor	Yes	Grab	<b>Other:</b>		
6/2/2022 11:04	GS08@0-6"	4.6	HC Staining	Slight HC Odor	Yes	Grab	Soil Loads Removed		
6/2/2022 11:06	GS09@0-6"	0.0	No Staining	No Odor	Yes	Grab	IMPACTED SOIL IDENTIFIED?		
6/2/2022 11:08	GS10 @ 0-6"	5.4	HC Staining	Slight HC Odor	Yes	Grab	ESTIMATED VOLUME OF IMPACTS:		
							Date	Number	CY
6/2/2022 11:10	GS11 @ 0-6"	0.0	No Staining	No Odor	Yes	Grab	6/2/2022		15
6/2/2022 11:12	GS12 @ 0-6"	0.0	No Staining	No Odor	Yes	Grab			
6/2/2022 11:56	SS01 @ 0-6"	2,266	HC Staining	Strong HC Odor	Yes	Lab			
6/2/2022 12:02	SS02 @ 0-6"	2.9	No Staining	Slight HC Odor	Yes	Lab			
6/2/2022 12:18	SS03 @ 0-6"	1.2	No Staining	Slight HC Odor	Yes	Lab			
6/2/2022 12:30	SS04 @ 0-6"	0.5	No Staining	No Odor	Yes	Lab	Total Removed		0      15

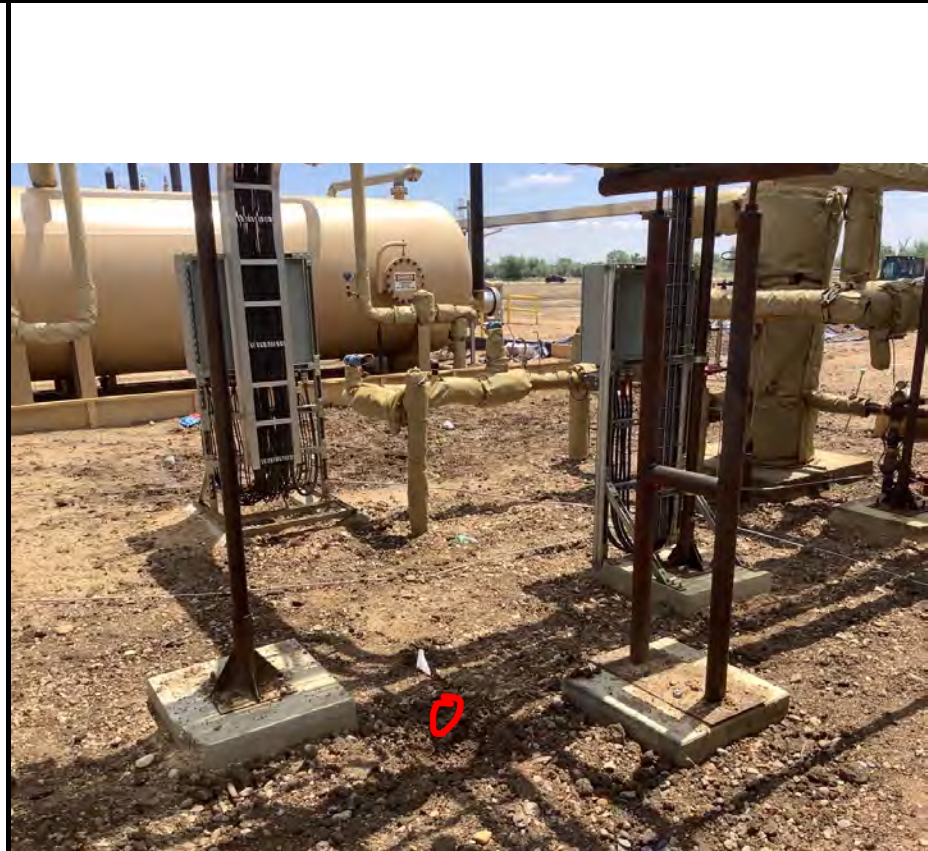
Equipment ID:SS05		Equipment Type:	
Material:	Volume:	Contents:	
Notes/Conditions:

6/2/2022 12:38	SS05 @ 0-6"	0.9	No Staining	No Odor	Yes	Lab	Disposal Facility:		
6/2/2022 12:45	SS06 @ 0-6"	377.6	HC Staining	HC Odor	Yes	Lab	Groundwater Recovery		
6/2/2022 12:51	SS07 @ 0-6"	5.2	No Staining	No Odor	Yes	Lab	DATE GW ENCOUNTERED:		DEPTH:
6/2/2022 13:00	SS08 @ 0-6"	6.4	No Staining	No Odor	Yes	Lab	GROUNDWATER IN CONTACT WITH IMPACTED SOIL?		
							LNAPL OR SHEEN OBSERVED ON GW?		
GROUNDWATER SAMPLING							Date		BBLS
Date/Time	Groundwater Sample ID	Depth Collected	Turbid?	Sheen?	Odor?	Photo?	6/2/2022		20
							Total Removed		20
							Disposal Facility:
