Colorado Oil and Gas Conservation Commission

# TEP Fed. RG 11-13-298, #482958 Annotation Report

# TEP Fed. RG 11-13-298, #482958 Issue Report

11/21/2022

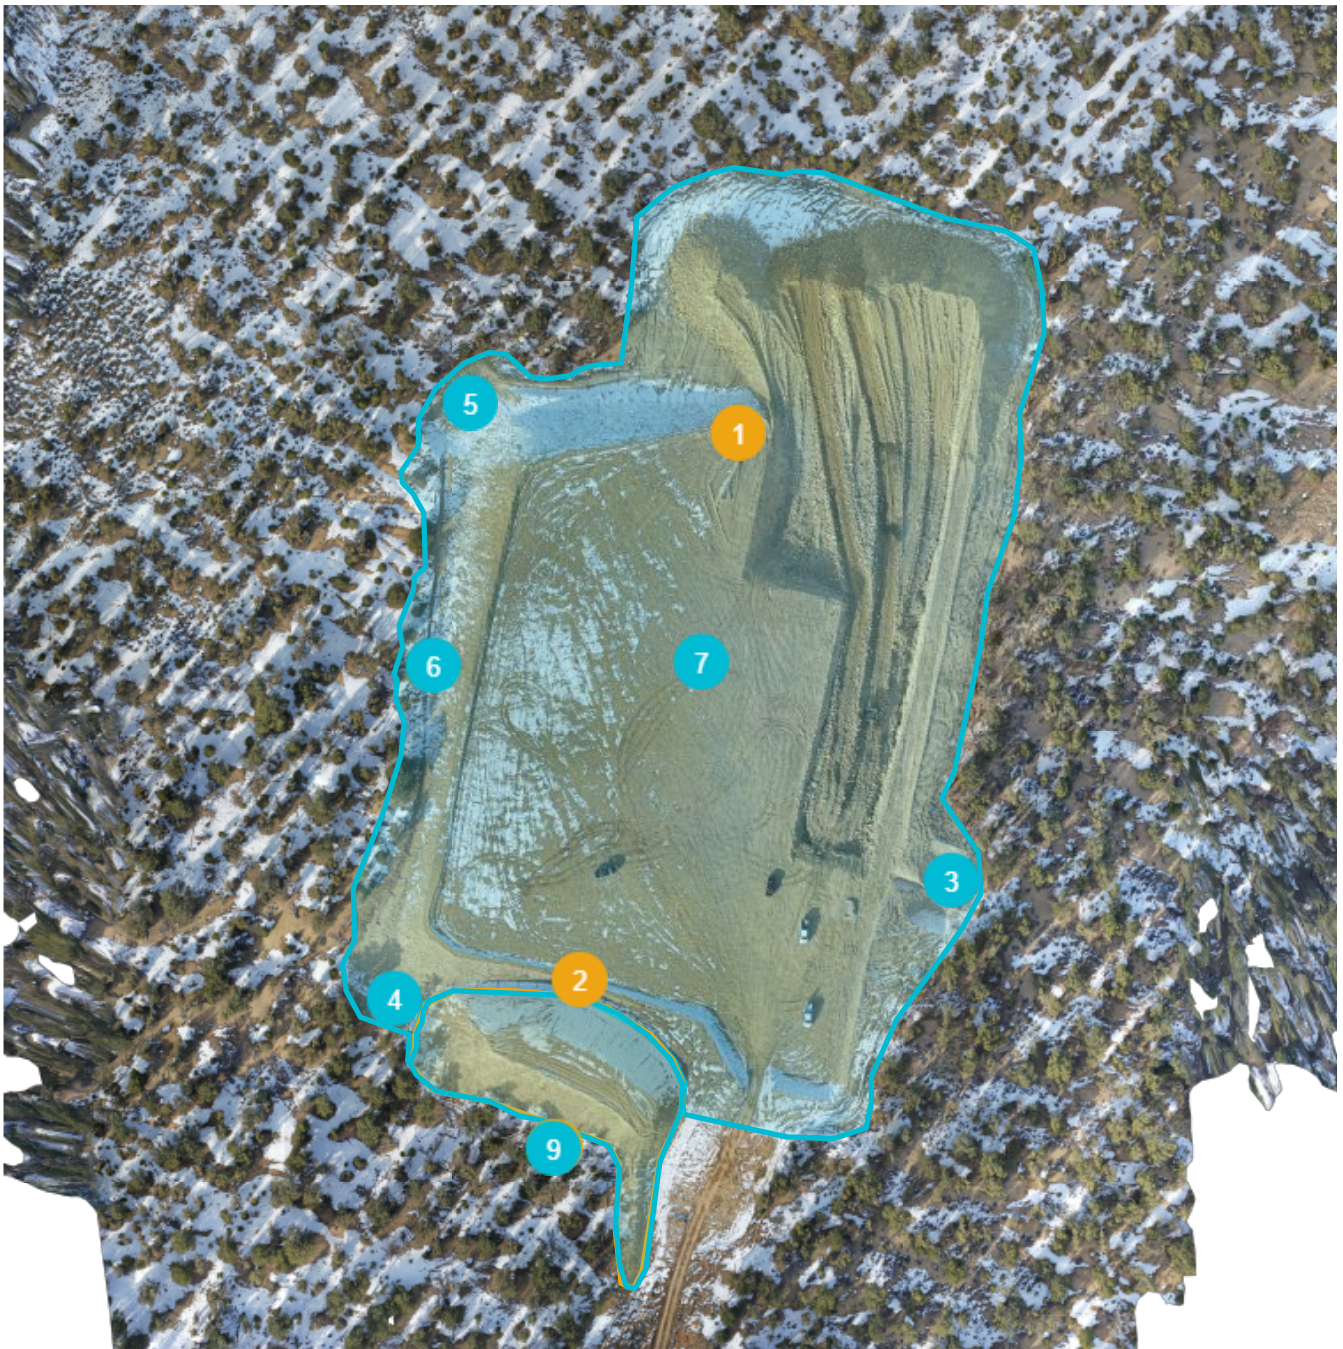
Missing point of discharge	6638.68 ft	39.8830589, -108.3463230
2

Missing point of discharge	6645.89 ft	39.8817811, -108.3468031
3

Sediment Trap	6633.82 ft	39.8820129, -108.3456702
4

Sediment Trap	6618.99 ft	39.8817374, -108.3473663
5

Sediment Trap	6595.66 ft	39.8831298, -108.3471382
6

Stormwater Diversion Ditch	6618.28 ft	39.8825156, -108.3472460

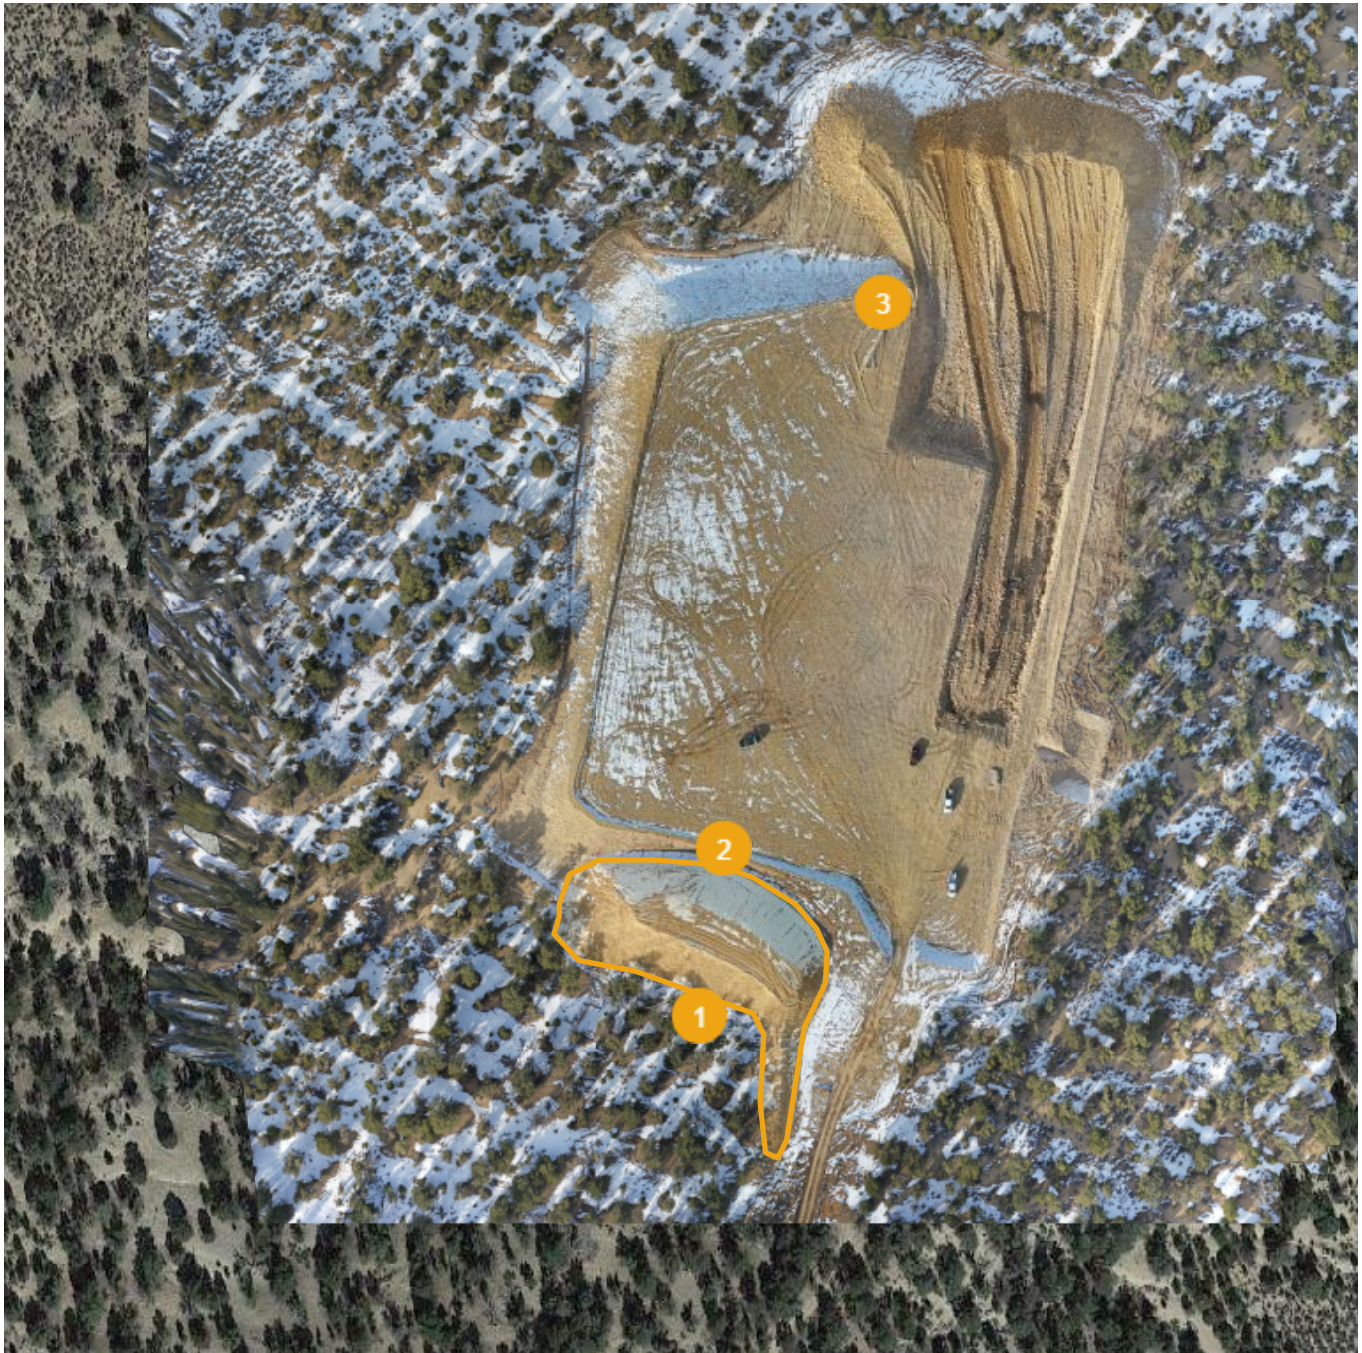
3 - Incomplete Work

Summary:	Figures within SWMP #403047575 identifies a stormwater discharge point, to allow stormwater discharge from the working pad area of the Location to the storwmater diversion ditch; no outlet has been constructed on the northern end of the Location to allow for discharge per the SWMP.		
Created:	Nov 28, 2022, 12:42pm by Aaron Trujillo		
Cost of Repair:	—		
Coordinates:	39.88306, -108.34632		
Elevation:	6638.68 ft
