PROJECT REPORT**REPORT NUMBER:** TAP-101122-1**DATE:** November 30, 2022**CLIENT INFORMATION**Taproot Energy Partners
555 17th Street, Suite 800
Denver, CO 80202
Attn: Dale Hunt**SAMPLE DESCRIPTION**

Three (3) samples of 4" Shawcor Flexpipe (FP301W) were received from the client on 10/11/2022. These three (3) samples were reportedly removed from the "Big Mountain Viper" pipeline and consisted of a ruptured section approximately 10 feet long with the rupture at the approximate center of the sample, as well as two undamaged sections approximately 8 feet long which were removed from locations near the failure. The samples contained the following printline:

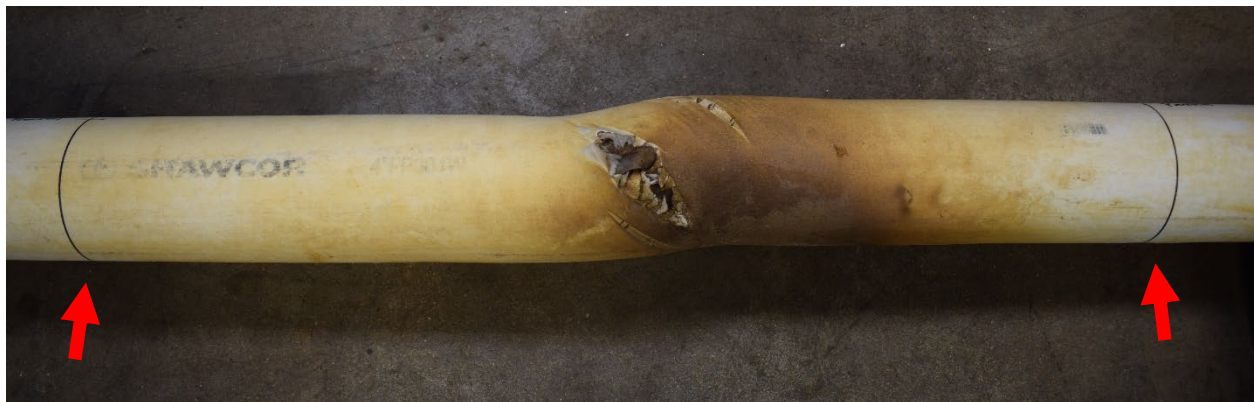
In order to ease sample handling, the ruptured sample was sectioned. A 3-foot-long section of the sample was removed with the center of this section corresponding to the failure locus.

Figure 4. The 3-foot-long section of the rupture sample marked prior to cutting.

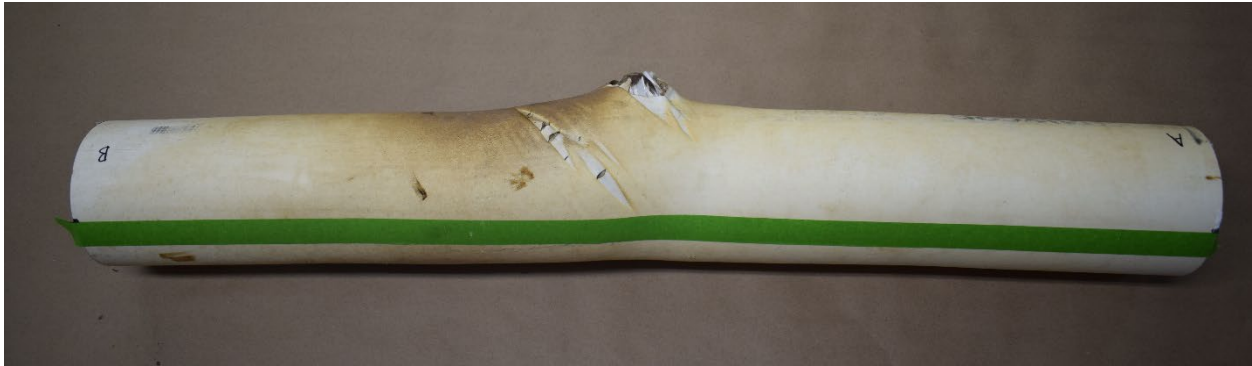
Following sectioning of the rupture sample using a reciprocating saw, the section was marked using masking tape. Two (2) lines running down the axis of the pipe were marked allowing cutting of the outer jacket outside of the rupture location (see Figure 5).

Figure 5. The 3-foot-long section following marking with masking tape. Note that another line is marked approximately 180° opposite the one shown.
