SITE NAME: Koch Kenneth E A1 O SA							DATE: 12/7/2022		REM. PROJECT #:		WEATHER: 38 Degrees, Sunny	
SITE DIRECTIONS: CO Hwy 52 & CR 3, S 5/10, W Into							CLIENT: Oxy					
LEGALS AND LAT/LONG: 40.079631, -105.038060							TASMAN PERSONNEL: Logan Molson					
SOIL TYPES: Clayey Sand - SC							SURFACE GRADIENT: West					
SOIL SAMPLING							FACILITY INFRASTRUCTURE					
Date/Time	Soil Sample ID	PID (ppm)	Visual	Olfactory	Photo?	Grab or Lab Sample?	EQUIPMENT		Quantity			
							Above Ground Storage Tank (AST)		3			
12/7/2022 10:30	PW1-B01@5'	0.4	Organic Content	Organic Odor	Yes	Lab	Buried or Partially Buried Vessel		1			
12/7/2022 10:35	PW1-N01@3'	0.5	No Staining	No Odor	Yes	N/A	Separator		1			
12/7/2022 10:37	PW1-S01@3'	0.2	No Staining	No Odor	Yes	N/A	Emission Control Device (ECD)		1			
12/7/2022 10:39	PW1-E01@3'	2.5	No Staining	No Odor	Yes	Lab	Dump Line		1			
12/7/2022 10:41	PW1-W01@3'	0.4	No Staining	No Odor	Yes	N/A	Wellhead

Photographic Log

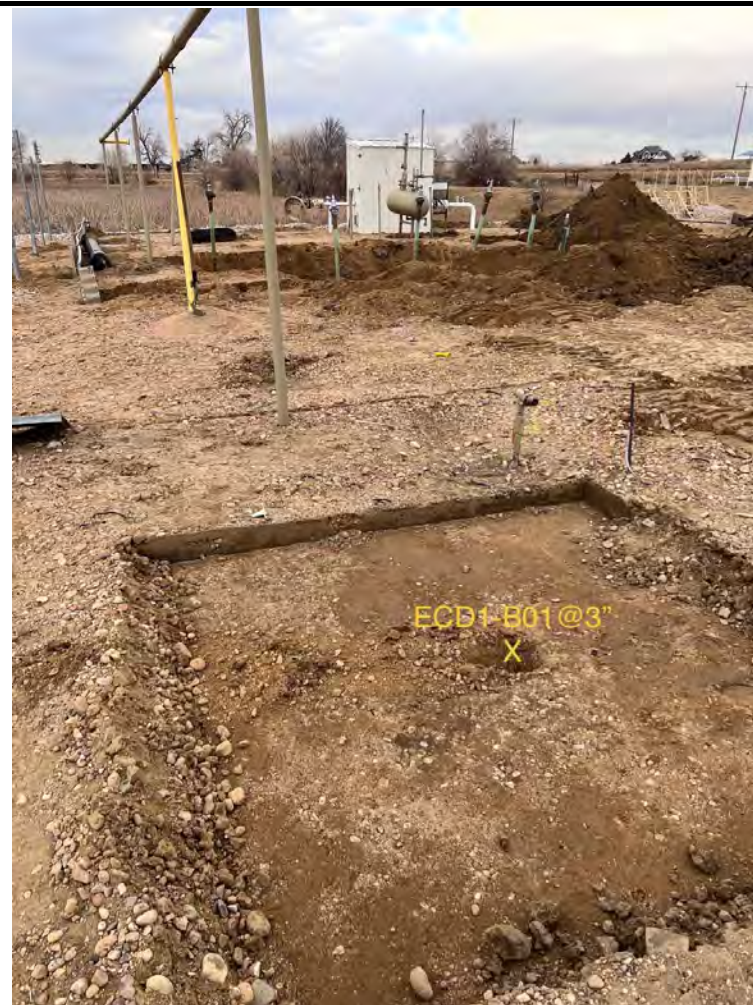
Equipment ID:		Equipment Type:	
Material:	Volume:	Contents:	
Notes/Conditions: Prior sampling location of 3" dug down to expose dump lines for removal
