# Site Inspection Report

**Site: UPRR 43 PAN AM I5**  
12/12/2022

SITE/LOCATION	DATE	TIME	INSPECTOR
UPRR 43 PAN AM I5	12/12/2022	11:40 AM	COGCC Representative
Comments			
Work Activity Notes			
Changes since previous inspection?	No	Drive by inspection	No
Actively being worked?	No		
Fieldwork Oversight Performed?	No	Oversight Type	
Were Oversight Samples Collected?	No	Sample Details

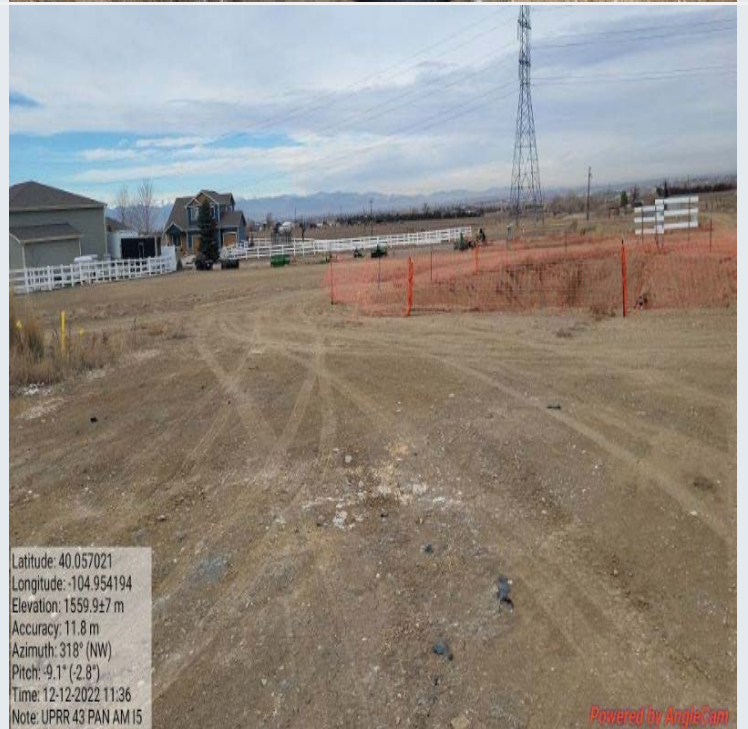
Photo
<p><b>Question:</b> Groundwater present within excavation? Note: Depth to water below grade surface (ft), free product/sheen</p> <p><b>Response:</b> No</p> <p><b>Notes:</b></p>	  <p>Latitude: 40.057212 Longitude: -104.954135 Elevation: 1558.1±9 m Accuracy: 9.1 m Azimuth: 280° (W) Pitch: -15.6° (-1.9°) Time: 12-12-2022 11:35 Note: UPRR 43 PAN AM I5</p> <p>Powered by AngliaCam</p>
<p><b>Question:</b> Monitoring well(s) present? Note: Number, approximate location(s), condition</p> <p><b>Response:</b> No</p> <p><b>Notes:</b> None present at site.</p>

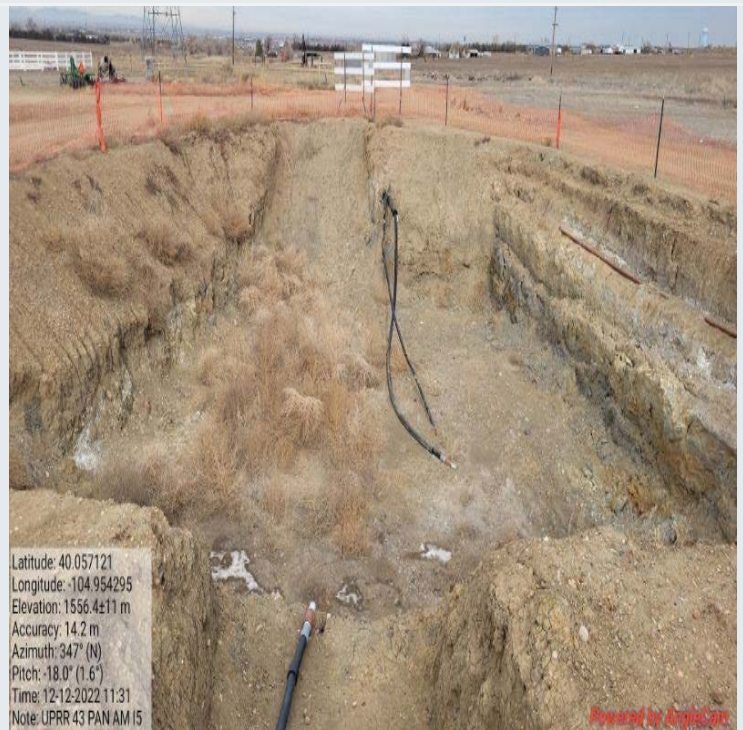
**Question:** Is earthen berm secondary containment present and in good condition (compacted, complete, no evidence of erosion, animal burrowing, etc.)?

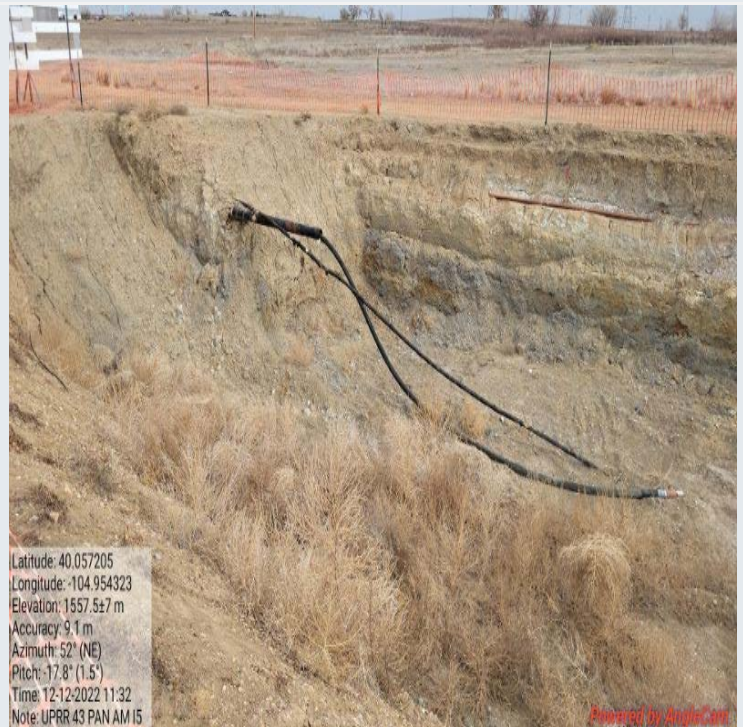
**Question:** All stormwater erosion control measures and BMPs are present and in good/working condition?

**Notes:** Weeds in excavation.
