# Storm Water Management and Erosion control

**Location Name: TEP ROCKY MOUNTAIN LLC DERE-66S95W /35SWSW**

**Location #: 334772**

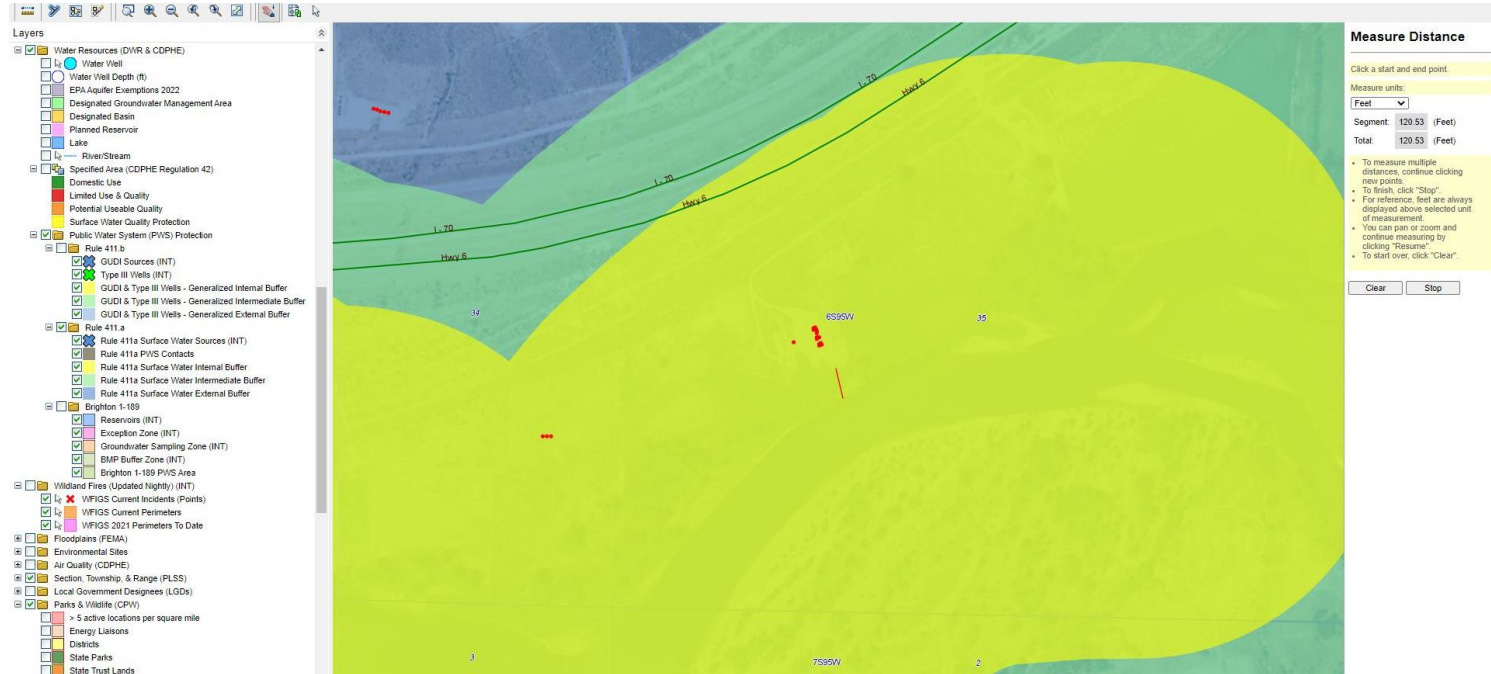
**Location Overview: Location is located in a 411 a. internal buffer zone.**  
**Additionally approximately 30 yards from the Colorado River.**  
**Section/Township/Range: 35 6S95W**
