# Final Reclamation Inspection

Operator: BONANZA CREEK ENERGY OPERATING COMPANY LLC - #8960

Location ID: 331251

Inspection Photos  
Location Name: DOW #21-28  
Location ID: 331251

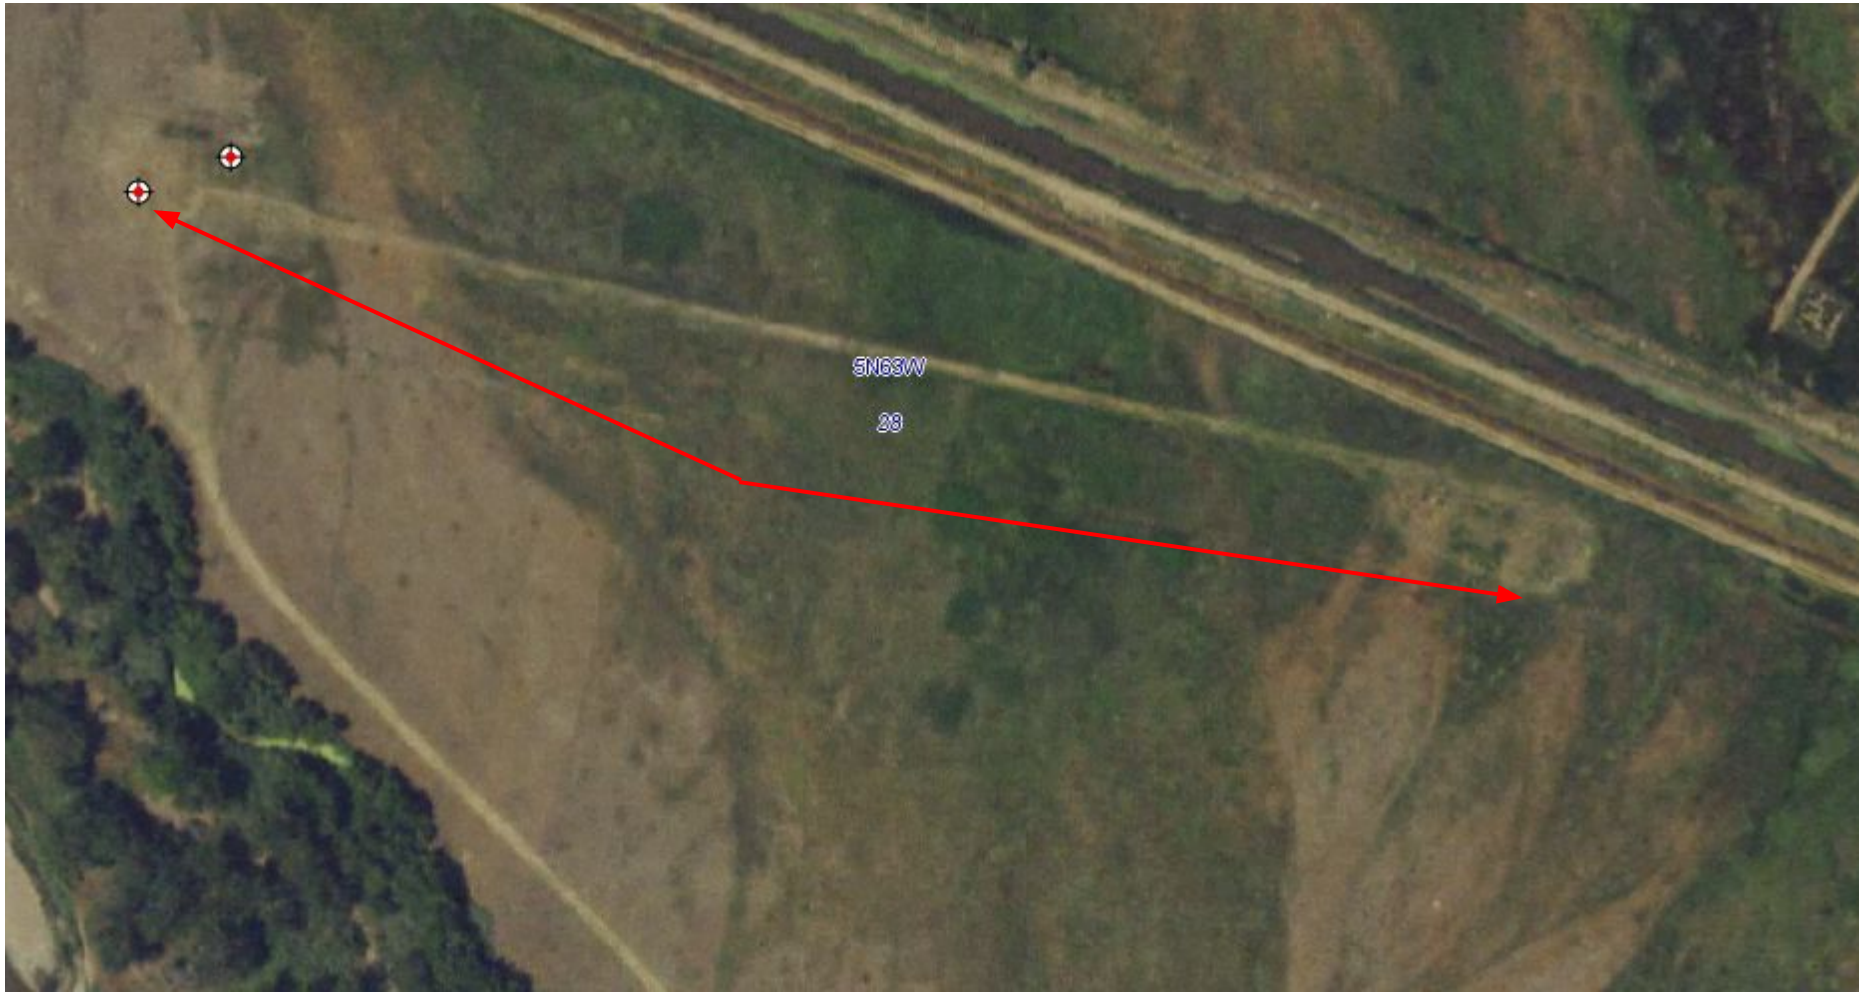
**Photo 1.** COGCC GISOnline aerial imagery from 2021. This inspection covers the well location, access road and tank battery.

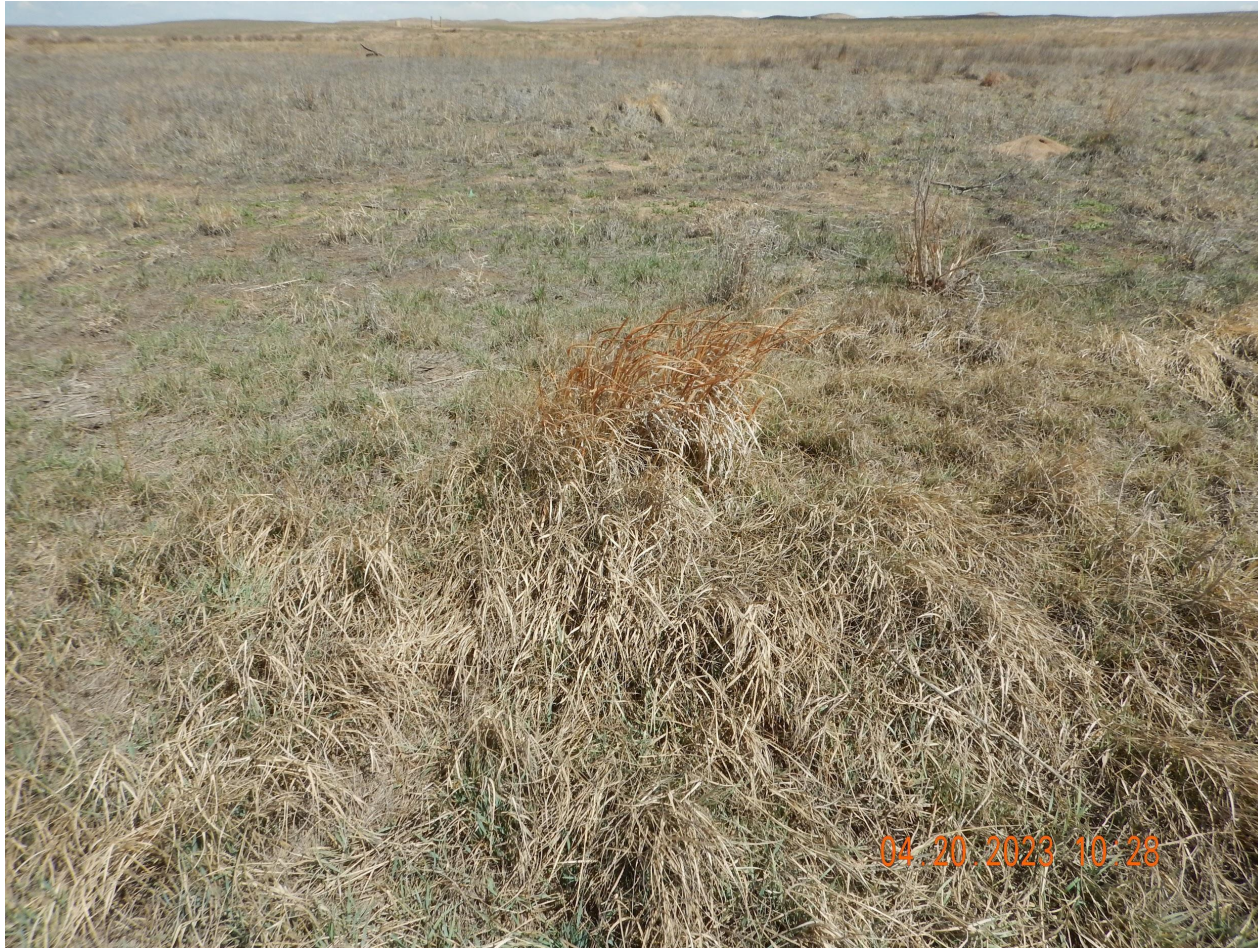
**Photo 4.** Reference photo taken adjacent to the well location, facing North.
