Well Name: Carpenter 32-6-3 2/Carpenter 32-6-3 15
Document Number: 712700091
Inspector: Curtis Pattillo

Location ID 438700

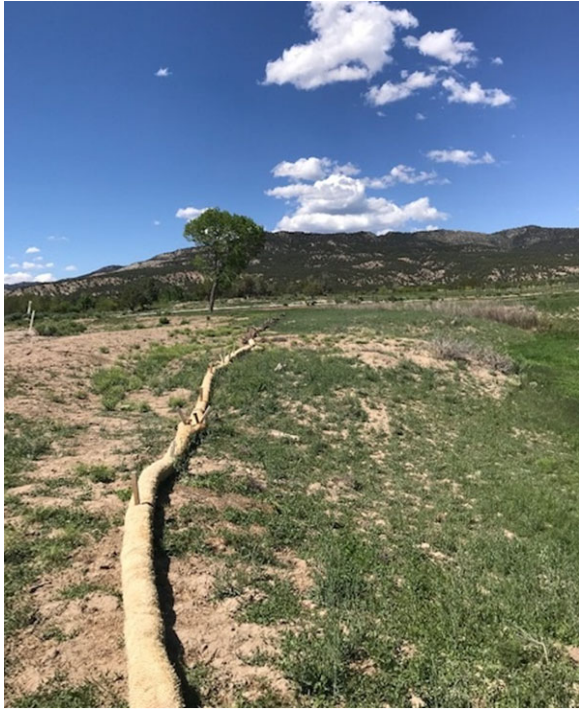
Installed wattles along eastern side of location berms must be maintained or removed. Previous inspection on 1/11/2022 required the installation of BMPs and spot seeding. The area has not been stabilized, reseeding as not been successful. Contact the SW Reclamation Specialist Ryan Costa regarding interim reclamation. See Photos #2 & #3.

Action Taken: Contacted SW Reclamation Specialist Ryan Costa regarding interim reclamation. Currently attempting to contact landowner to get permission to fence location to keep livestock away from reclamation areas. Plan to re-seed once permission is received to fence off location. Installed new wattles/repositioned existing wattles surrounding location.
