Donovan Brothers Incorporated

Engineering Field Observation
August 8, 2022, between 8:45 AM and 2:30 PM
Plug and Abandon Off Location Pipeline
Livengood 7-7 flowline
Facility ID 481142
SWNE Section 7, Township 7 North, Range 59 West, 6th P.M.
Weld County, Colorado
Local access: from the intersection of County Roads 86 and 105:
East 2.5 miles, South 1.5 miles, and West 0.4 miles

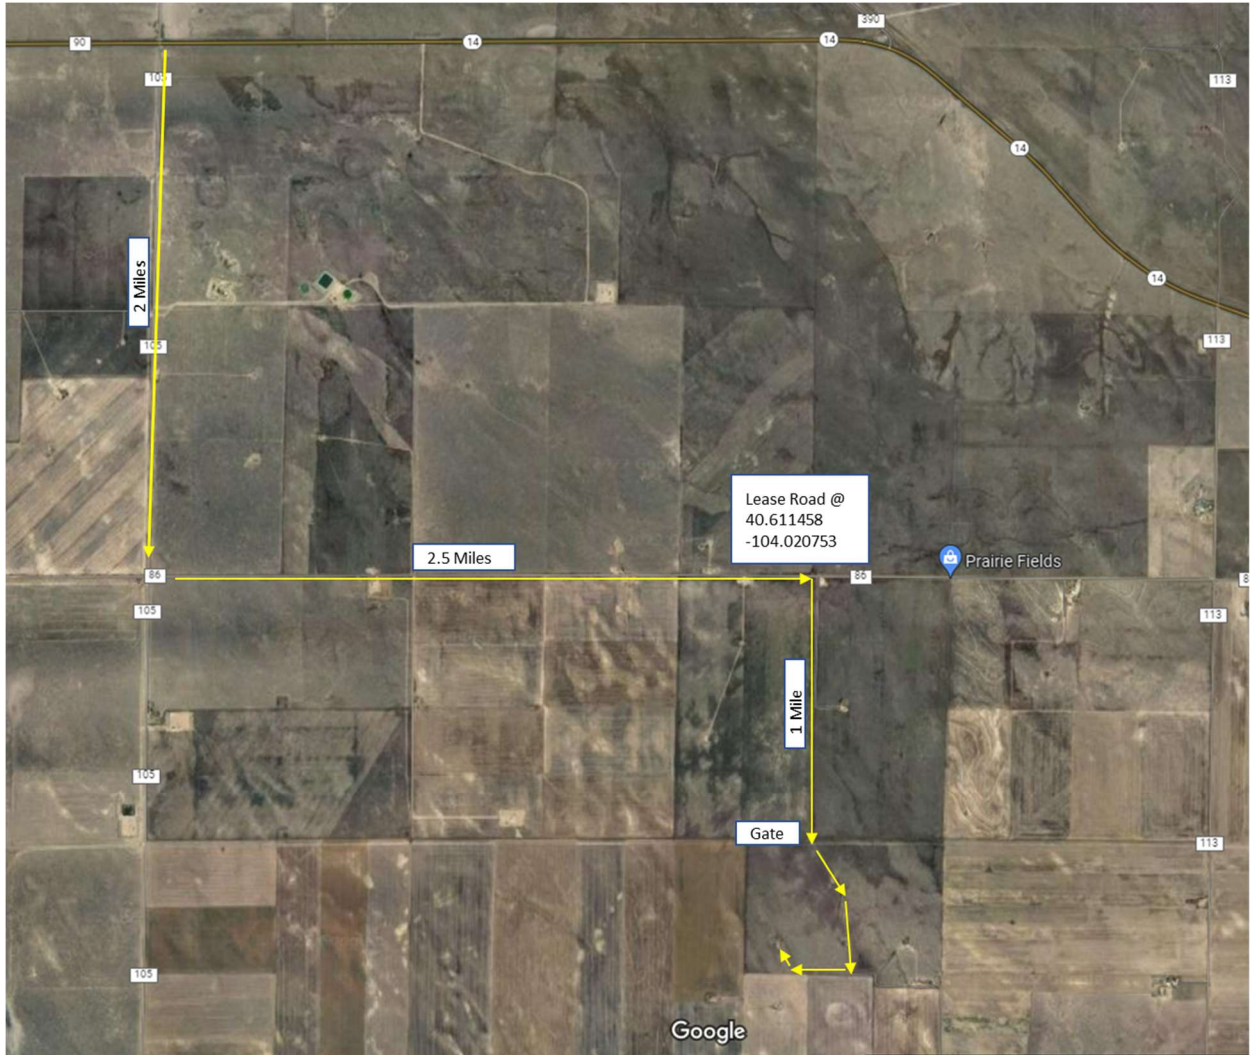
Figure 2-Aerial Photograph

The provided aerial photograph (see figure 2) shows the abandoned well location and abandoned production pad. The approximate flowline path between the abandoned well and production was visually inspected. The visual inspection of the surface from the abandoned well to the abandoned production pad was performed. Walking in a zig-zag pattern to the abandoned well from the abandoned production pad and back again showed that no surface valves or valve

Livengood Tank Battery & Flowline Map
Location ID 481140
Livengood 7-7 Wellhead – API No. 05-123-14742
