Location  
: 446527

**COLORADO**  
Energy & Carbon Management  
Commission  
Department of Natural Resources

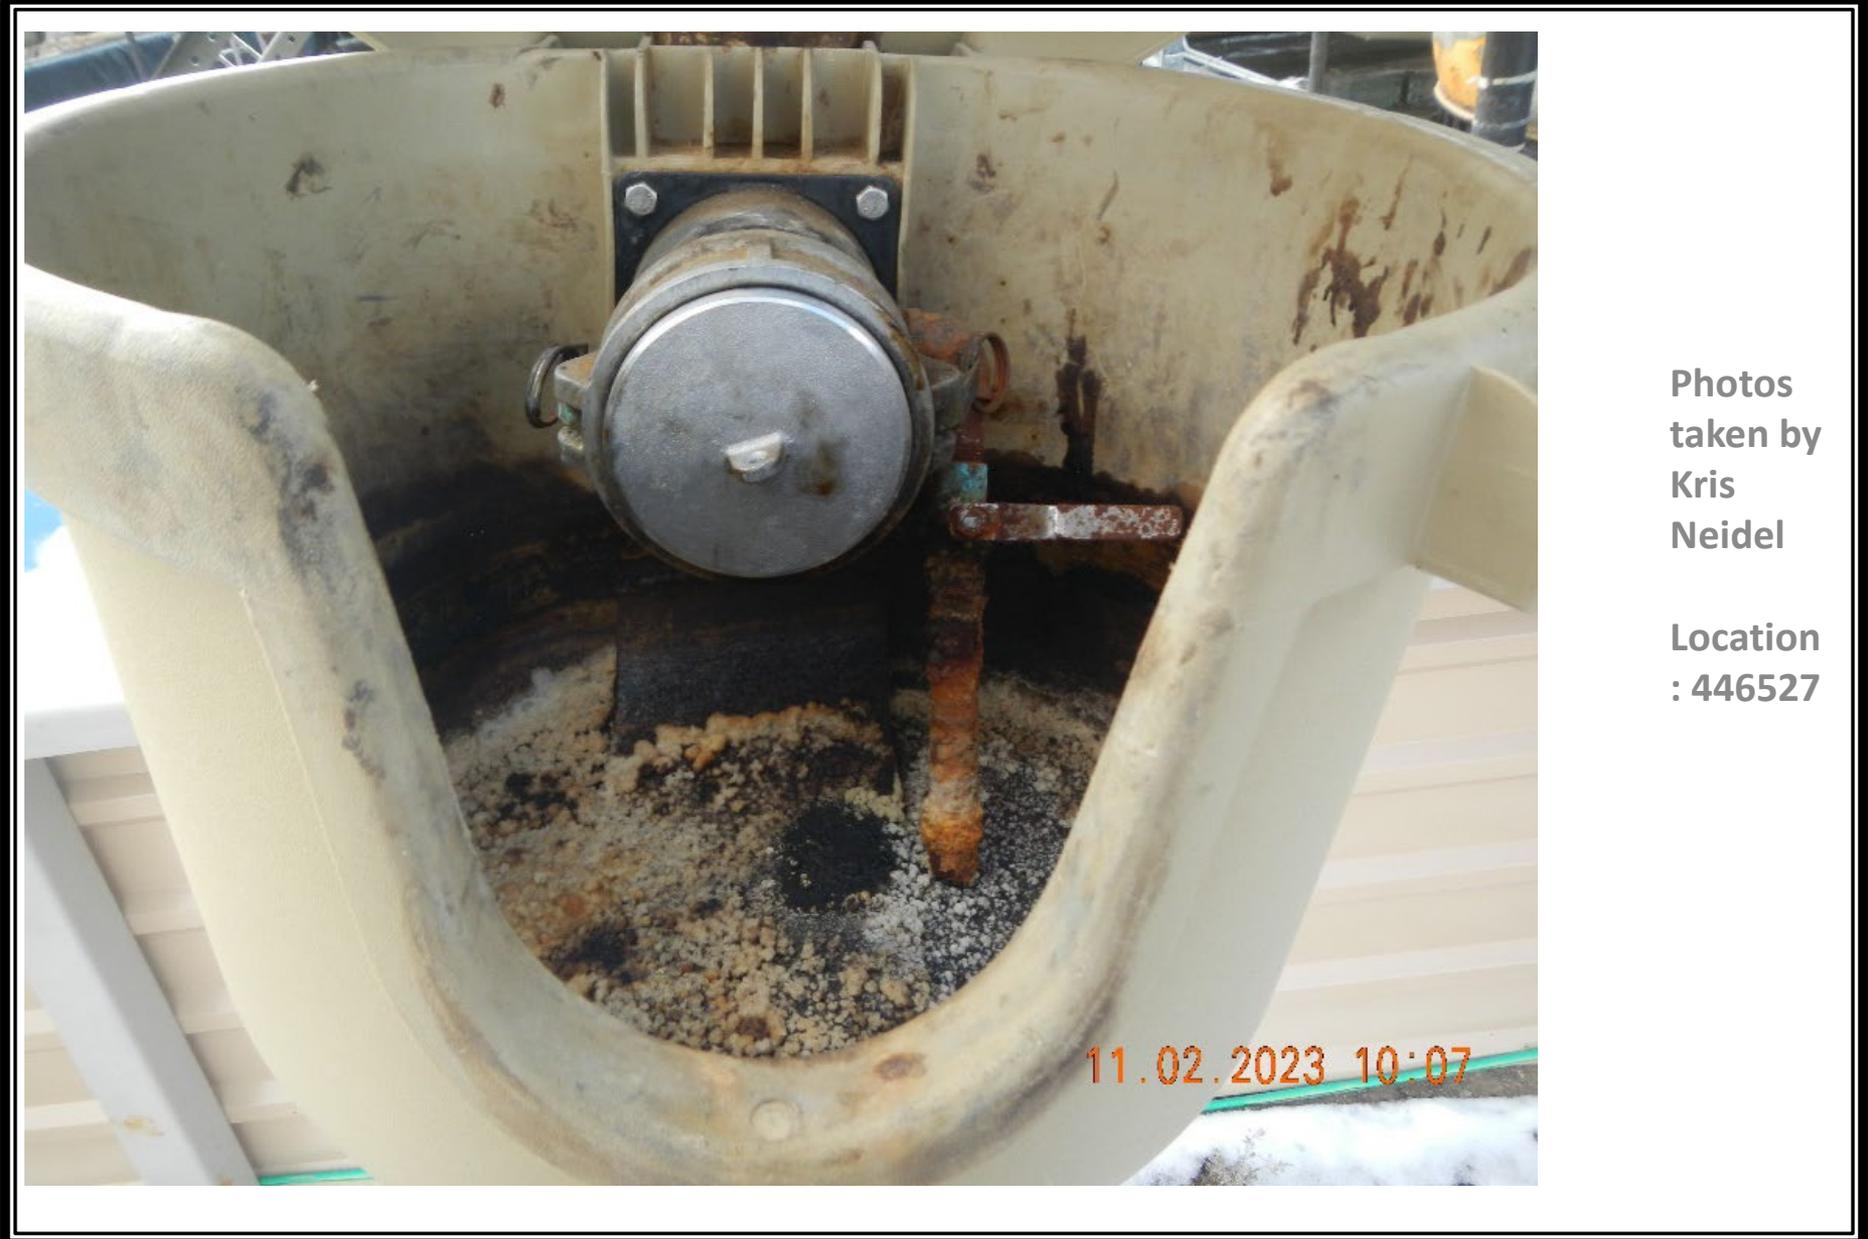
**Photo #10 close up of liner and spilled fluid and perhaps water  
that was inside of secondary containment. All fluid should be  
handled as E&P waste.**
