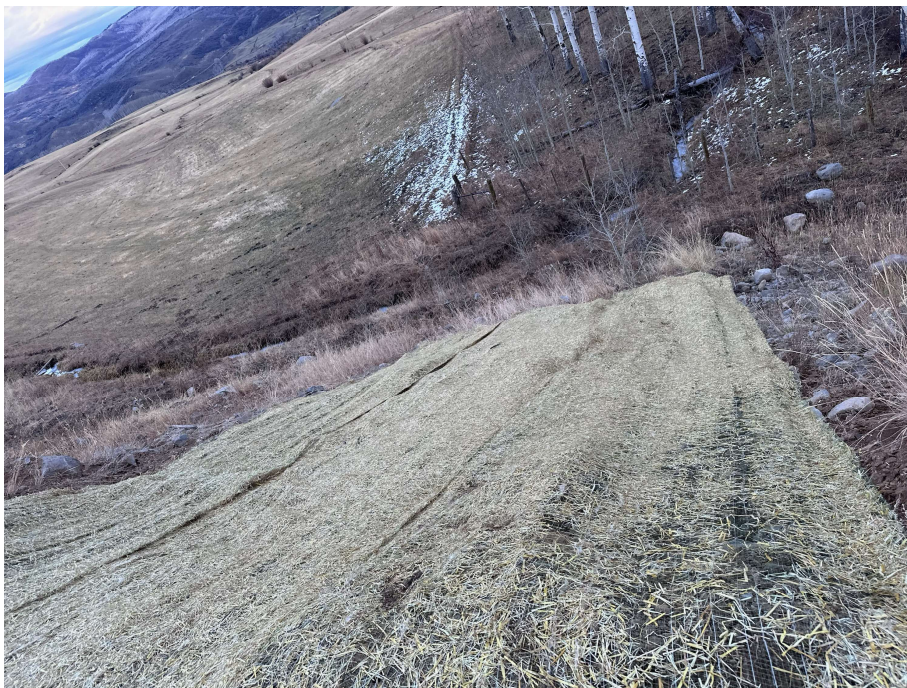
Sloping on the north and east areas of the pad were seeded and coconut matting was placed in areas of potential erosion.
