**SITE-SPECIFIC QUALITY ASSURANCE
& QUALITY CONTROL AUDIT**

PERMIT CLOSURE REPORT – CROPLAND

Location ID 329854

Location Name KAMMERZELL-65N66W/29NWNW

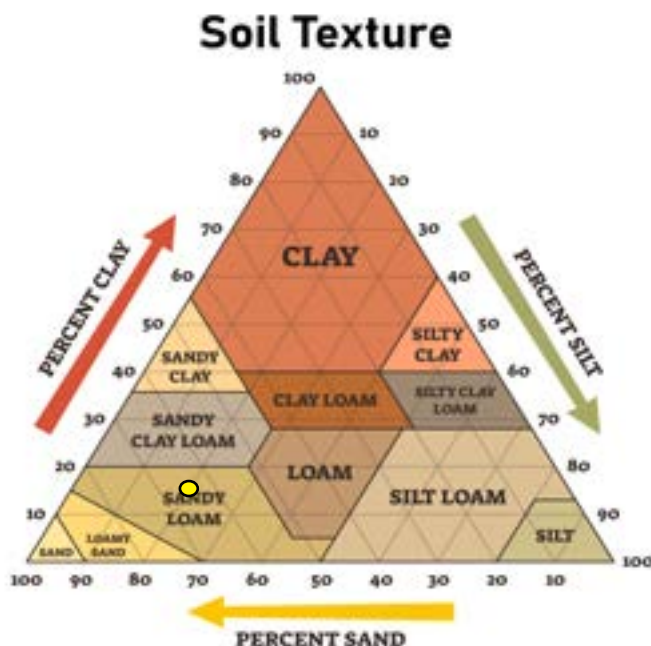
Soil Texture Triangle reflect the 0-10 in depth

- K Factor, Whole soil - .24. Values of K range from 0.02 to 0.69. Other factors being equal, the higher the value, the more susceptible the soil is to sheet and rill erosion by water.
- Wind Erodibility Group – 3. The soils assigned to group 1 are the most susceptible to wind erosion, and those assigned to group 8 are the least susceptible.

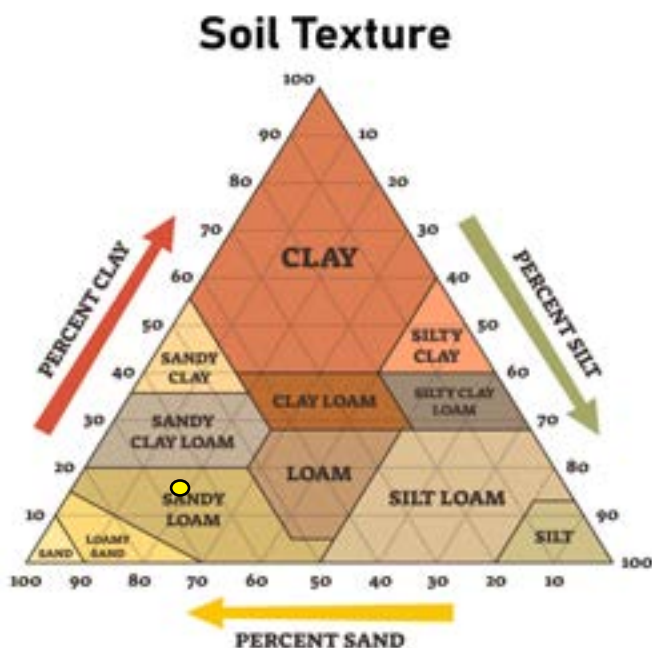
Soil Texture Triangle reflect the 0-10 in depth

- K Factor, Whole soil - .15. Values of K range from 0.02 to 0.69. Other factors being equal, the higher the value, the more susceptible the soil is to sheet and rill erosion by water.
- Wind Erodibility Group – 3. The soils assigned to group 1 are the most susceptible to wind erosion, and those assigned to group 8 are the least susceptible.
