**SITE-SPECIFIC QUALITY ASSURANCE
& QUALITY CONTROL AUDIT**

Final Reclamation Complete Notice – Cropland Drone Imagery

PERMIT CLOSURE REPORT – CROPLAND

Location Name BOULDER BANK-61N66W/7SWSE

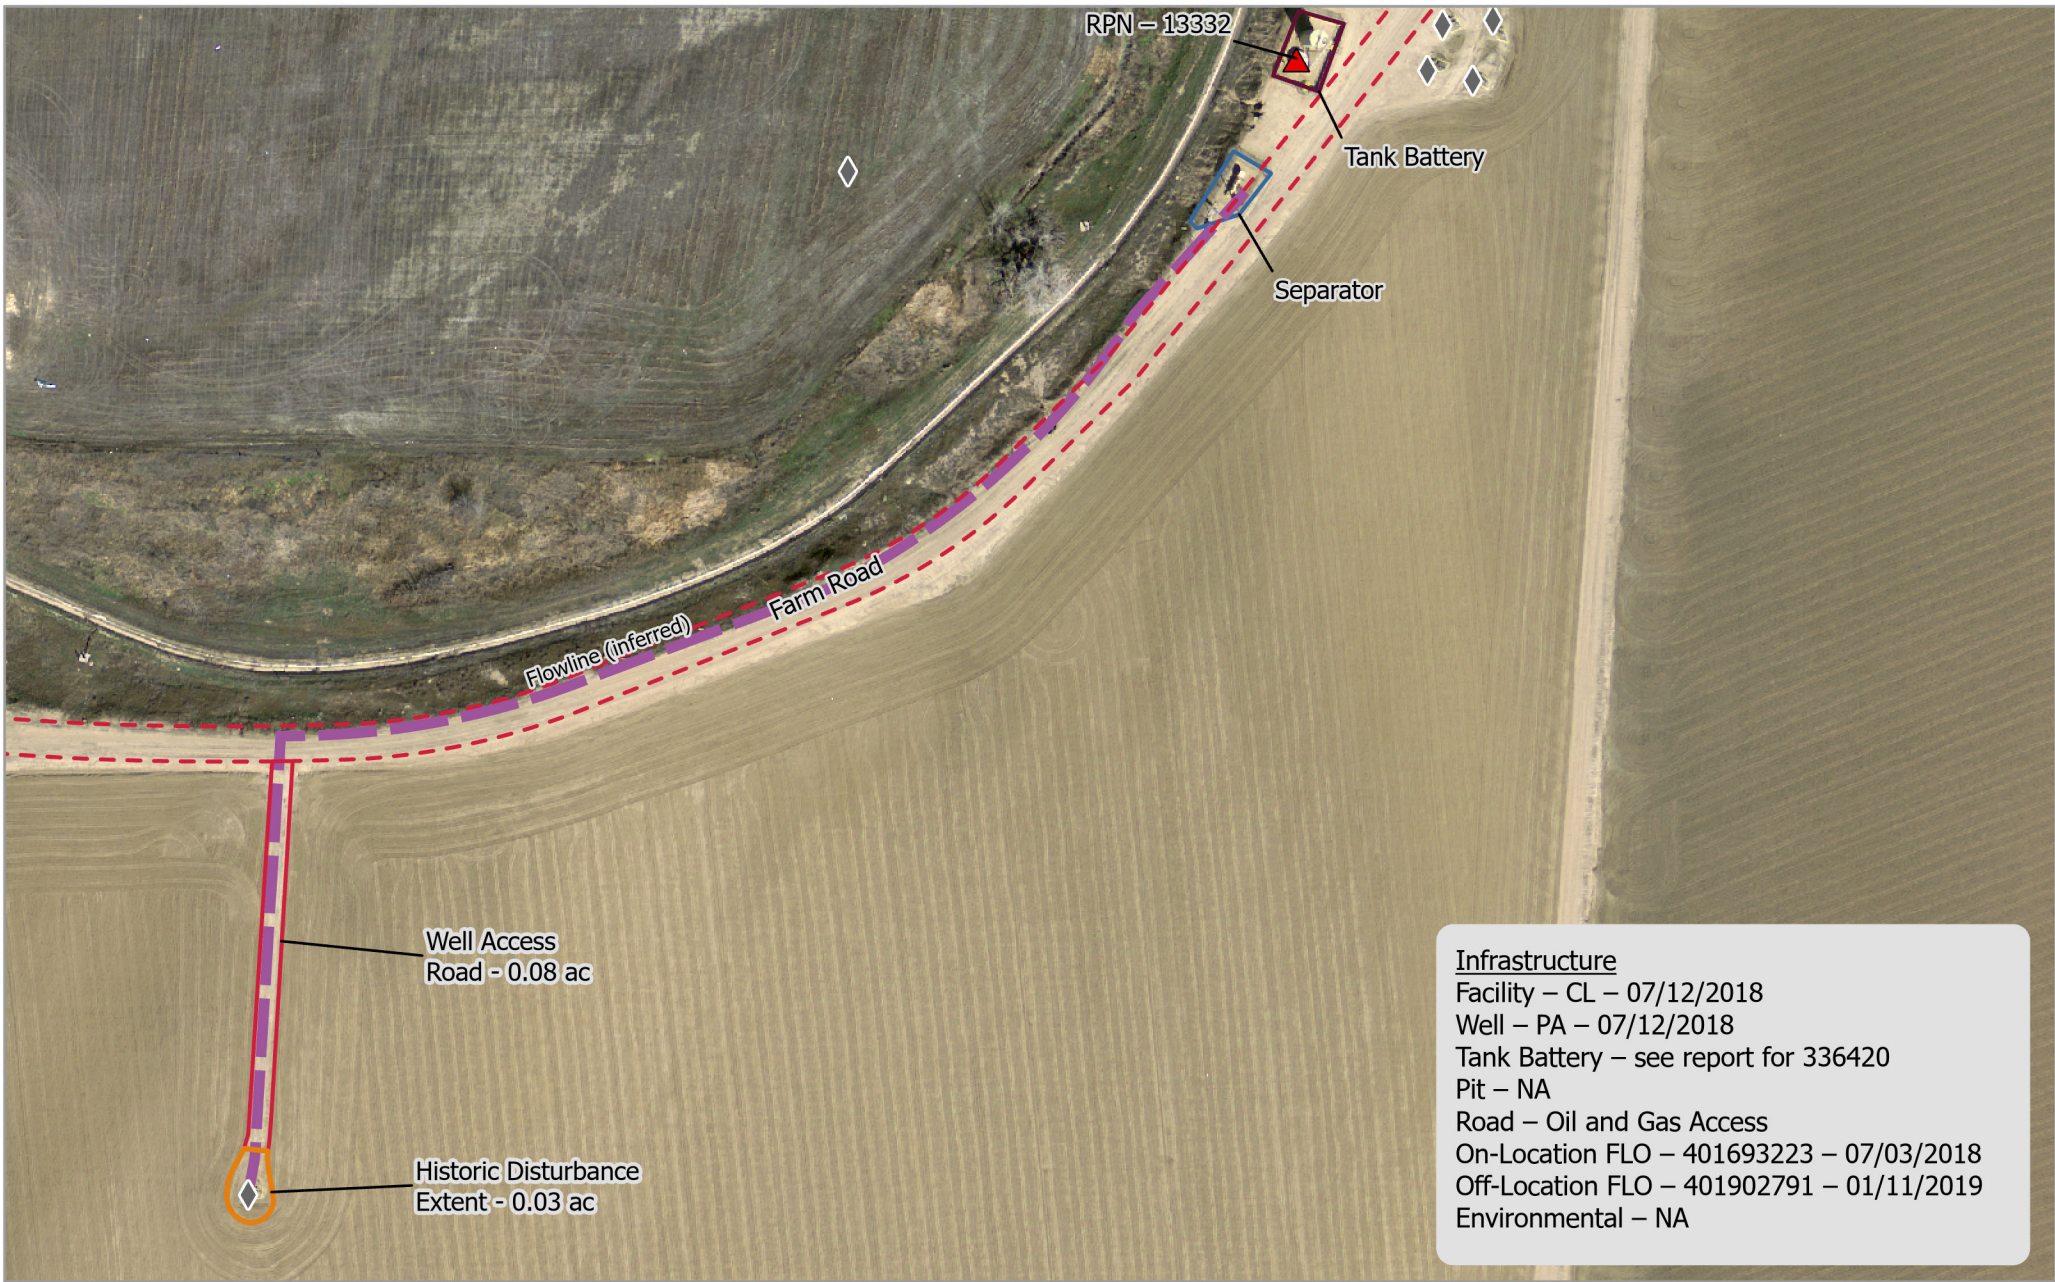
**CIV - 330775- BOULDER BANK
 Map Extent - Pre-Plugging Overview**

RPN - 13332

Well Access Road - 0.08 ac

Historic Disturbance Extent - 0.03 ac

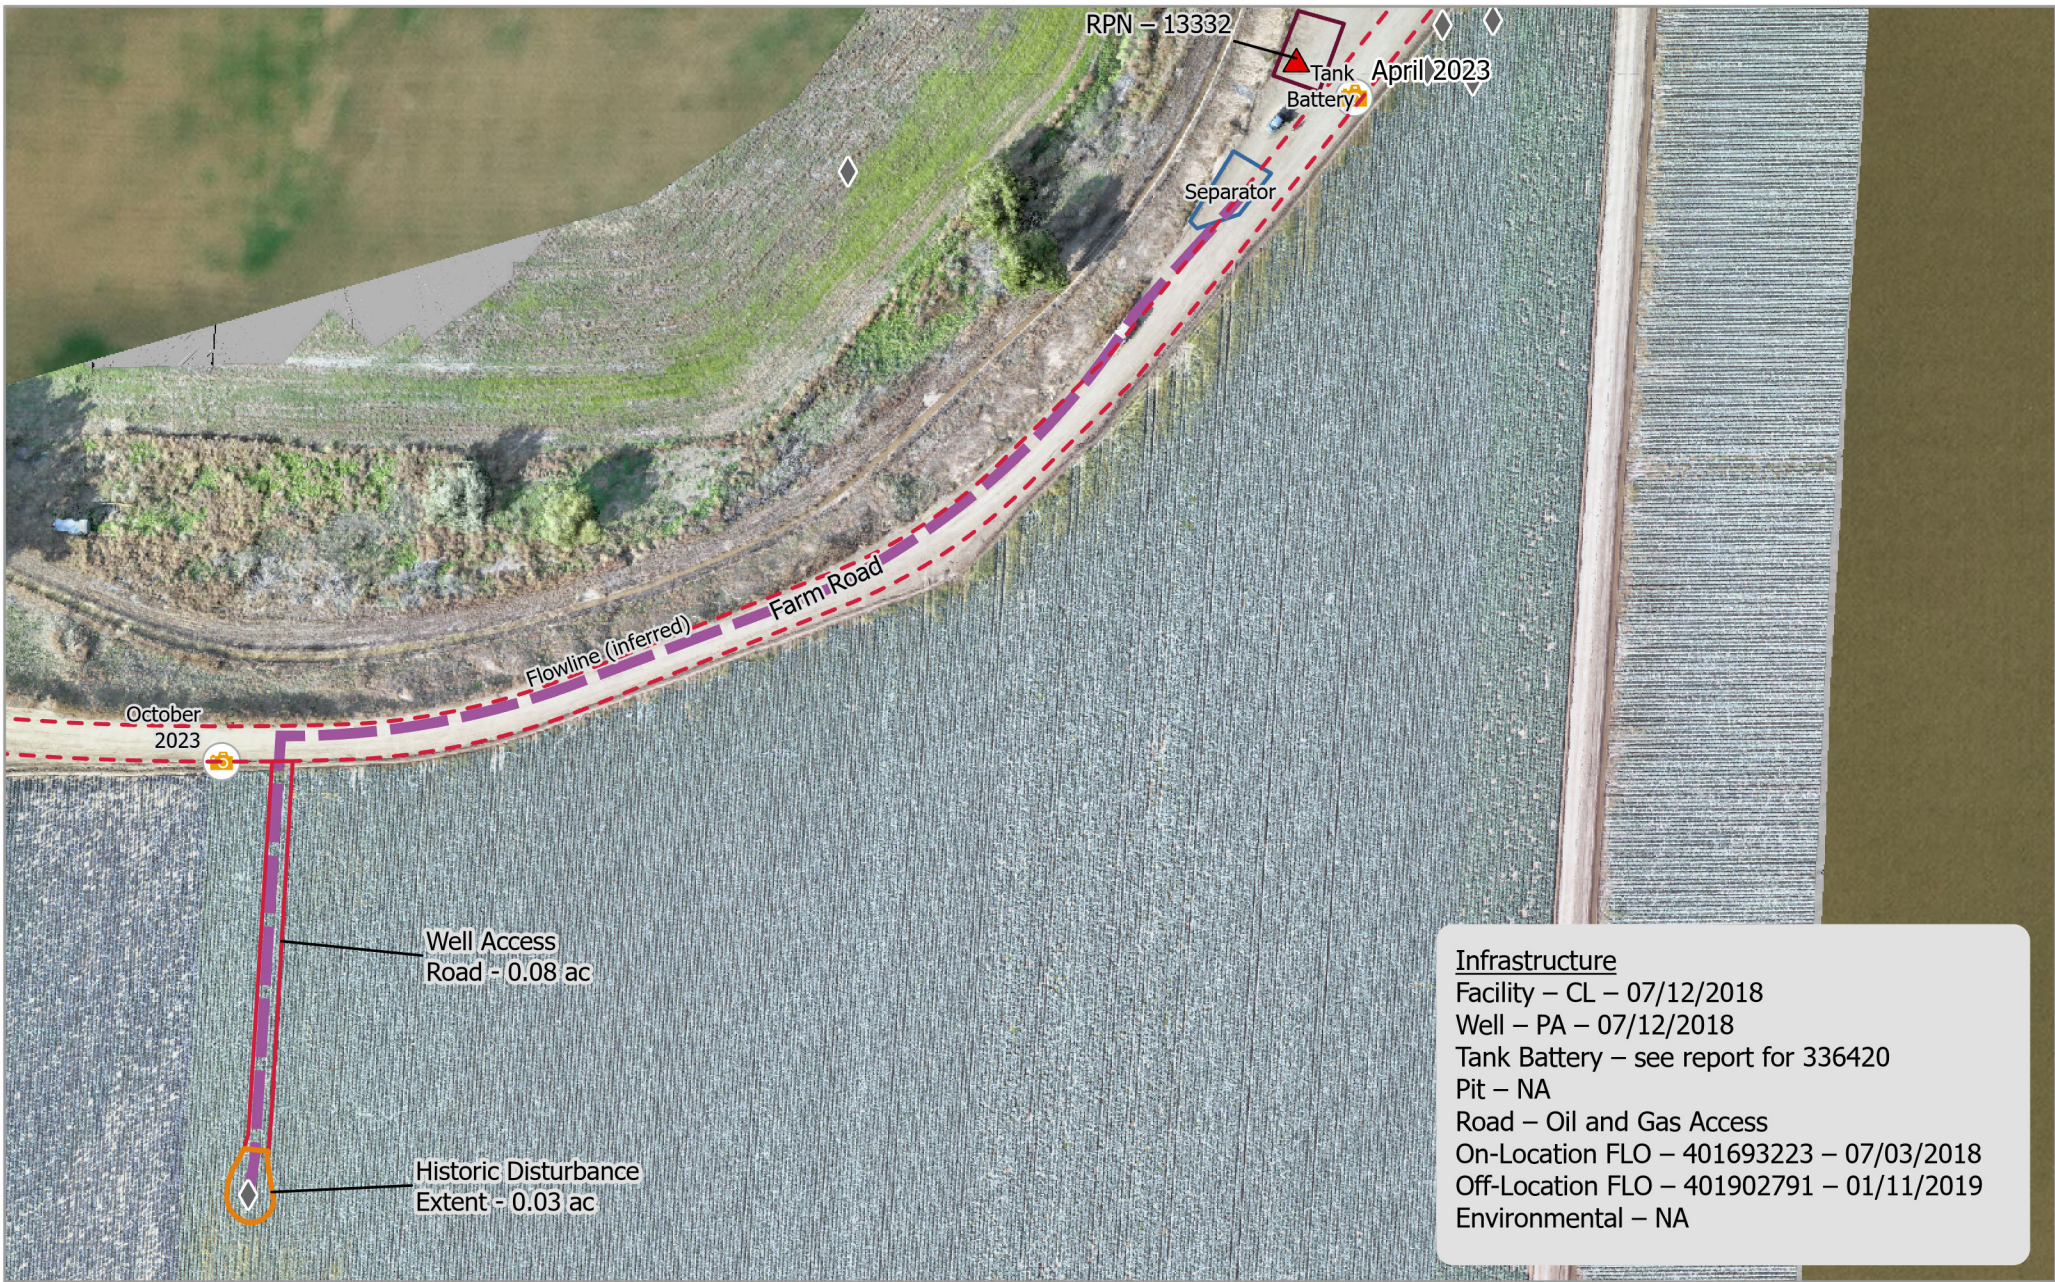
CIV - 330775- BOULDER BANK
Map Extent - Post-Plugging Flowline
Overview

Well Access Road - 0.08 ac

Historic Disturbance Extent - 0.03 ac

Total Disturbance:
0.11 Acres

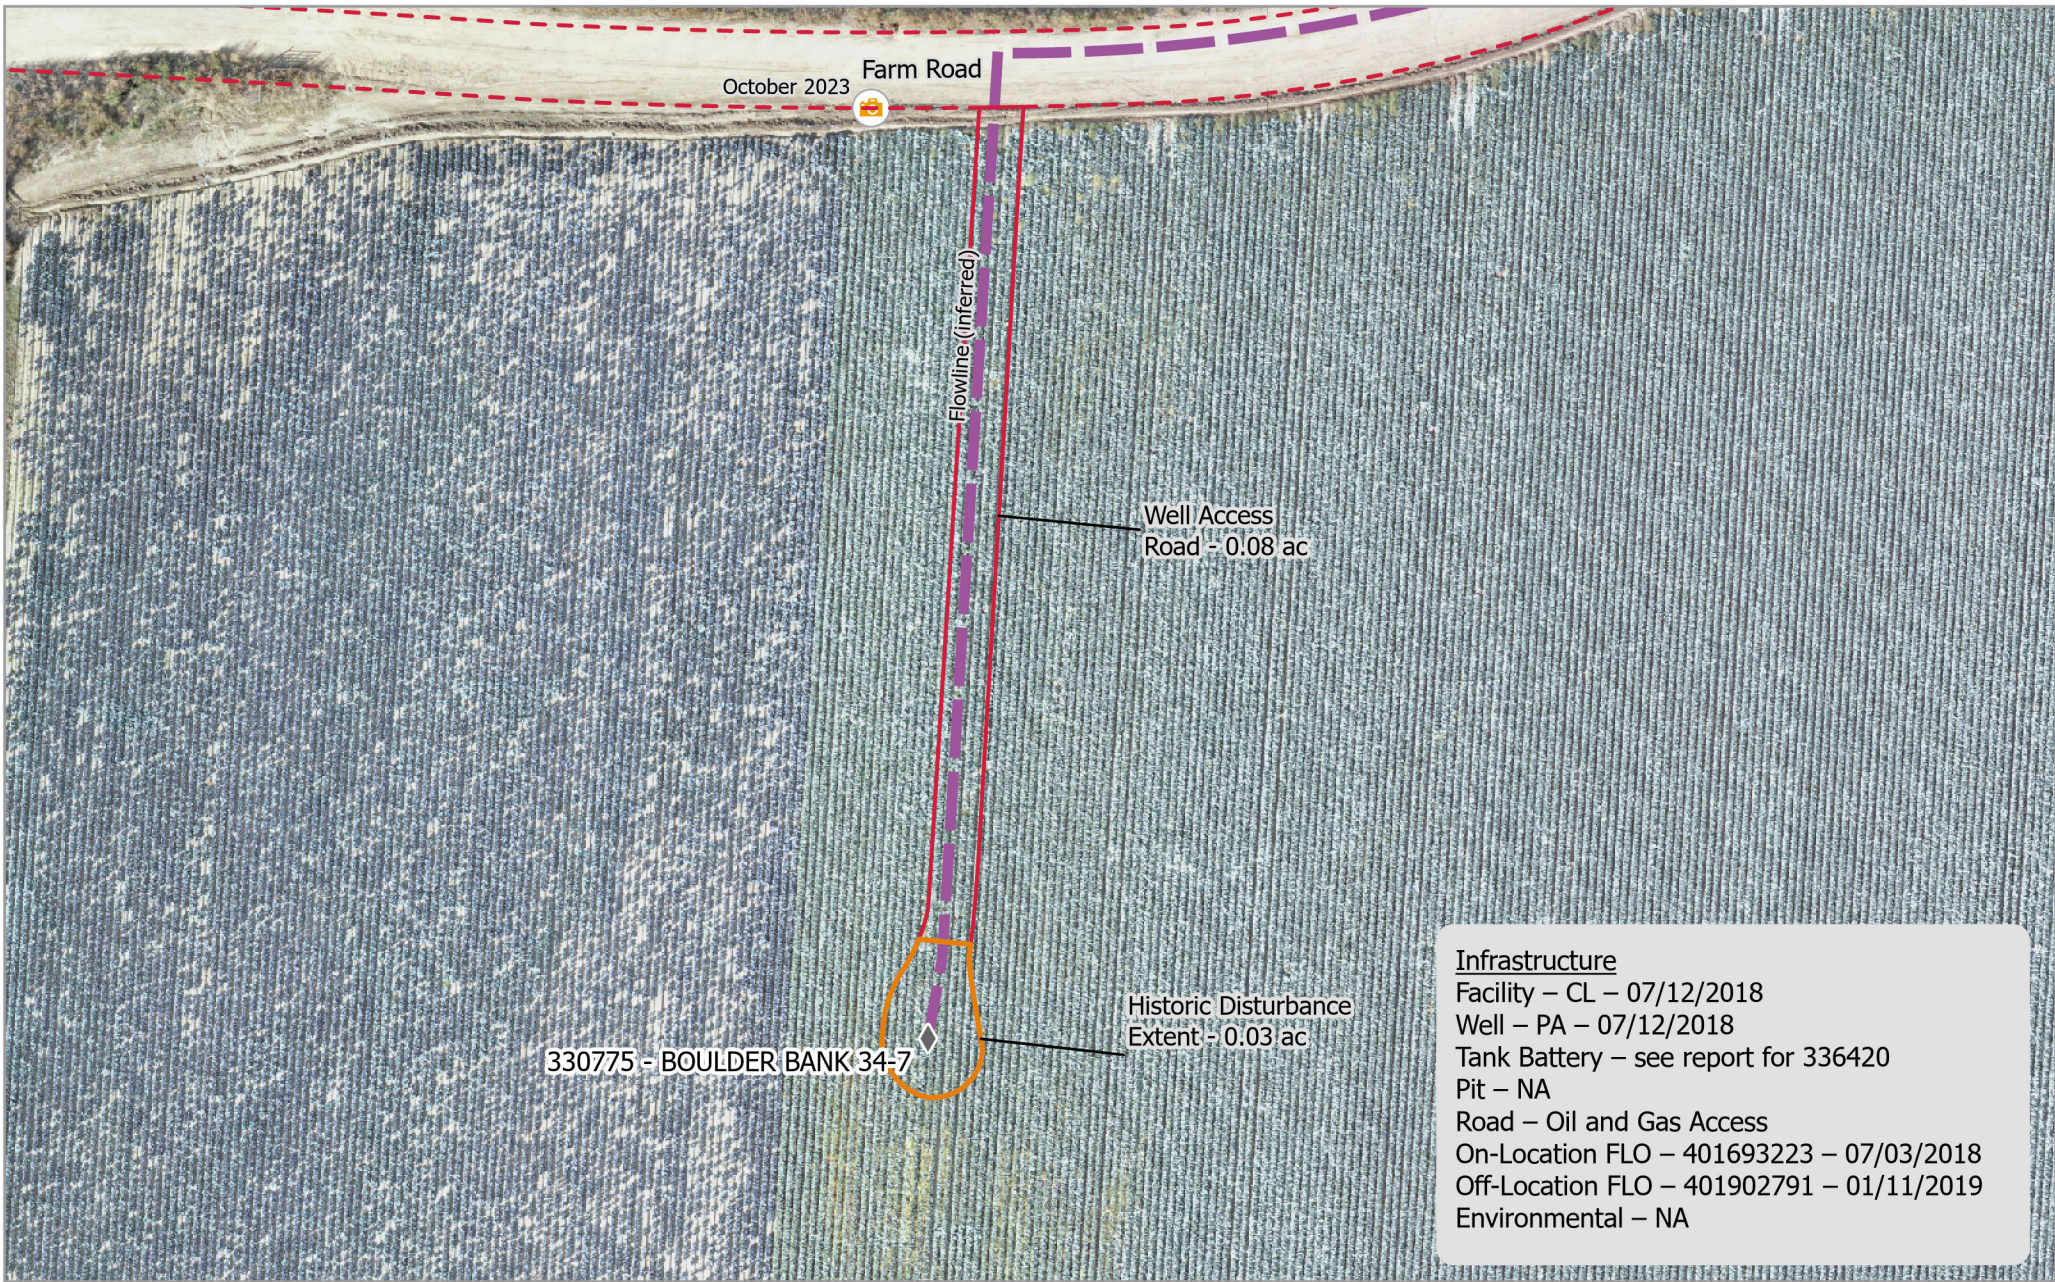
**CIV - 330775- BOULDER BANK
 Map Extent - Post-Plugging Overview**

Total Disturbance: 0.11 Acres
 Scale: 1:700

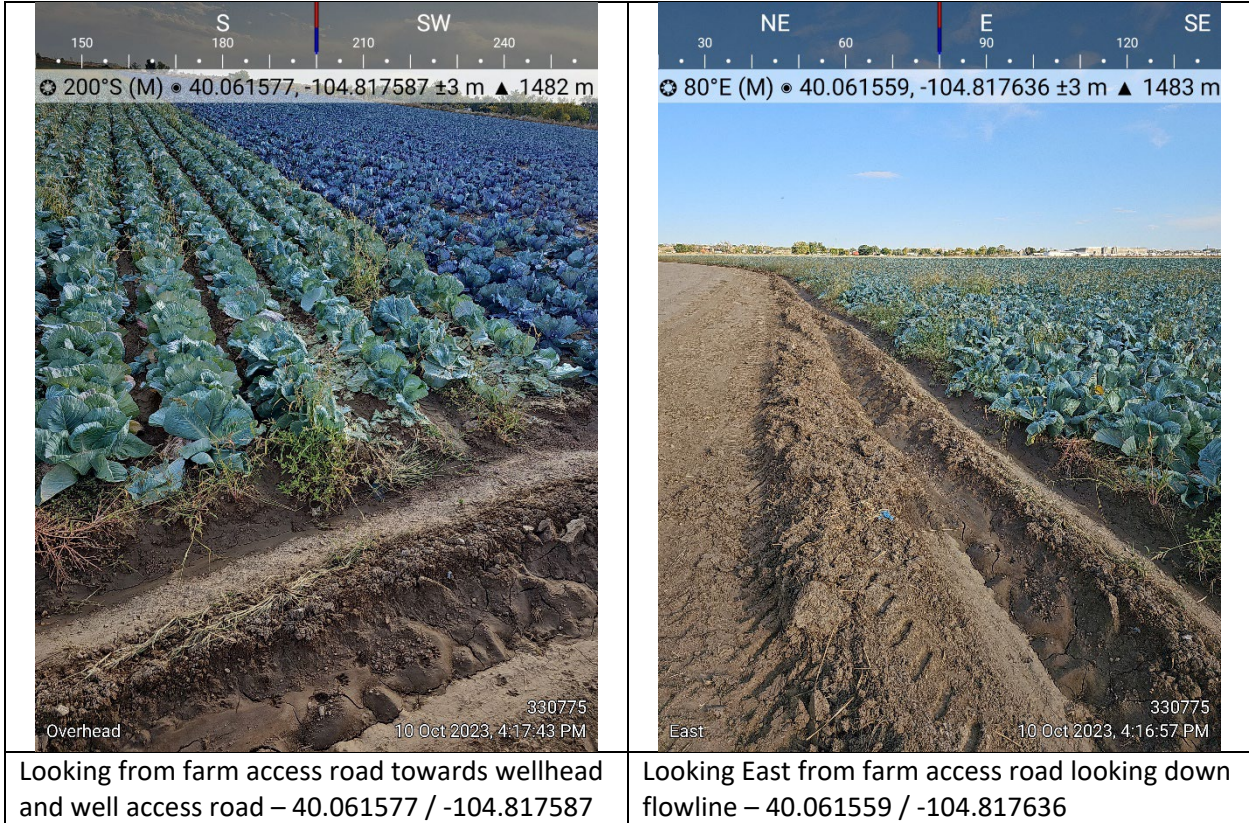
Handheld photos taken from farm access road looking towards Boulder Bank 34-7 wellhead.
No handheld photos were taken from Boulder Bank 34-7 wellhead location due to crop height.
