Inspection Photos and Issue Report

Operator: ANSCHUTZ EXPLORATION CORP

Location ID: 430926

Inspection Doc: 696205676

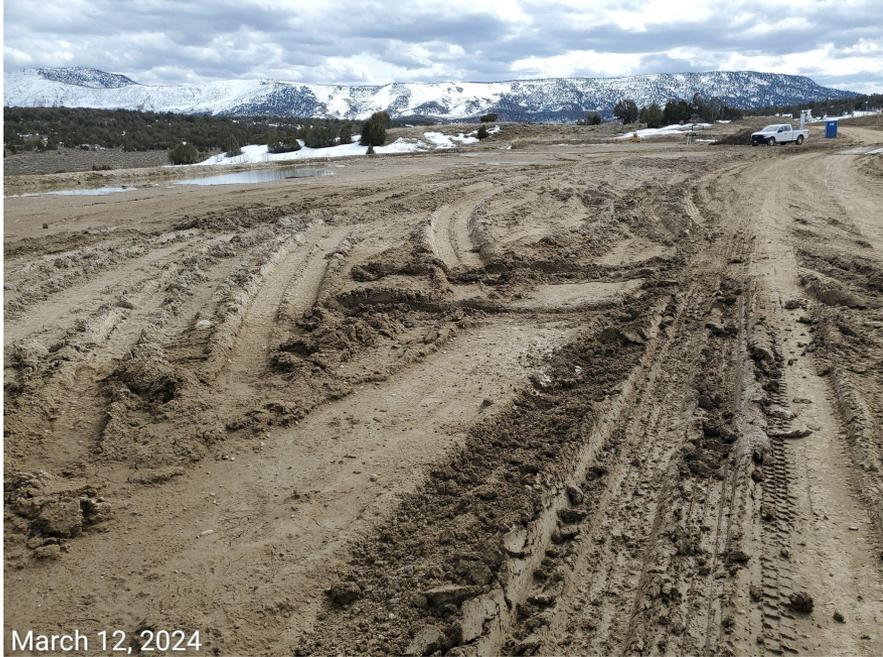
Photo 7: Photos 7-11 taken throughout the working pad surface. Photos examples showing that stormwater and erosion control BMPs to stabilize the working pad surface, as well as to minimize erosion, degradation, tracking and sediment transport are missing or insufficient; pad lacks stabilization. Stormwater ponding on the pad evident and is not being properly discharged, and is contributing to further destabilization of the pad/Location.

Photo 9: See comments under photo 7.

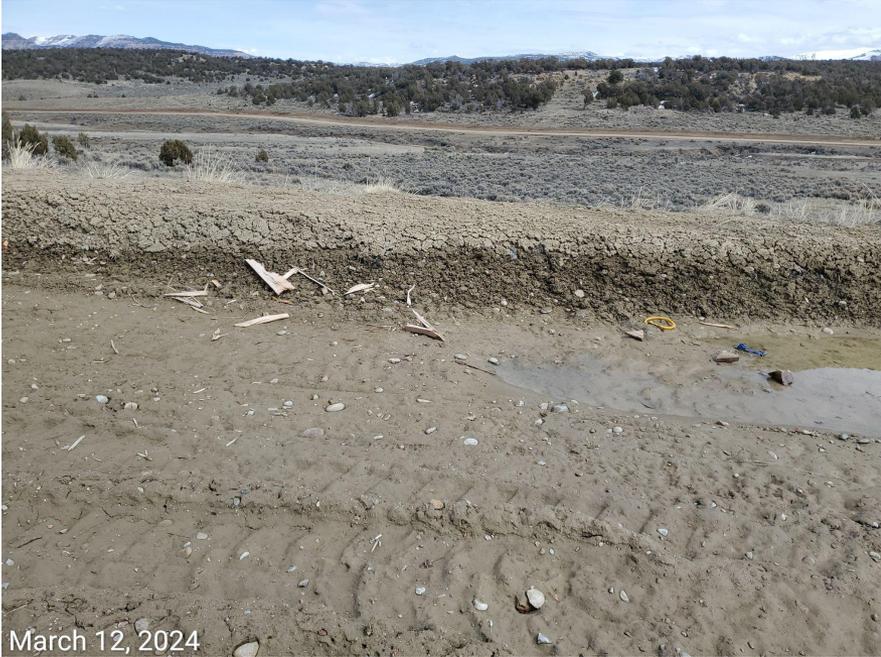
Photo 14: Photos 14-31 taken throughout the working pad surface, interim areas, and around production equipment/facilities of the Location. Photos show various trash/debris/unused equipment/etc... remain improperly stored throughout the entire Location.

Photo 16: See comments under photo 14.

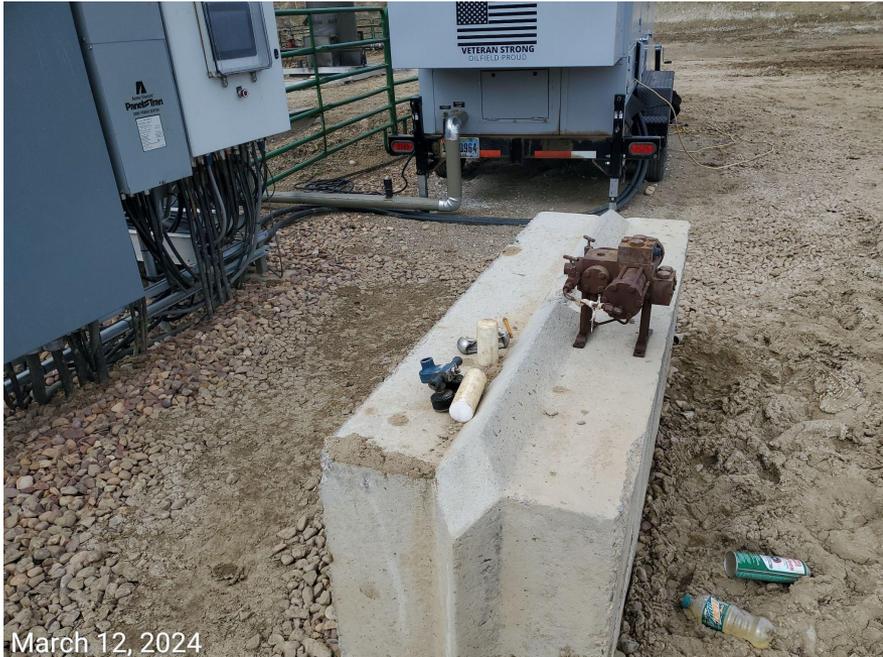
Photo 22: See comments under photo 14.
