# Photos, Annotation and Issue Report

**Operator:** PETROLEUM RESOURCE  
MANAGEMENT CORP #10421

**Location ID:** 485573

# PRM Duncan Pad Unpermitted Pad Annotation Report

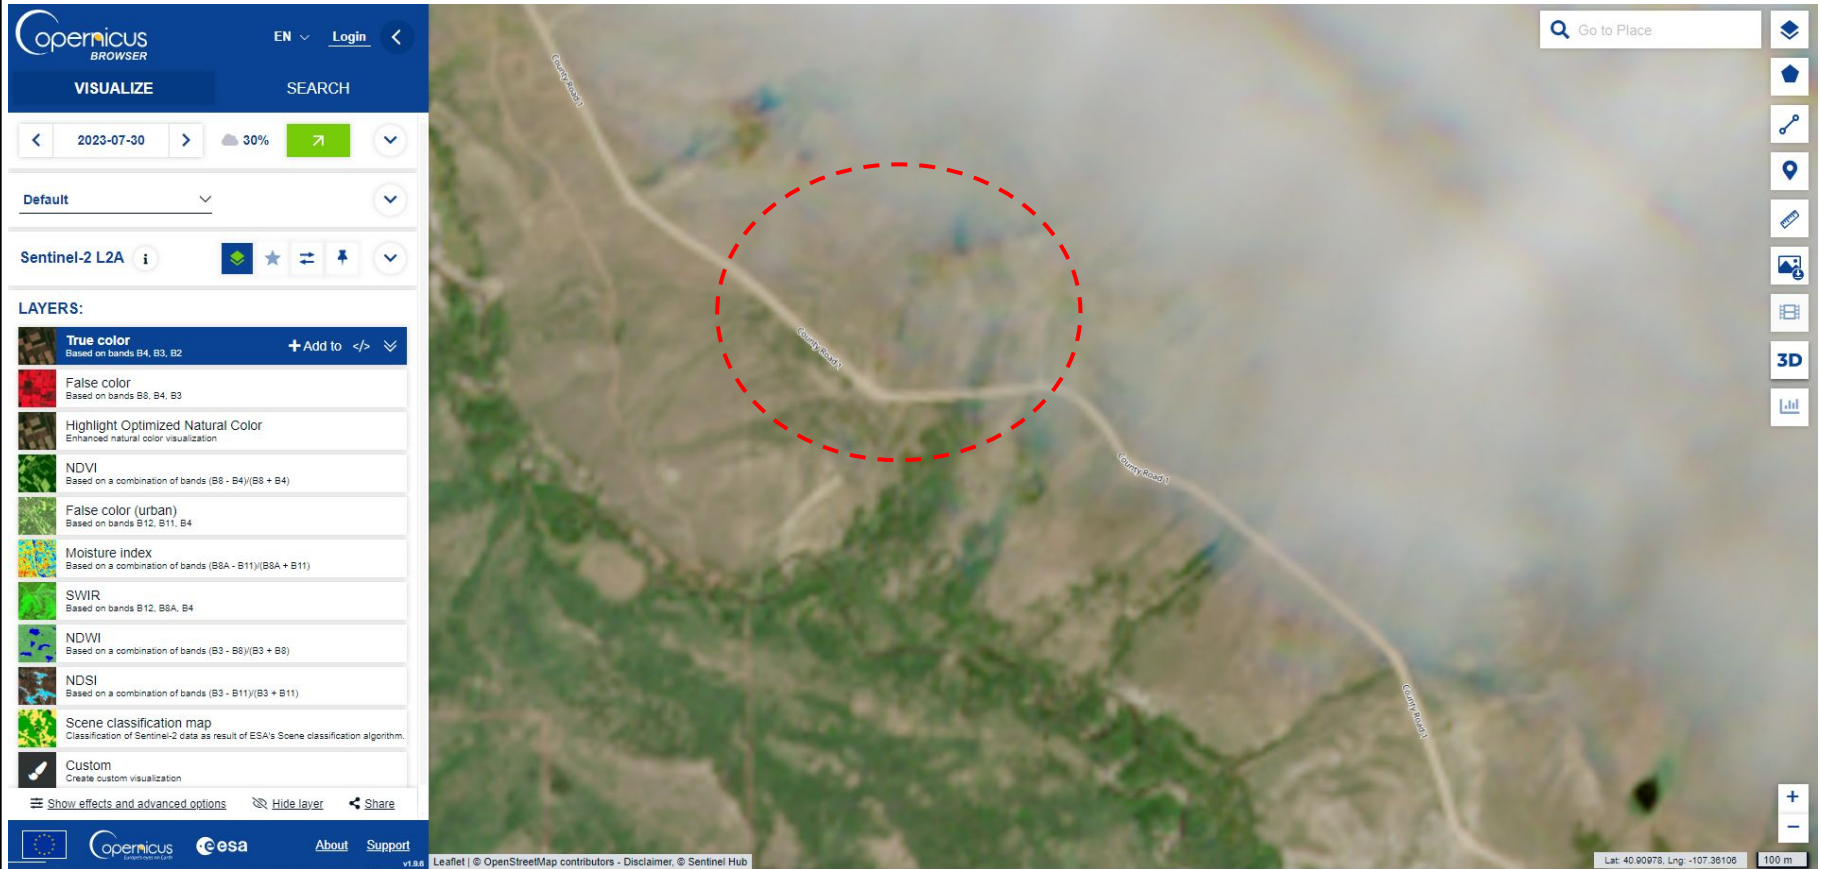
**Photo 1:** 7/30/2020 Satellite aerial imagery. Photo shows Location (circle) of the “Duncan Unpermitted Pad” Location prior to construction activities.

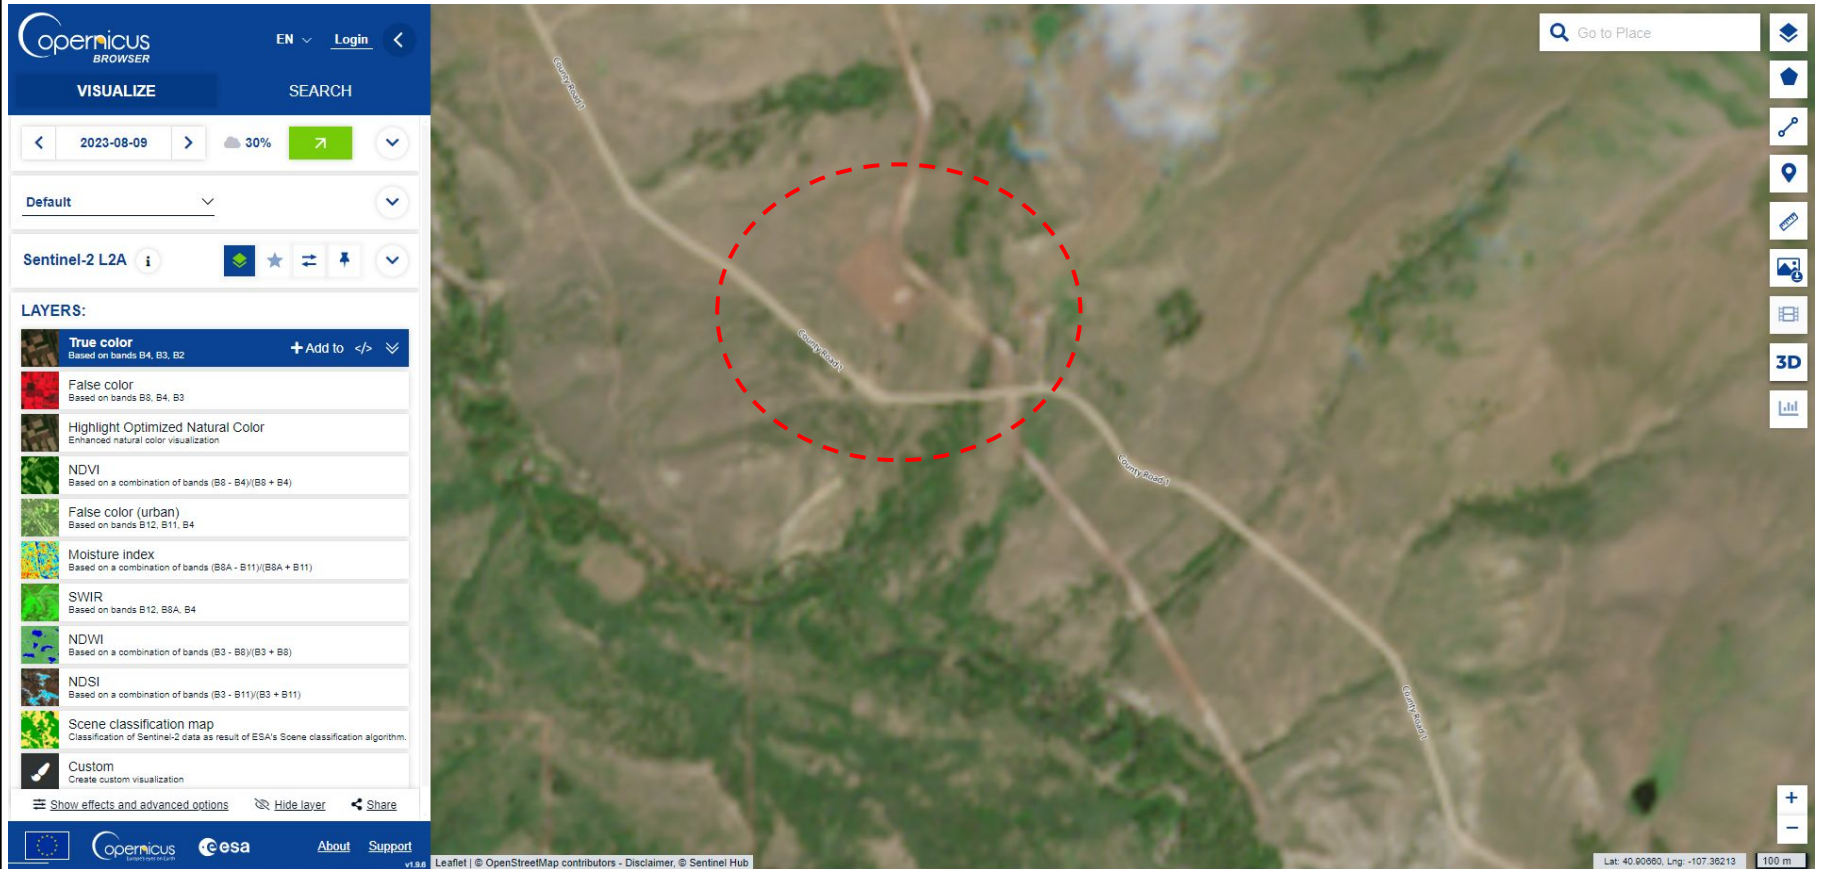
**Photo 2:** 8/9/2020 Satellite aerial imagery. Photo shows Location (circle) of the Duncan Unpermitted Pad Location. Disturbances apparent indicating construction activities for the Location and Flowline System commenced between 7/30/2023 and 8/9/2023.

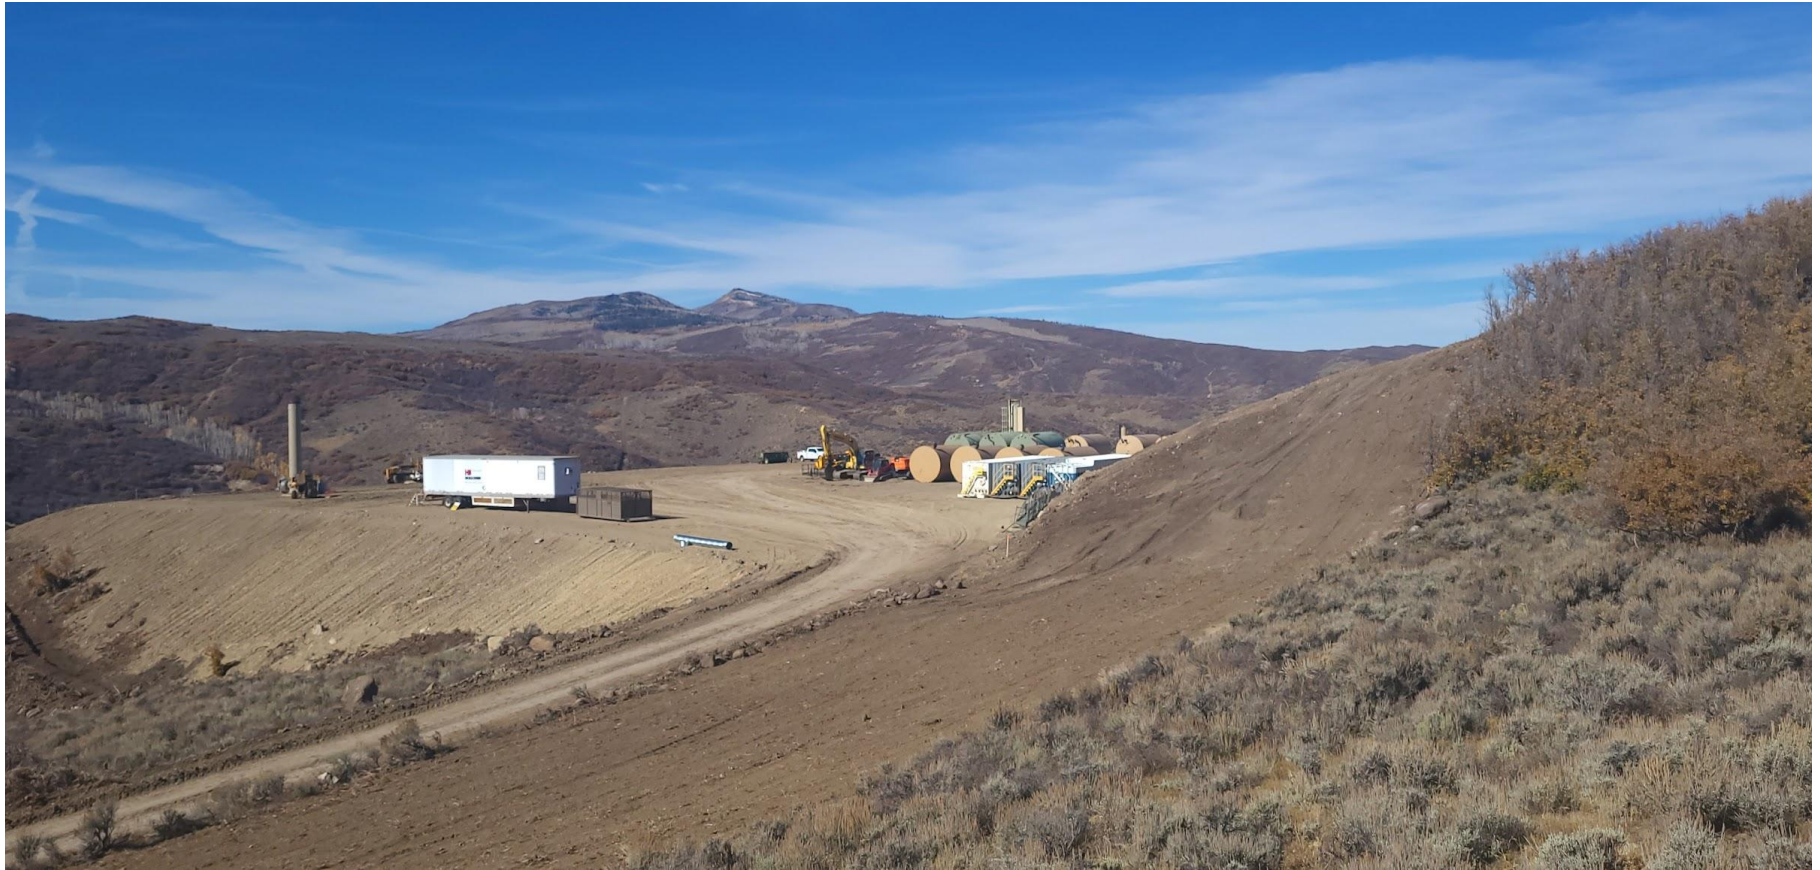
**Photo 3:** Photo taken from the east of the Location, facing northwest. Photo provides an overview of the Location.

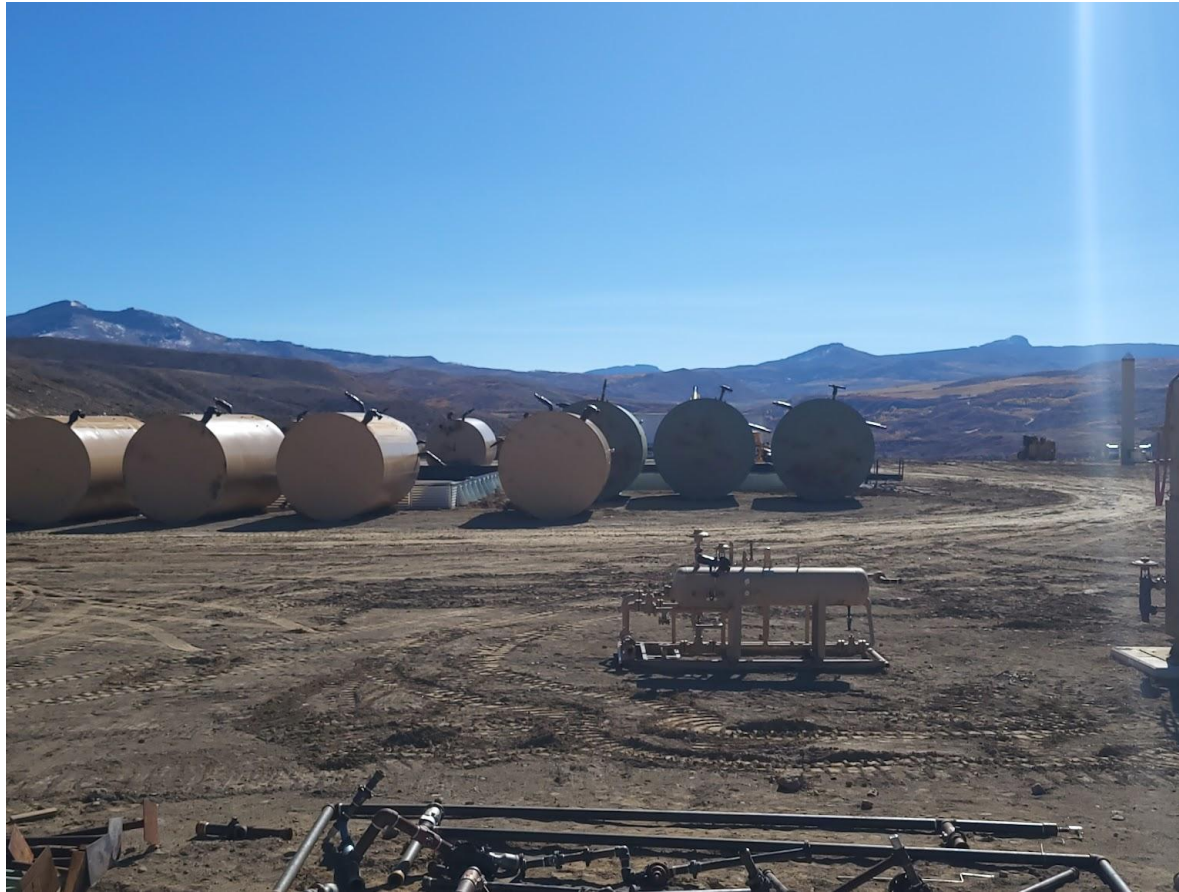
**Photo 12:** Photo taken from the northwest end of the Location, facing southeast. Photo shows production equipment placed and/or installed on the Location.

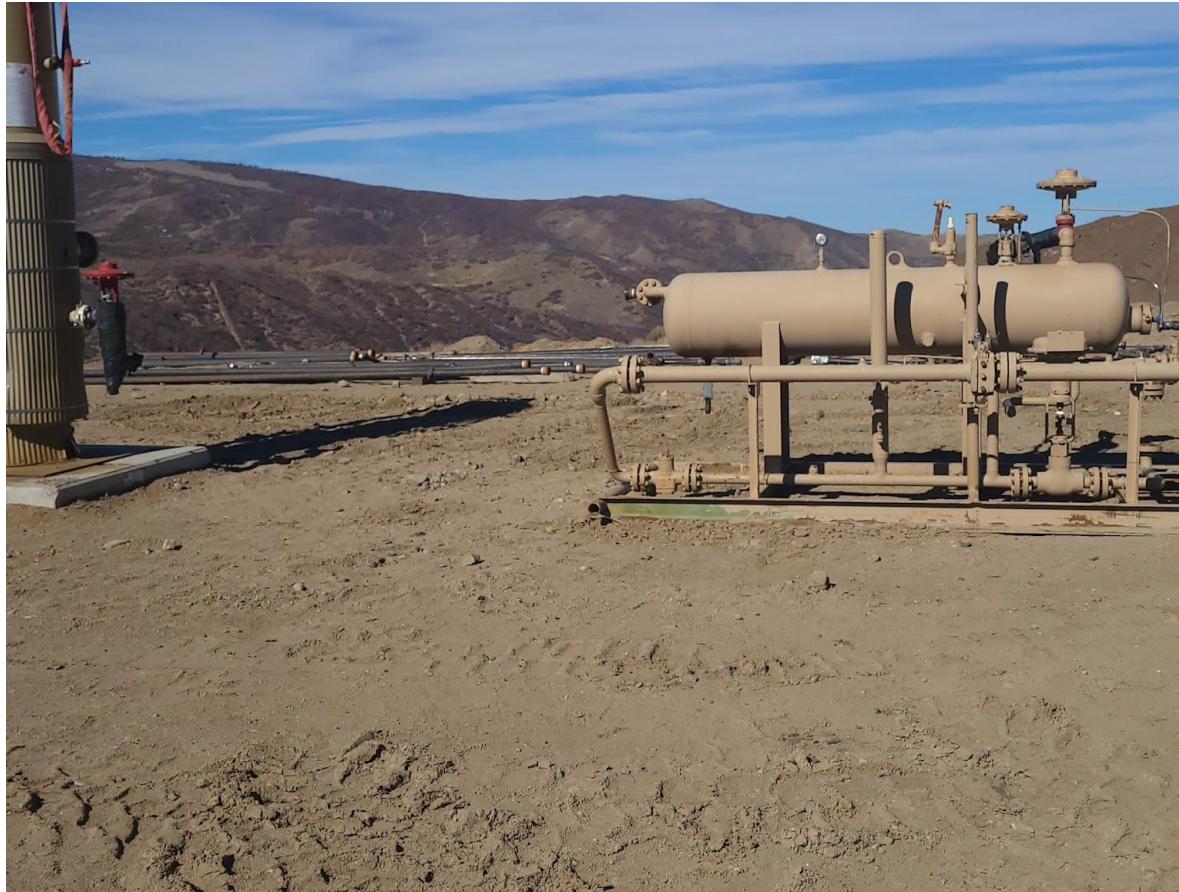
**Photo 14:** Photo taken from the northwest end of the Location, facing northwest. Photo shows production equipment placed and/or installed on the Location.

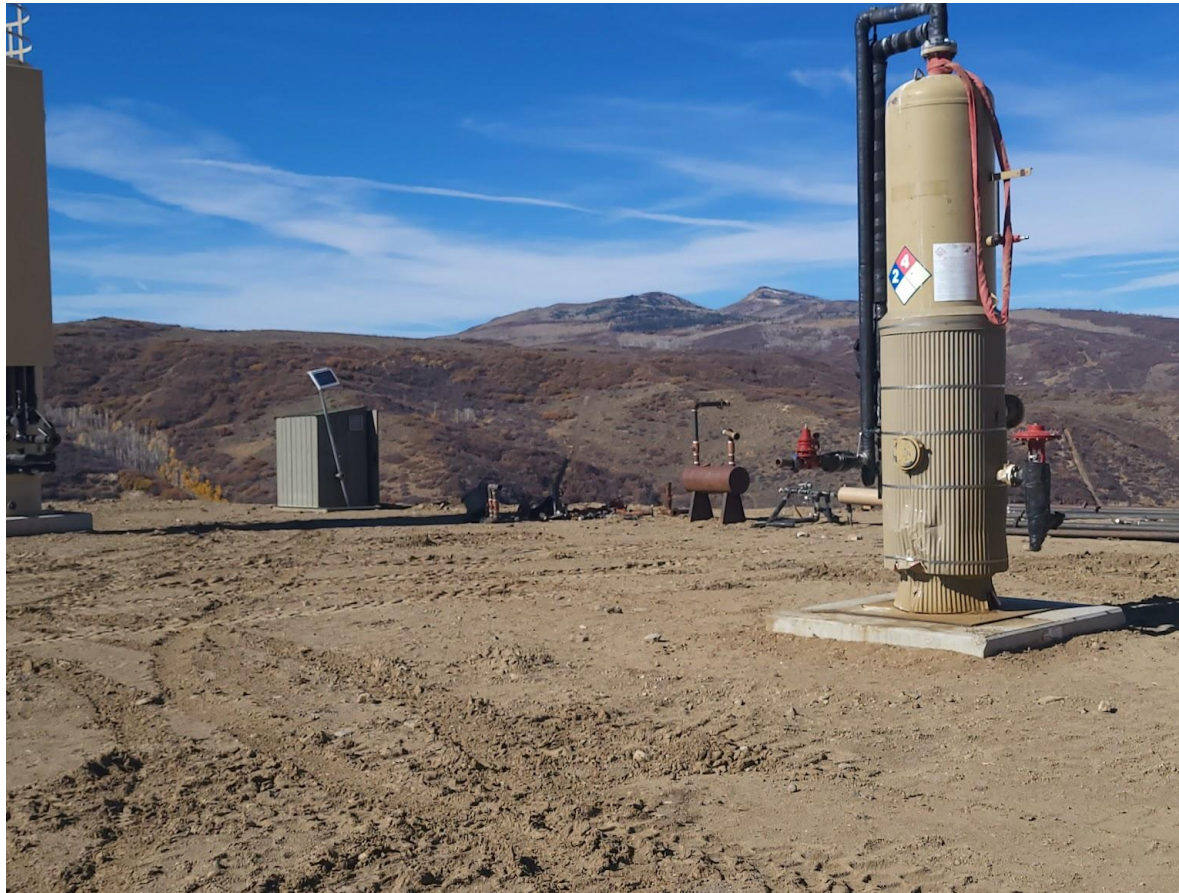
**Photo 15:** Photo taken from the northwest end of the Location, facing west. Photo shows production equipment placed and/or installed on the Location.

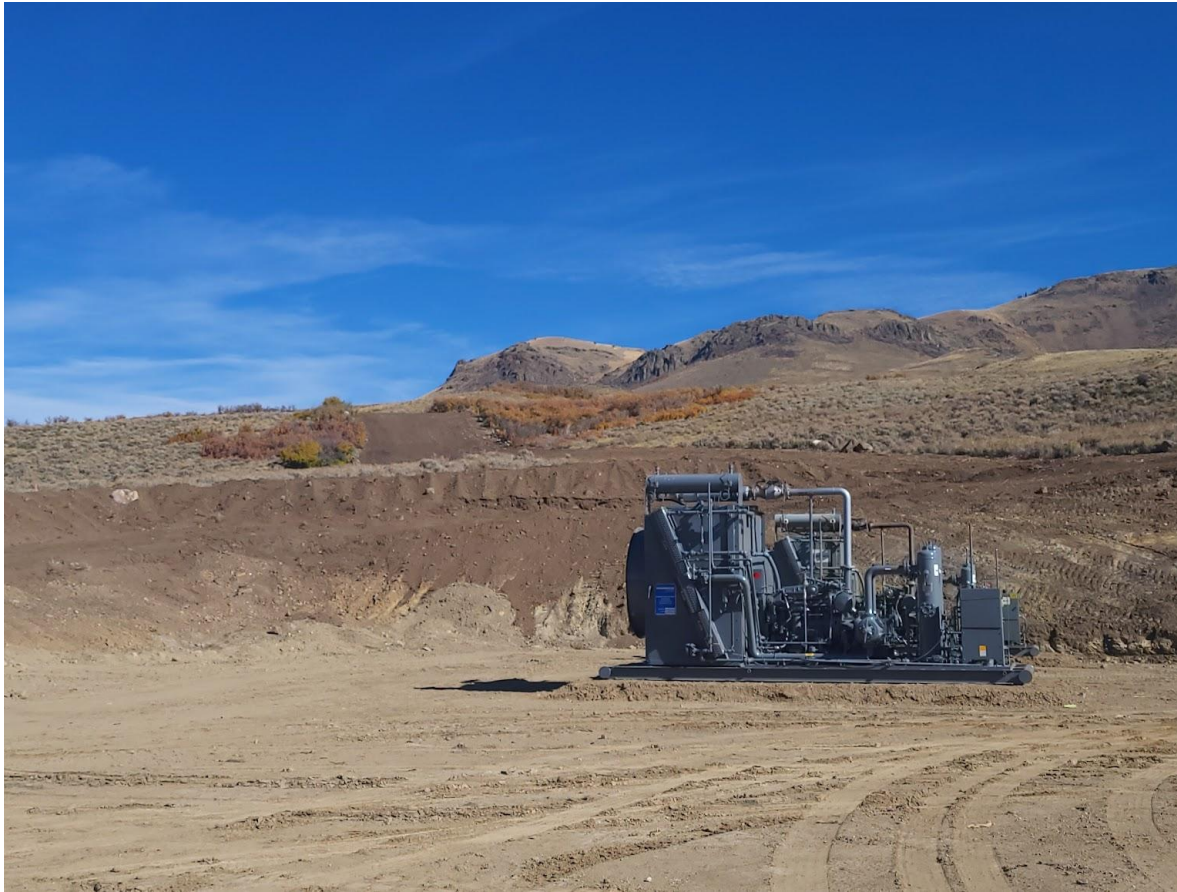
**Photo 8:** Photo taken from the north end of the Location, facing northeast. Photo shows cut slopes of the Location lack stabilization. BMPs to minimize erosion, degradation and sediment transport are missing or insufficient; BMPs to manage runoff/runoff along eastern perimeter missing or insufficient. Photo also shows the mixing of soil horizons, such as the topsoil; Operator failed to salvage all topsoil on the Location; Operator failed to separate and store soil horizons separately based on changes in physical characteristics (such as organic content, color, texture, density or consistency).

**Photo 16:** Photo taken from the north end of the Location, facing northeast. Photo shows production equipment placed and/or installed on the Location. See comments under photo 8 regarding stormwater, soil salvage, segregation and protections.
