Storm Water Management and Erosion control

Location Name: TEP ROCKY MOUNTAIN LLC BATTLEMENT MESA PARTNERS GV 82-5 Pad

Location ID: 334825

COLORADO
Energy & Carbon Management
Commission
Department of Natural Resources

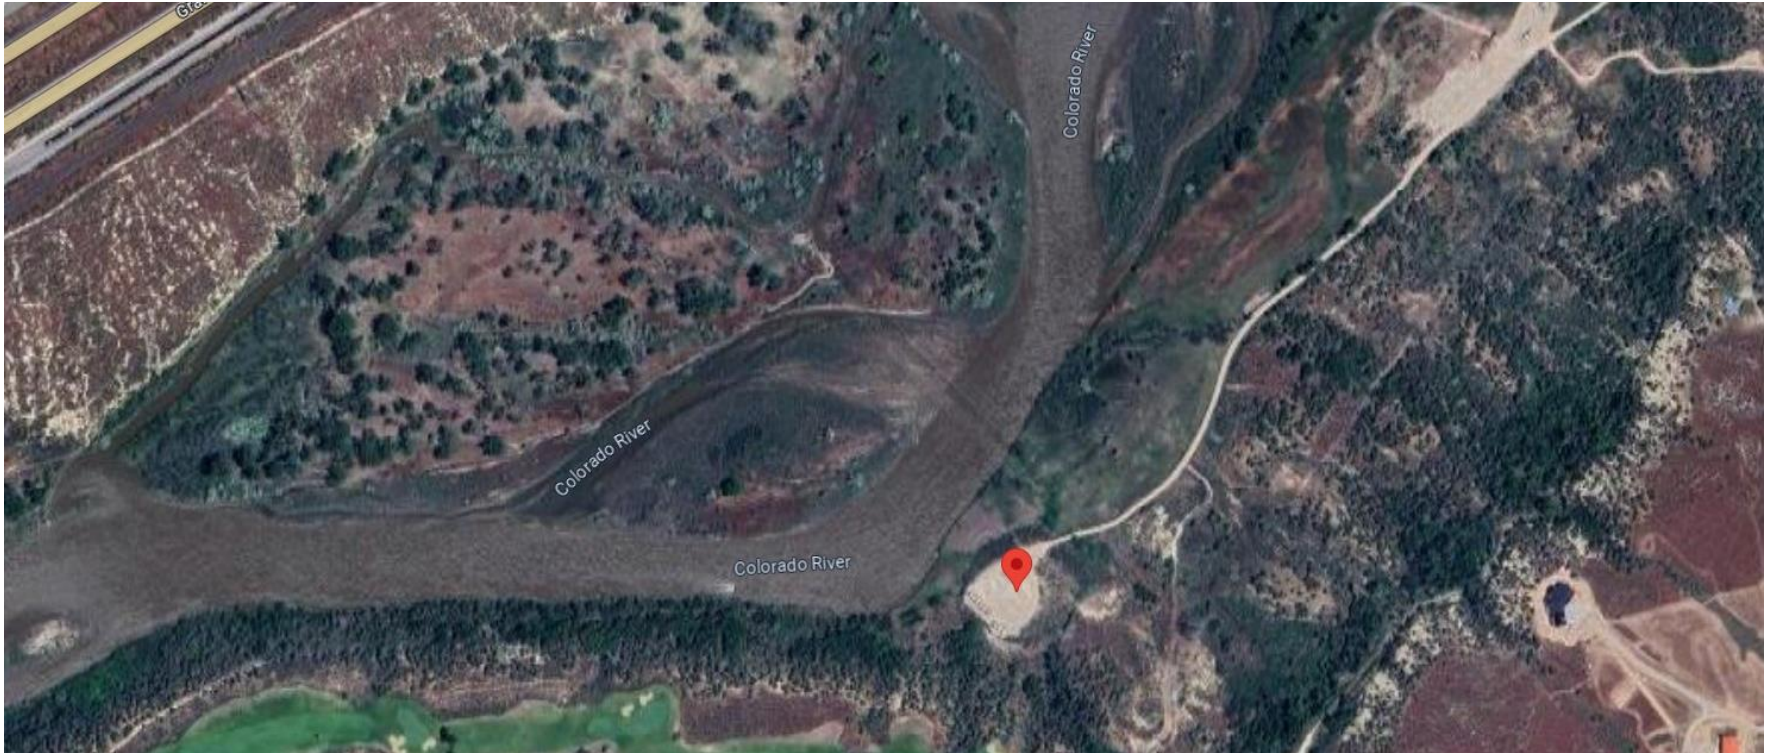
Location Overview: Location is within High Priority/Density/NSO/Black Bear Habitat areas & Bald Eagle Roost sites. Location is within Rule 411a Surface Water Internal Buffer & Rule 411b Generalized Internal Buffer. Location is approximately 39 yards from the Colorado River.
