# Interim Reclamation and Stormwater Inspection

Operator: WESTERN OPERATING COMPANY - 95620

Location ID: 312291

Inspection Document #: 708201332

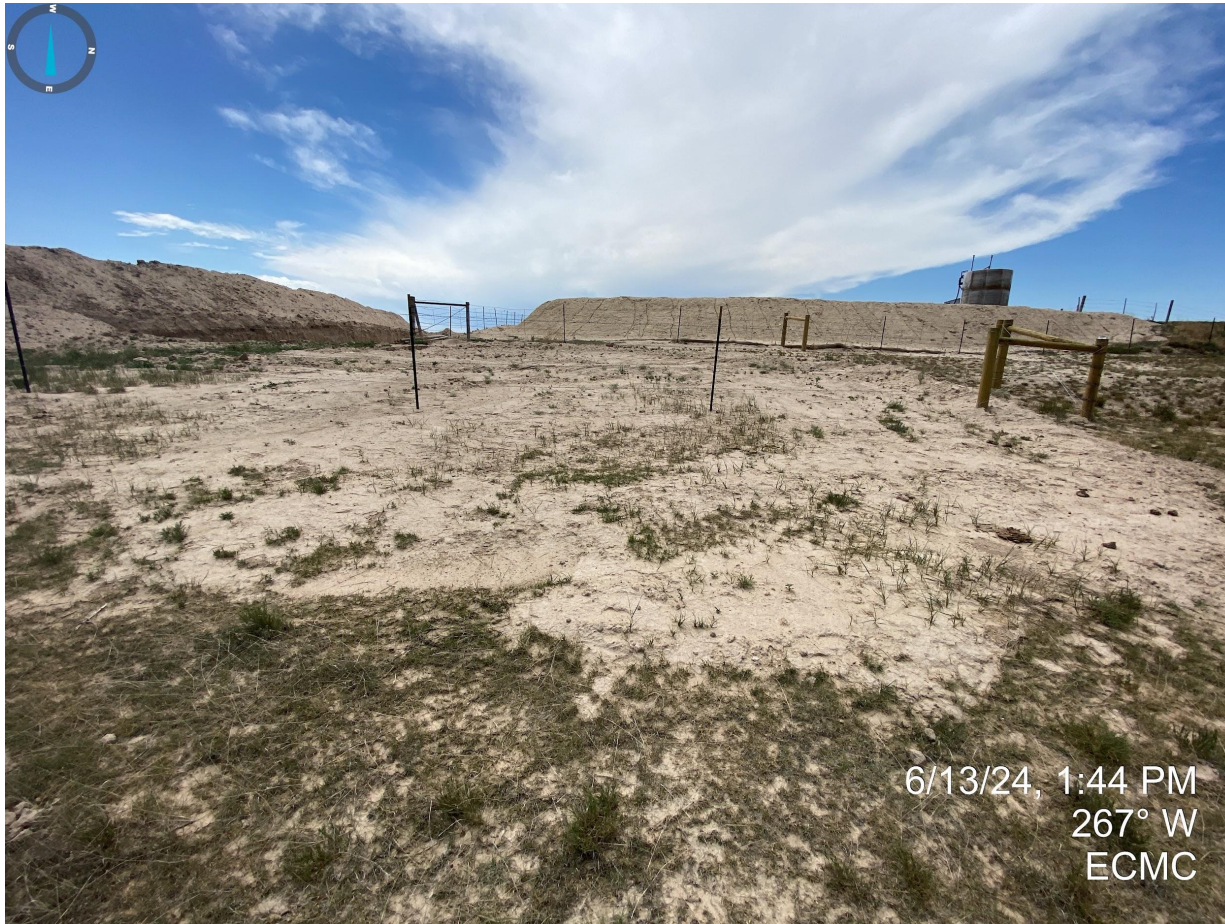
**Photo 13.** Taken from the north side of the stockpiled soils. No perimeter stormwater control measures/BMPs, or impermeable liners underneath the stockpile were observed during this inspection. Impacted soils appear to have been placed directly on top of undisturbed lands. Additionally, it does not appear that topsoil has been salvaged Per Rule 1002.b prior to stockpiling the soil on undisturbed portions of land.

**Photo 19.** Taken southeast of the excavated area and stockpiled material; see comments in Photo 13.

**Photo 20.** Continued from Photo 19, facing west.
