Operator: 8 NORTH

Location Name: HALEY-RAY-611N61W 21SWSW

Loc ID: 305413

Inspection: 691200008

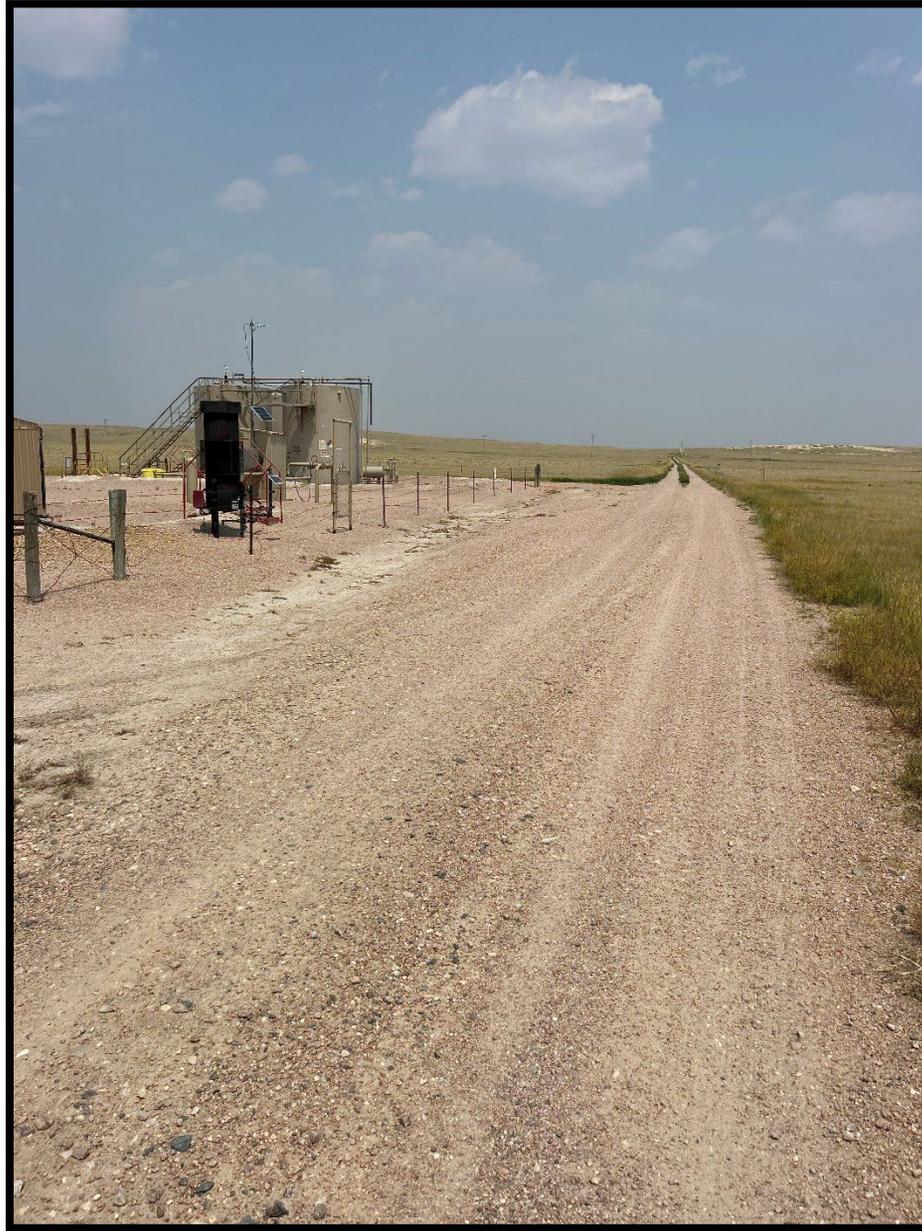
CA: Stained soil at wellhead. Comply with Rule 603.f.

CA Resolution: Operator has provided photo evidence showing that the stained soil at the wellhead has been addressed in compliance with rule 603.f.
