Operator: 8 North

Location Name: DF RANCH-611N61W 15NWSE

Loc ID: 410055

Inspection: 696300875

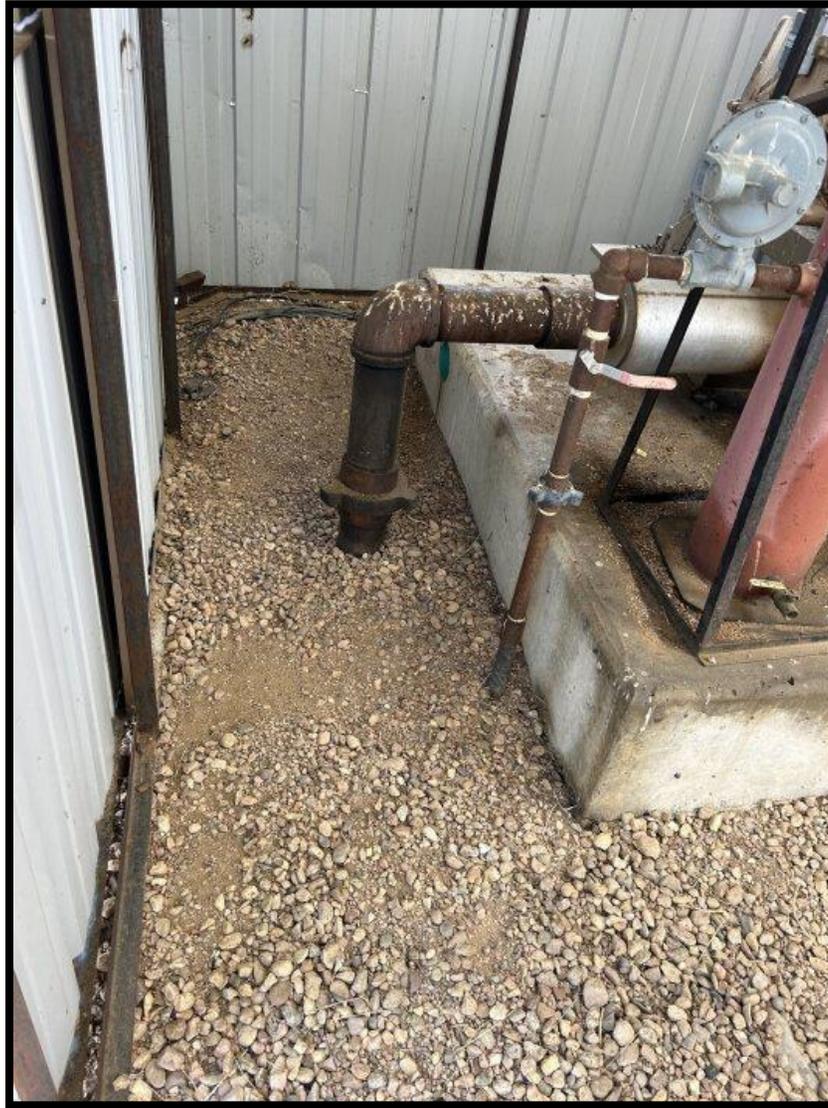
Exhibit C

CA: Stained Soil at Exhaust and Gas Engine, see photo 2. Corrective Action: "Properly treat or dispose of oily waste in accordance with 907.e

CA Resolution: Operator has provided photo evidence that the stained soil at exhaust and gas engine area has been addressed in accordance with the 900 series.
