Final Reclamation and Stormwater Inspection

Operator: Bonanza Creek Energy Operating
Company LLC - 8960

Location ID: 331414

Inspection Document #: 713900952

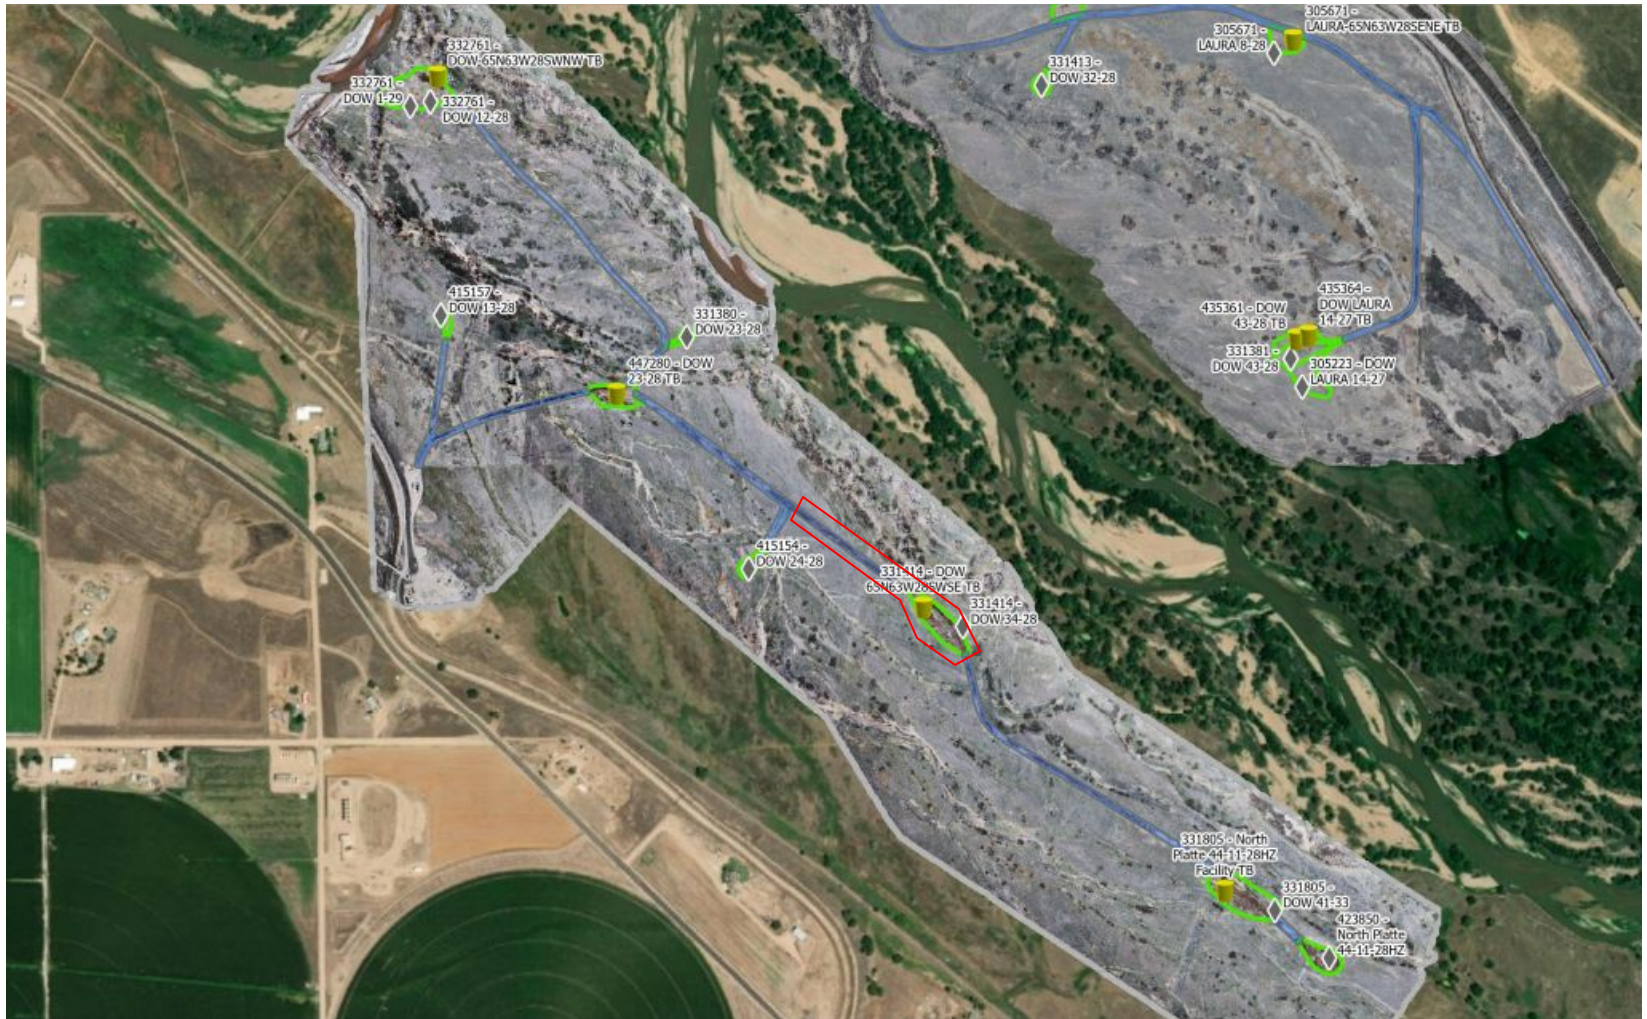
Photo 1. The photo is imagery from Operator supplied Document #403596868, CPW Centennial Valley State Wildlife Area Reclamation Report. The photo illustrates an overview of the access roads and facilities in the area under the reclamation plan. Outlined in Red are the facilities that will be associated with this inspection based on Operator determined layouts.
