**Operator: 8 North**

**Location Name: DF RANCH-611N61W 15SENE**

**Loc ID: 310707**

**Inspection: 696300873**

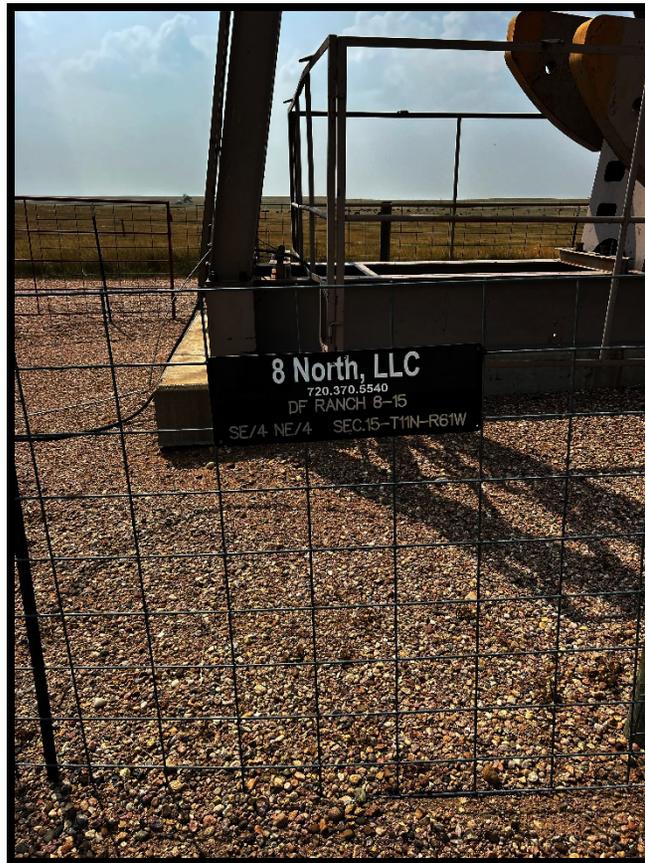
**CA:** Stained Soil at Wellhead, Exhaust, and Gas Engine. See photos 2, 3, 4, 5. Corrective Action: Properly treat or dispose of oily waste in accordance with 907.e  
**CA Resolution:** Operator has provided photo evidence to show that the stained soil has been appropriately removed/cleared and mechanical issues leading to the leak have also been addressed.
