Inspection Photos

Operator: Petrox Resources Inc. - 69805

Location ID: 378718

Inspection Photos
Location Name: Wright 33-5 16-1
Location ID: 378718

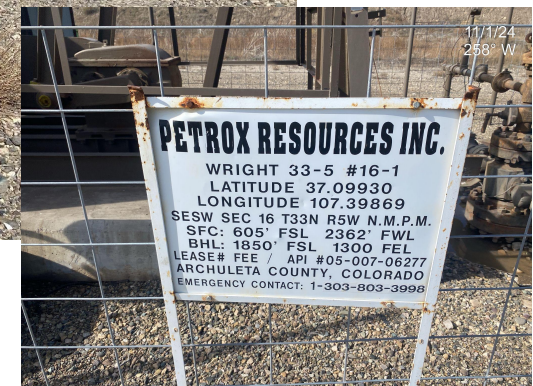
Photo 1. View of the well disturbance taken from the access point facing center. Local emergency # missing from well signage.
