Energy & Carbon Management Commission

Laramie/0993-29-01 #487592 Annotation Report

Captured on November 12, 2024

Laramie/0993-29-01 #487592 Issue Report

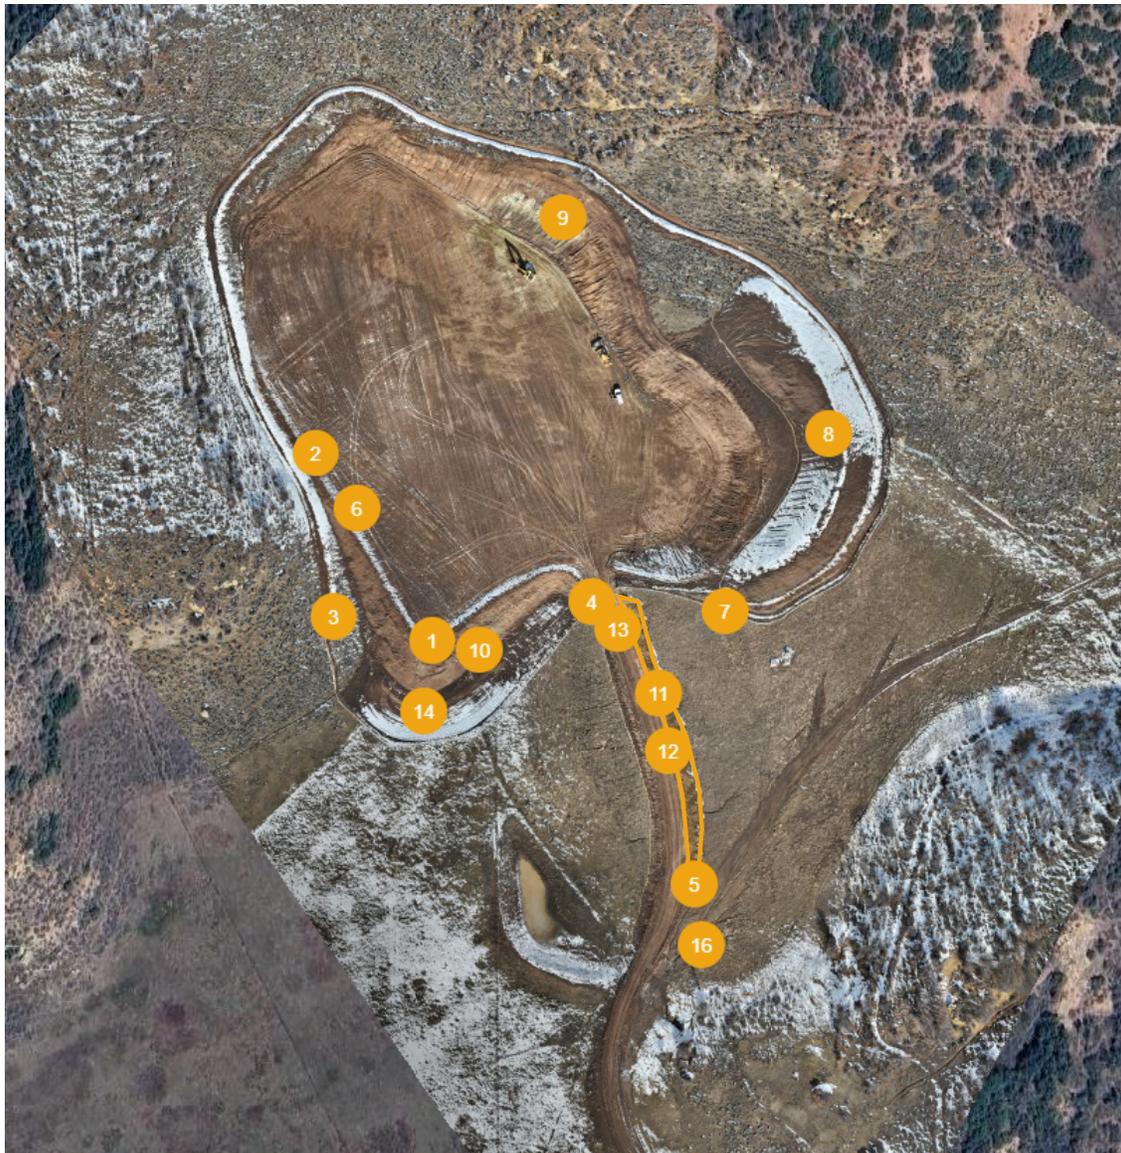
16 - Observation

Summary:	Signage has not been maintained and requires posting at the Location entrance.
Created:	Nov 15, 2024, 10:40am by Aaron Trujillo
Cost of Repair:	—
Lat/Long:	39.2529688, -107.7830474
Northing:	1525151.3 US ft
Easting:	2353566.4 US ft
Elevation:	-1.76 US ft
