Well Integrity Report  
Multifinger Caliper  
Wildcat  
Currier 7-2

Survey Date: 06 September 2024

<b>Customer:</b>	Snow Consulting	<b>API No.:</b>	0507708022
<b>Well:</b>	Currier 7-2	<b>Survey date:</b>	06 Sep 2024
<b>Field:</b>	Wildcat	<b>Job no.:</b>	ANS 1442

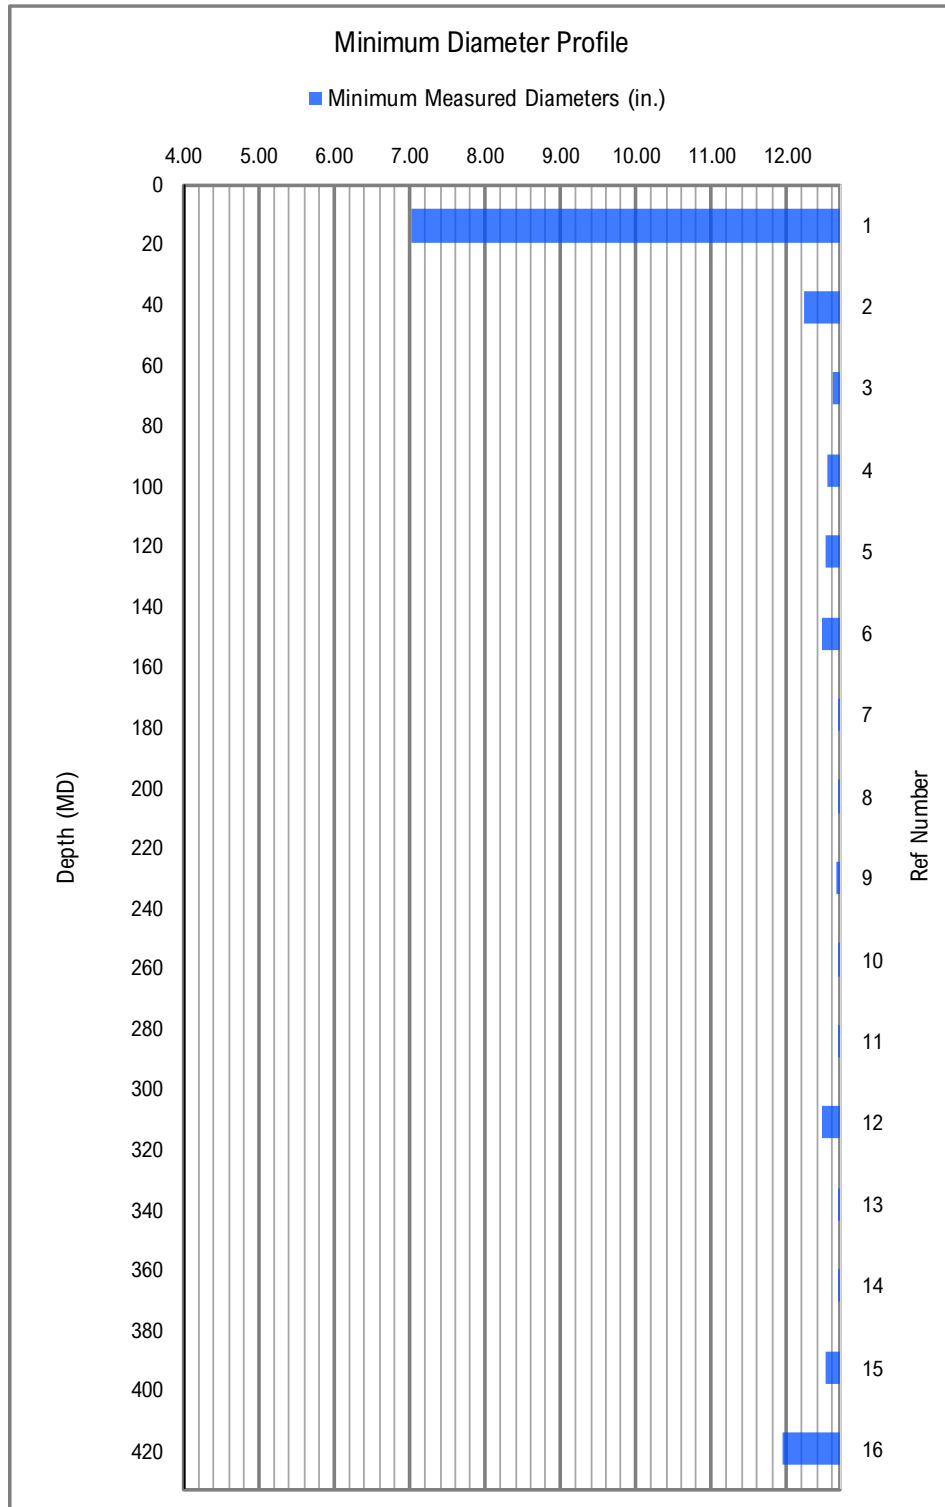
**Figure 17: Minimum ID Profile**

- The survey minimum diameter is found within the wellhead/casing hanger assembly reducing the ID to 7.015" at -1.76 ft, see Figure 2.

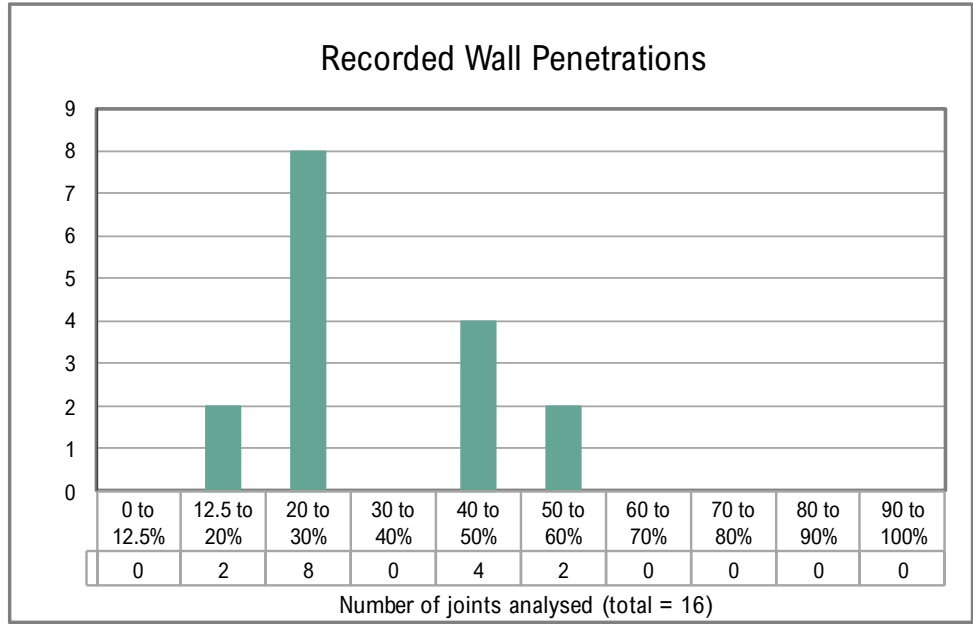
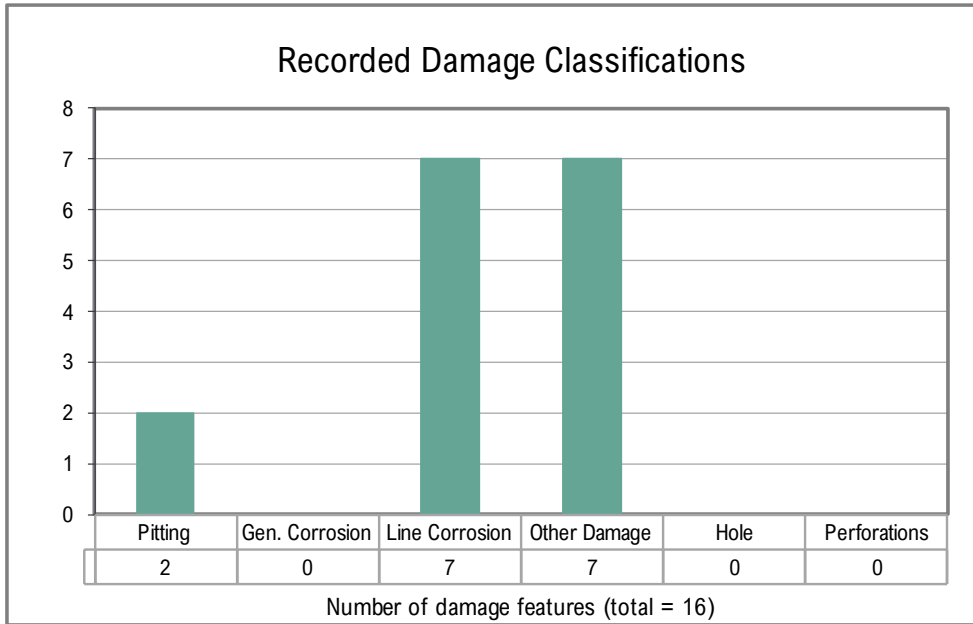
**Figure 18: Recorded Wall Penetrations and Damage Classification**

Description	Percent Wall Penetration	Ref No.	Depth (ft)
Apparent Wear / Line Corrosion	55.2	10	242.35
Apparent Wear / Line Corrosion	55.1	9	239.58
Apparent Wear / Line Corrosion	48.7	14	366.95
Apparent Wear / Line Corrosion	44.8	13	363.39
Apparent Wear / Line Corrosion	42.9	7	156.94
