## Annual Reclamation Assessment Report (2024)

<b>ECMC Location Name (ID)</b>	MATT-64N67W /24NWSW (331001)
<b>Operator Location Name</b>	Matt 1 Well Pad & Facility
<b>ECMC Operator Name (ID)</b>	PDC ENERGY, INC (69175)
<b>Legal Description</b>	NWSW Sec. 24 T4N-R67W
<b>Well Pad Geographic Coordinates (WGS84)</b>	40.295627/ -104.846841
<b>Facility Pad Geographic Coordinates (WGS84)</b>	40.294865/-104.848239

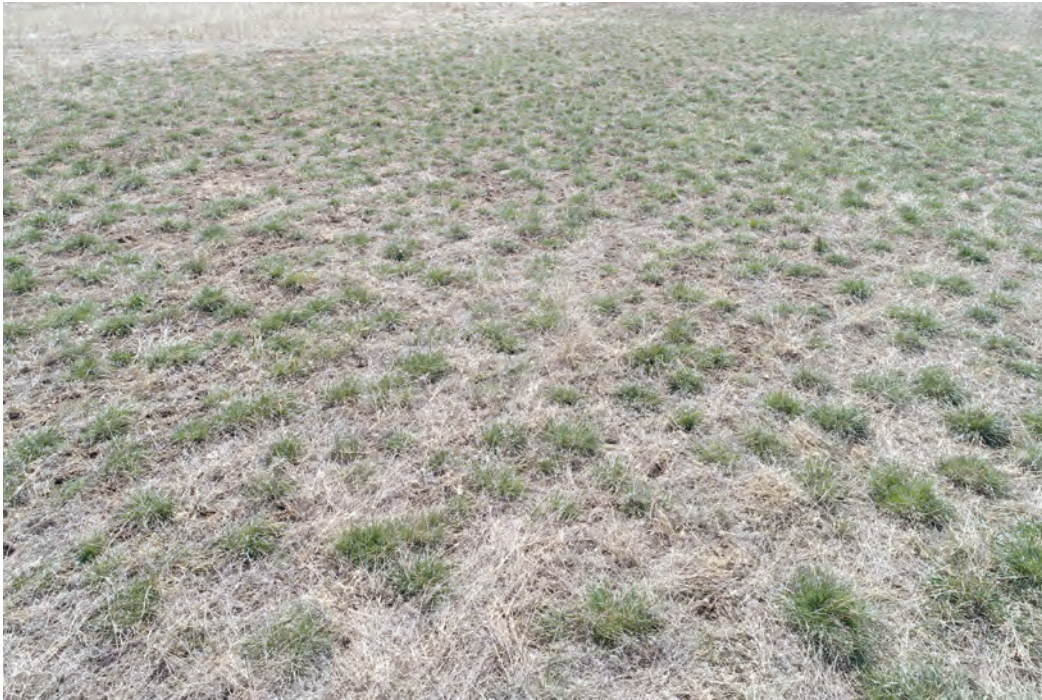
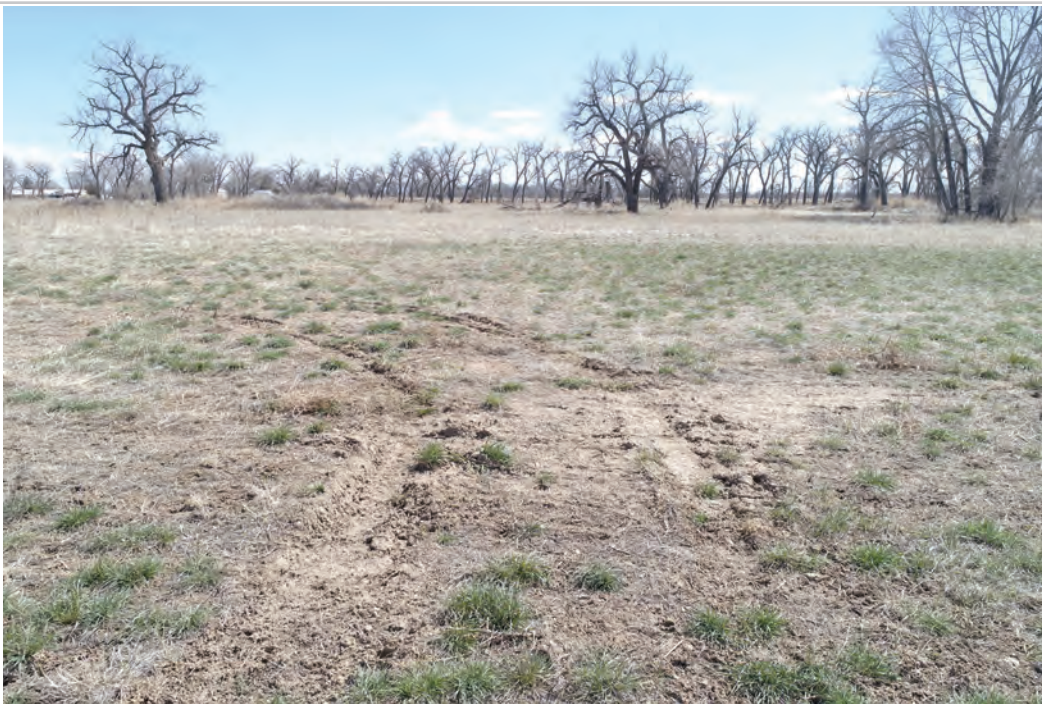
PRIMARY SITE RECOMMENDATION: Continue Monitoring

Secondary Recommendation:	Rationale:	Description:
Continue Monitoring	Reclaim vegetation establishment approaches but does not yet meet vegetation cover, composition, and/or health of the reference area.	Continued monitoring is recommended to reevaluate reclamation trajectory.

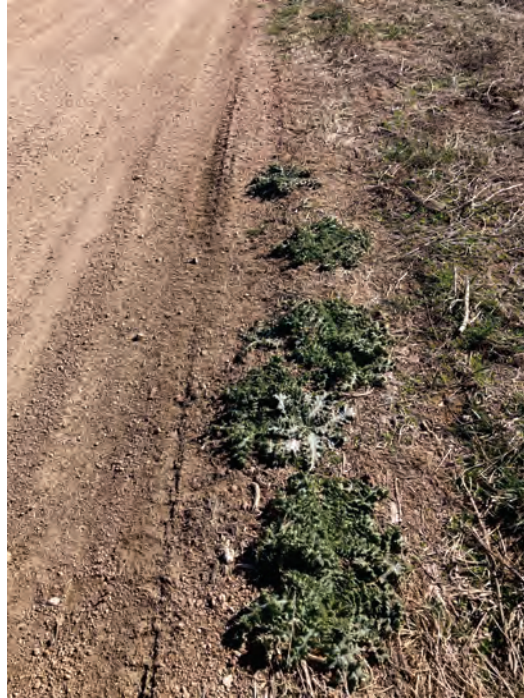
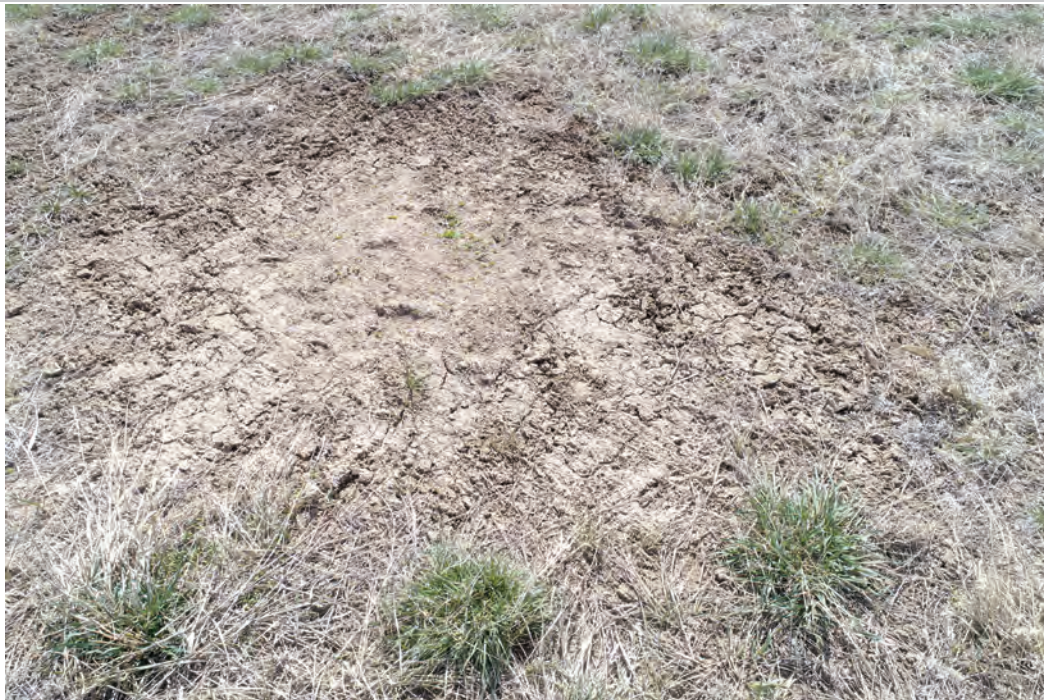
**SECONDARY SITE RECOMMENDATION: Maintenance**

Primary Recommendation:	Rationale:	Description:
Maintenance	Weeds are over-represented within the reclaim when compared to the reference.	Coordination with surface owner is recommended to discuss the preferred approach to managing weeds on Location. Spot treating noxious thistle species is recommended to reduce the potential spread of noxious vegetation within the reclaim.

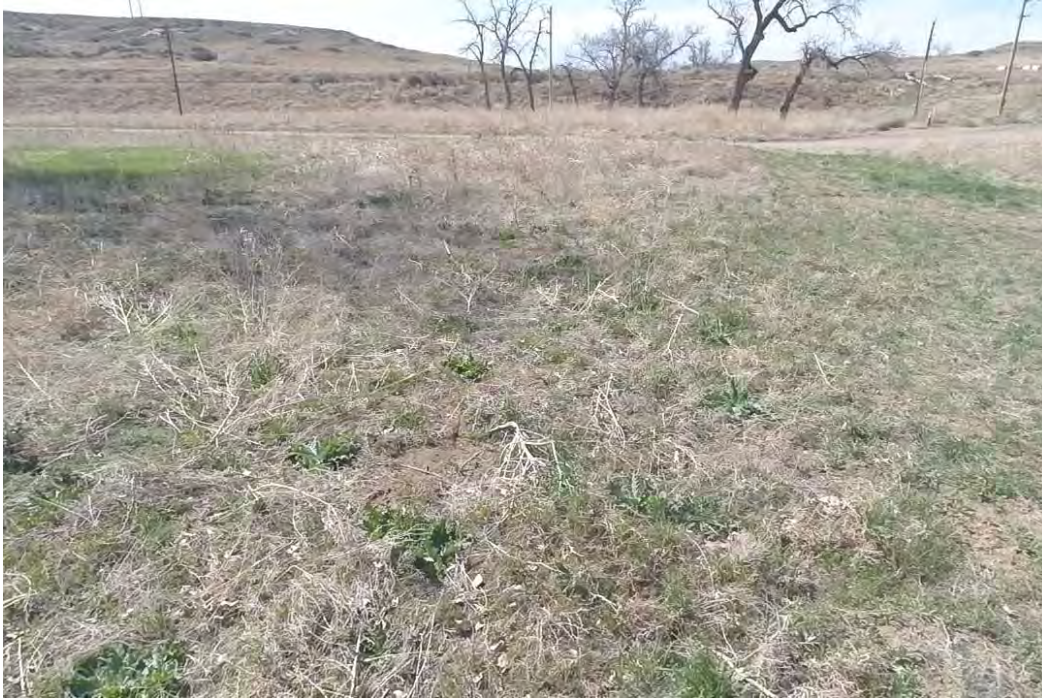
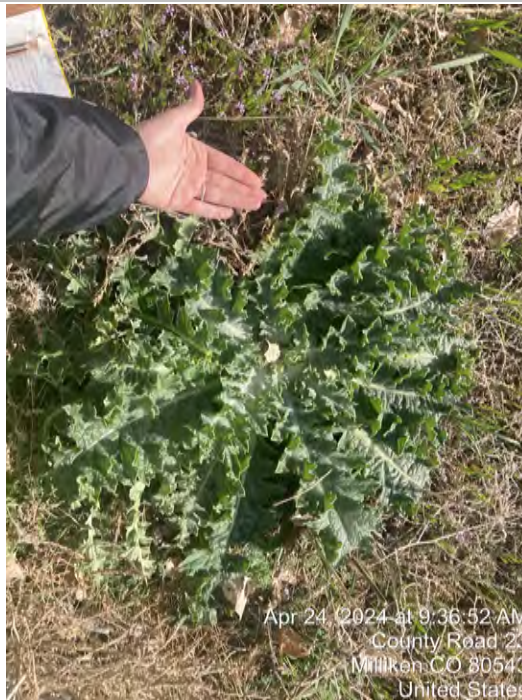
**PRIMARY SITE RECOMMENDATION: Maintenance**

Primary Recommendation:	Rationale:	Description:
Continue Monitoring	Reclaim vegetation establishment approaches but does not yet meet vegetation cover, composition, and/or health of the reference area.	Annual grasses are growing in the reclaim. However, the portion of the reclaim previously used as a stockpile and the location of the tank battery still remain mostly barren.

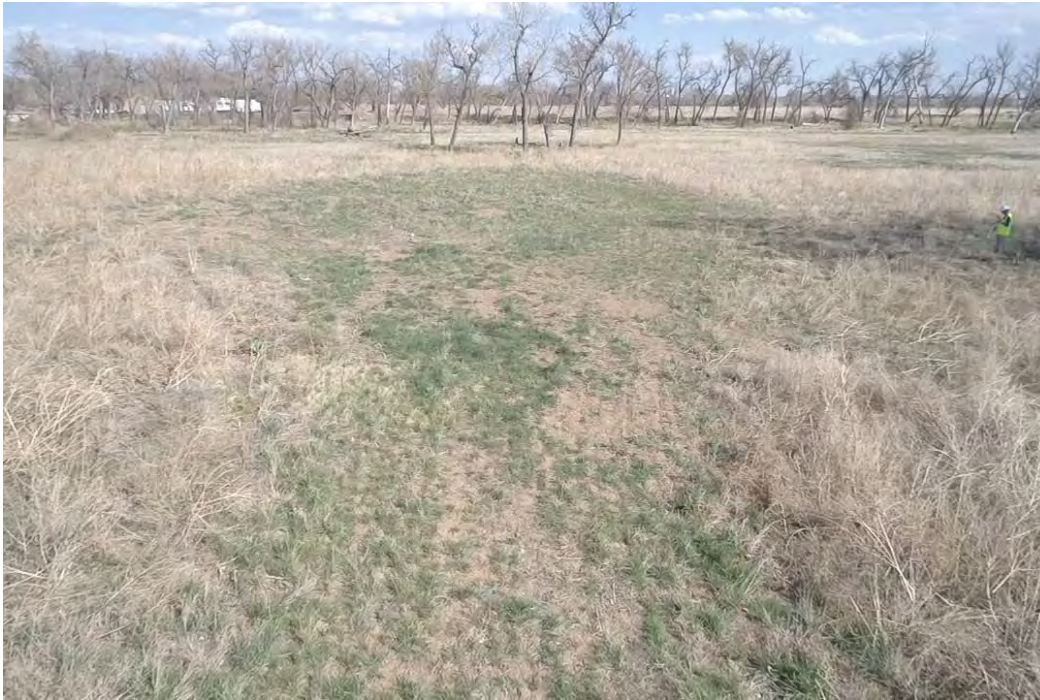
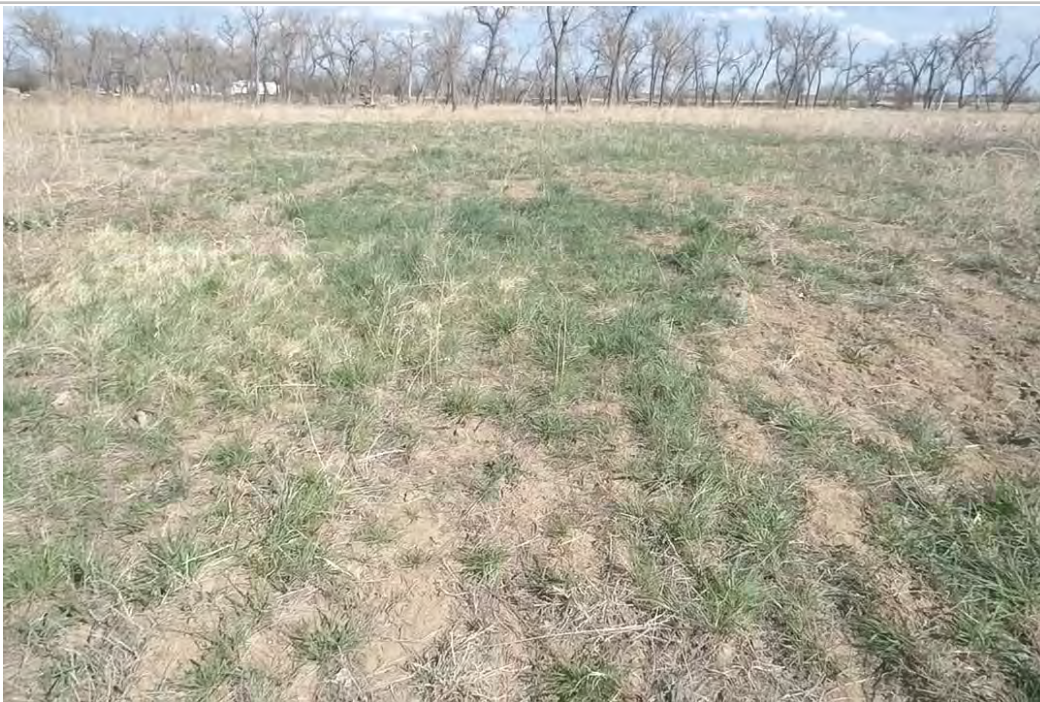
**SECONDARY SITE RECOMMENDATION: Continue Monitoring**

Secondary Recommendation:	Rationale:	Description:
Maintenance	Weeds are over-represented within the reclaim when compared to the reference.	Noxious thistles and undesirable vegetation are present along the access road north of the Location. Recommend spot treating thistles to reduce potential encroachment into the reclaim.

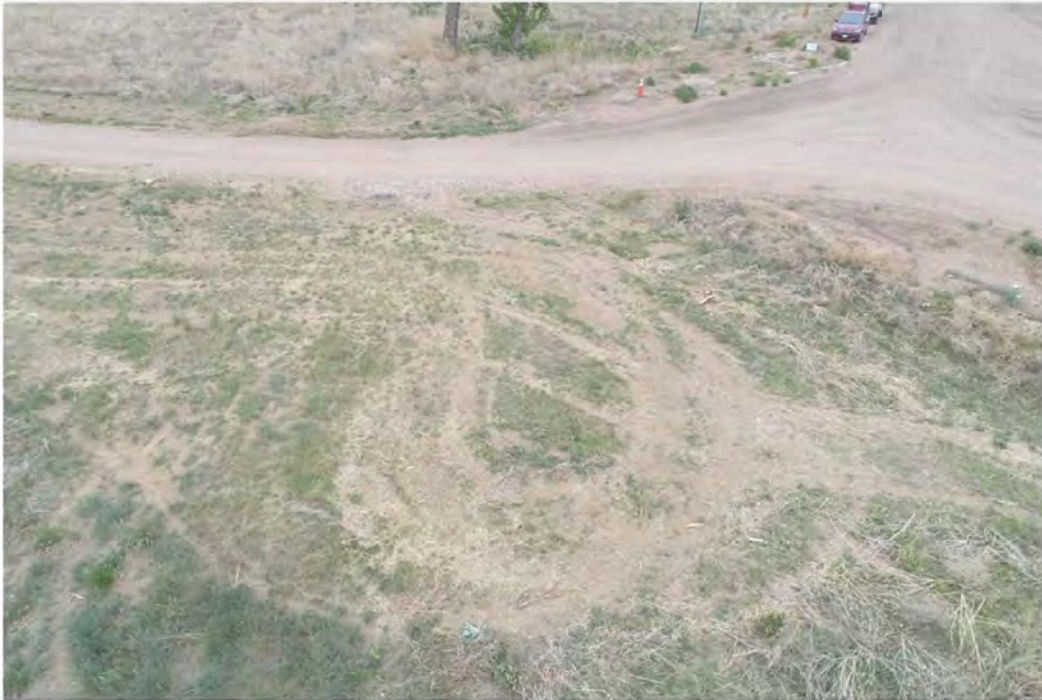
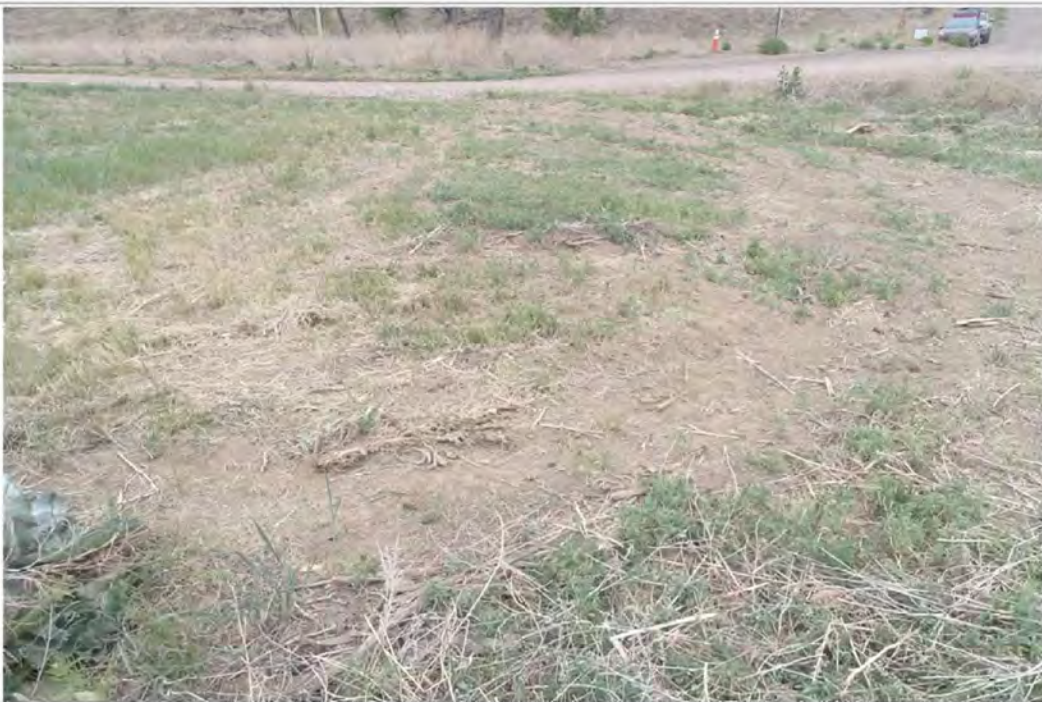
**PRIMARY SITE RECOMMENDATION: Maintenance**

Primary Recommendation:	Rationale:	Description:
Maintenance	Weeds are over-represented within the reclaim when compared to the reference.	Noxious thistles, kochia, perennial pepperweed, and leafy spurge have colonized throughout the disturbance. Confluence recommends a broad leafed herbicide application to mitigate further establishment of undesirables throughout the location.

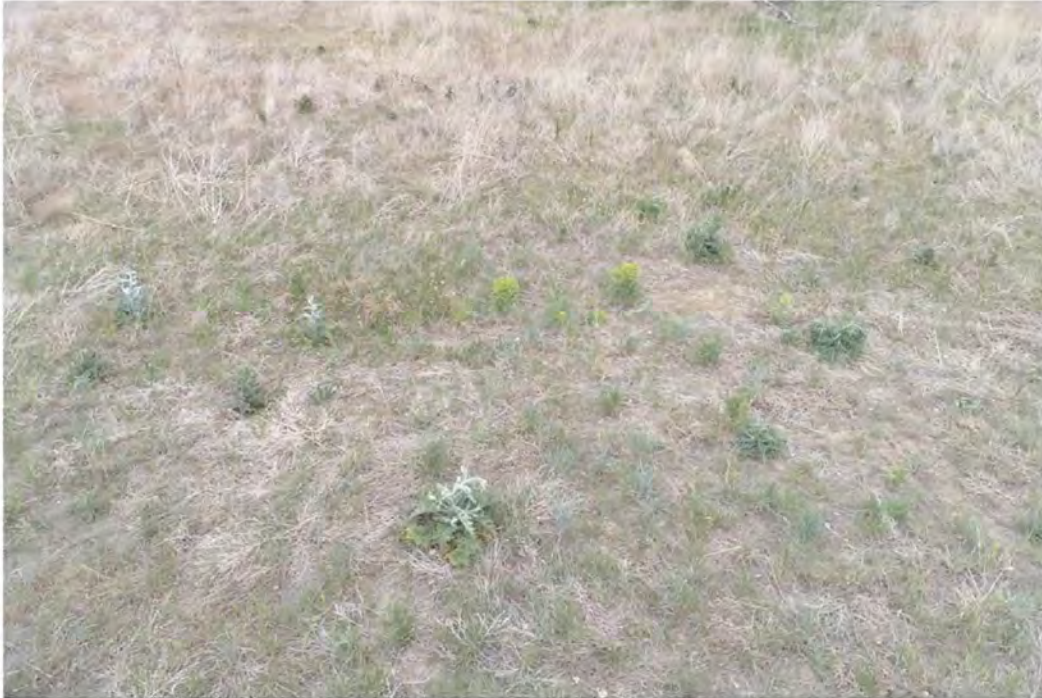
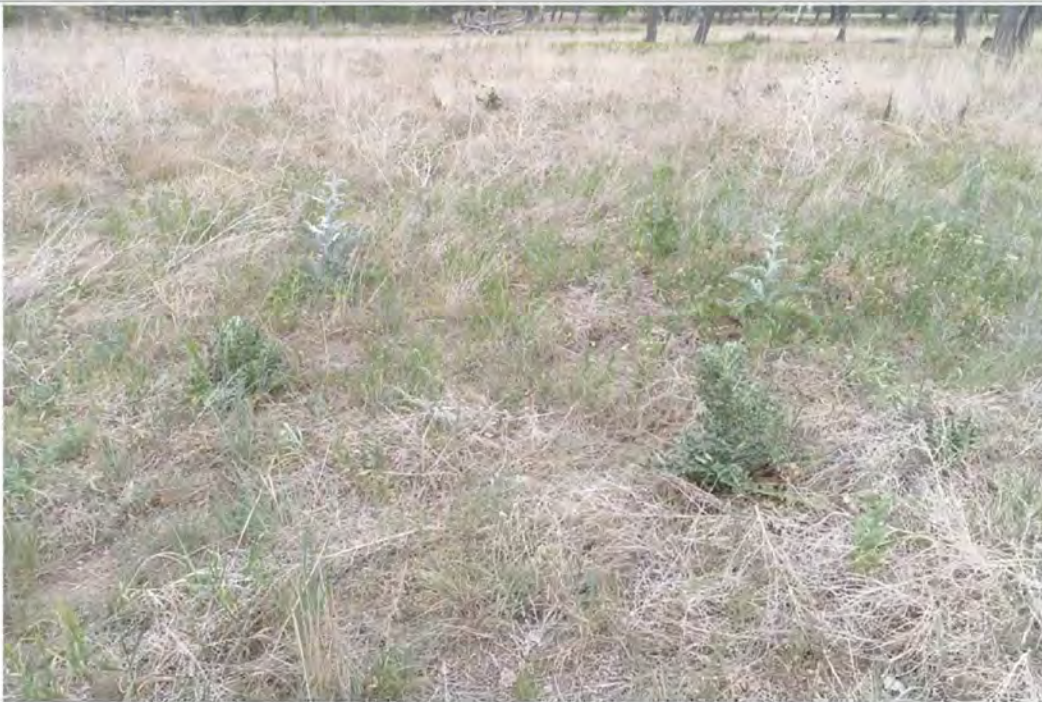
**SECONDARY SITE RECOMMENDATION: Maintenance**

Secondary Recommendation:	Rationale:	Description:
Maintenance	Vehicle damage to reclaim surface observed.	Vehicle damage from recent mowing observed at site entrance. Bare areas present at well head and immediately adjacent to well head. Confluence recommends interseeding throughout bare areas to increase cover of native grasses.

Maintenance Contract Type: Level 2 - Verbal Authorization. (Use for jobs that cost ~ \$500 - \$1,500, seeding, soil sampling, and/or erosion repair)  
 Square Foot Estimate: NA

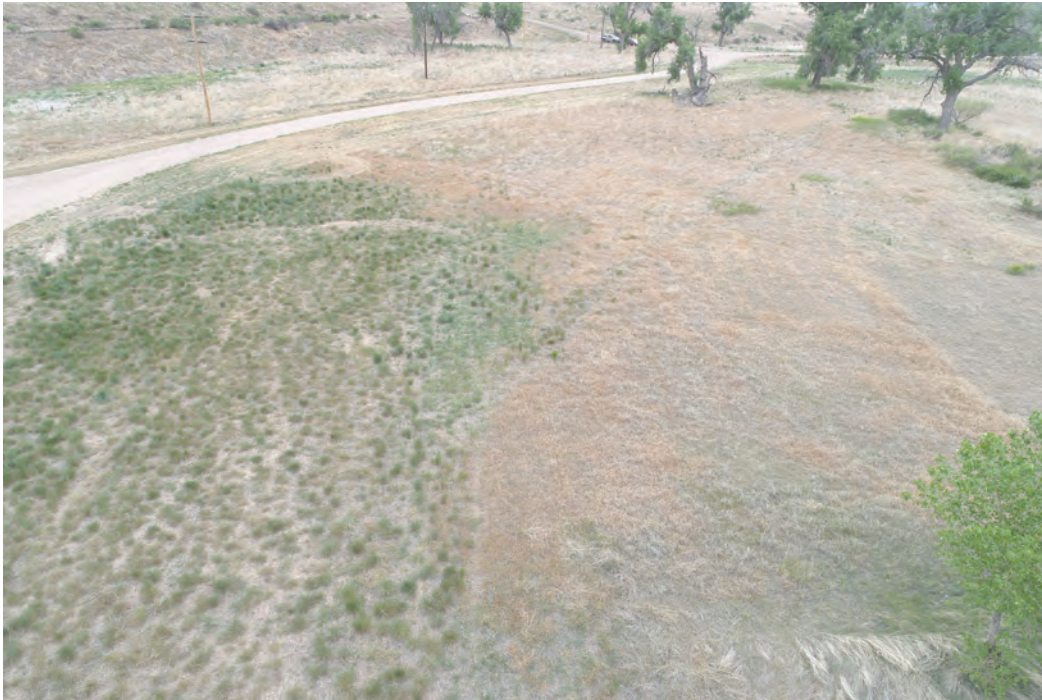
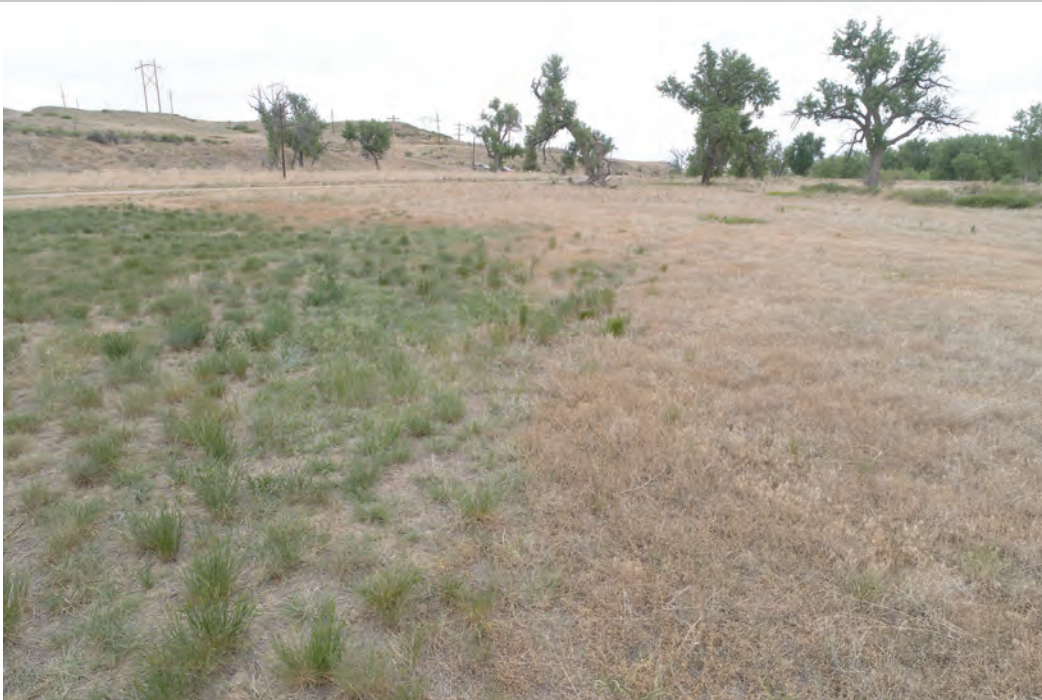
**PRIMARY SITE RECOMMENDATION: Quantitative Vegetation Survey**

Primary Recommendation:	Rationale:	Description:
Quantitative Vegetation Survey	Non-crop, perennial vegetation observed within reclaimed surface appears to be comparable to reference vegetation cover, composition, and vigor.	Reclaim surface appears to have an abundance of desirable grasses compared to the reference. Confluence recommends a QVS to compare vegetation composition between the reclaim and reference.

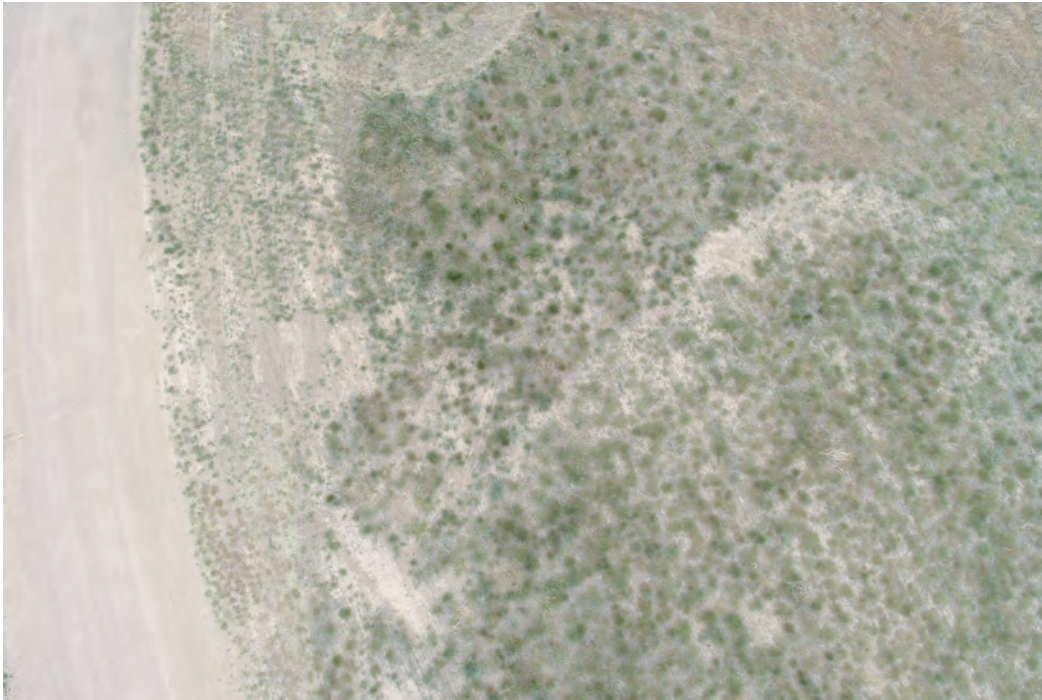
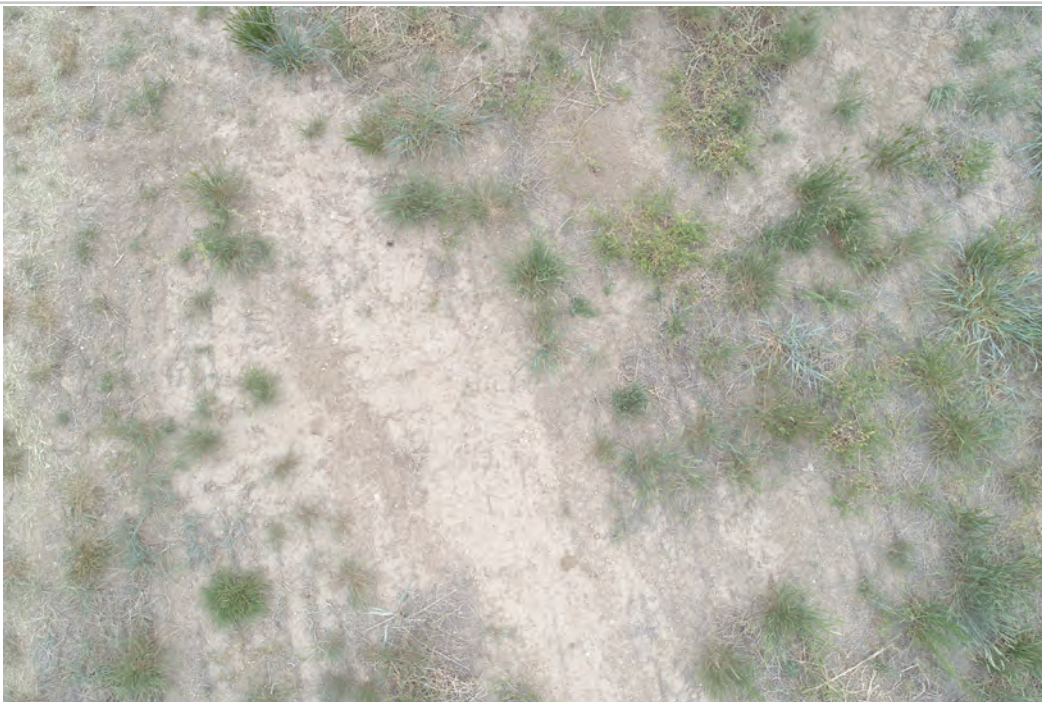
**SECONDARY SITE RECOMMENDATION: Maintenance**

Secondary Recommendation:	Rationale:	Description:
Maintenance	Vehicle damage to reclaim surface observed.	Tire tracks are present due to recent mowing. Confluence recommends interseeding to alleviate damage from mowing and increase cover of desirable vegetation within the bare patches.

Maintenance Contract Type: Level 2 - Verbal Authorization. (Use for jobs that cost ~ \$500 - \$1,500, seeding, soil sampling, and/or erosion repair)  
 Square Foot Estimate: NA

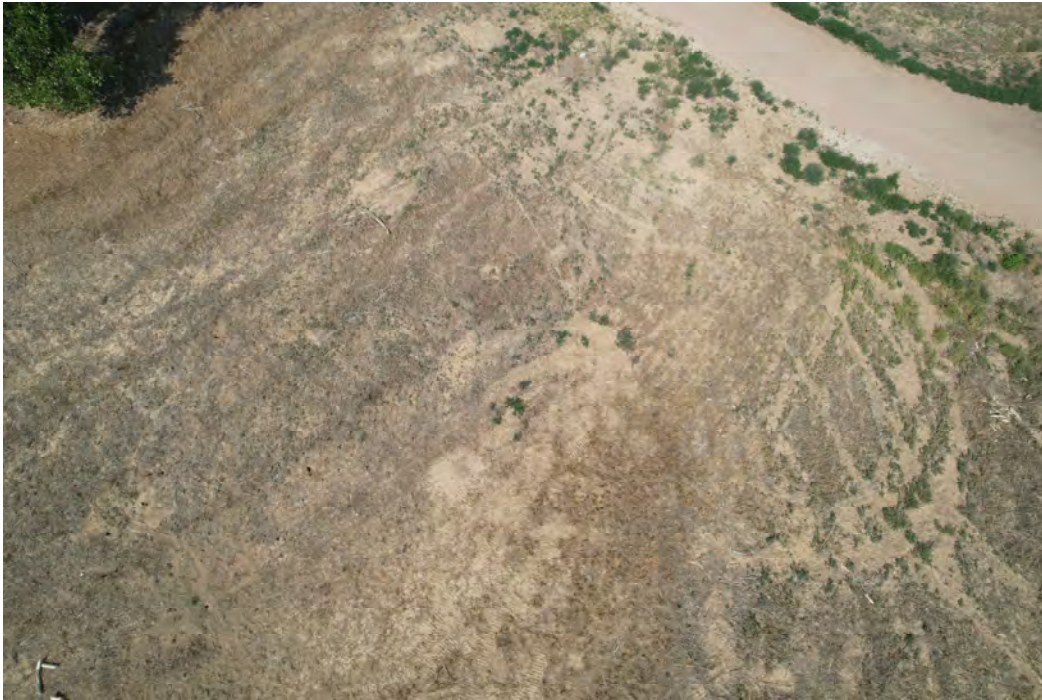
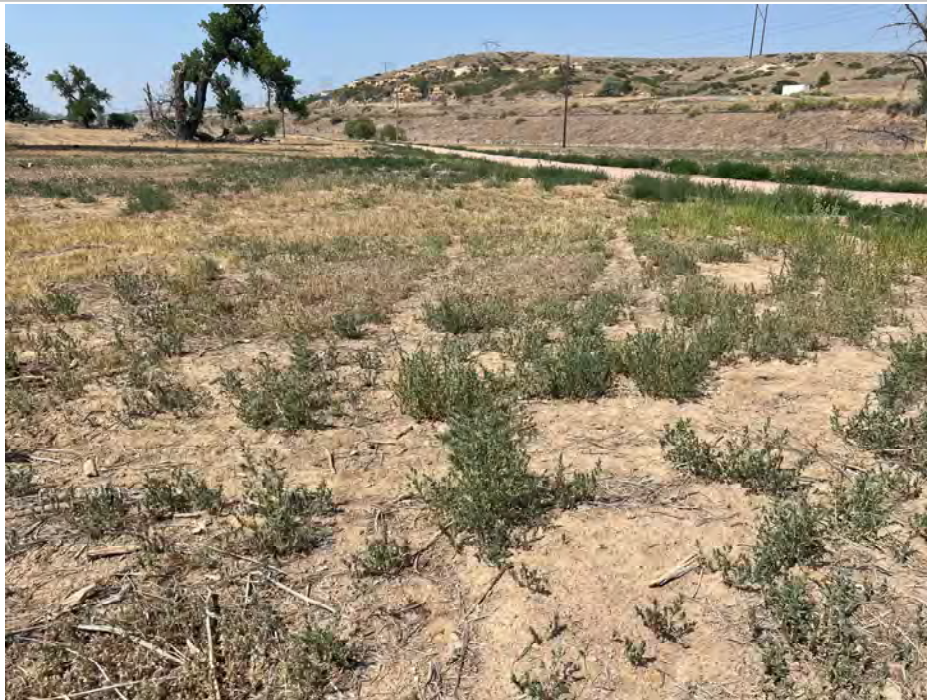
**SECONDARY SITE RECOMMENDATION: Maintenance**

Secondary Recommendation:	Rationale:	Description:
Maintenance	Vehicle damage to reclaim surface observed.	Some bare spots present on site along with two prairie dog burrows and vehicle tracks. Confluence recommends interseeding to enable positive revegetation.

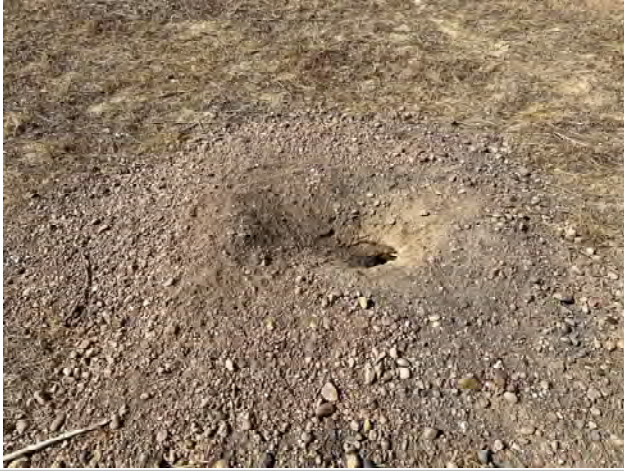
Prairie dog hole

Prairie dogs observed onsite. Two burrows at this time. May warrant further investigation/maintenance in the future.

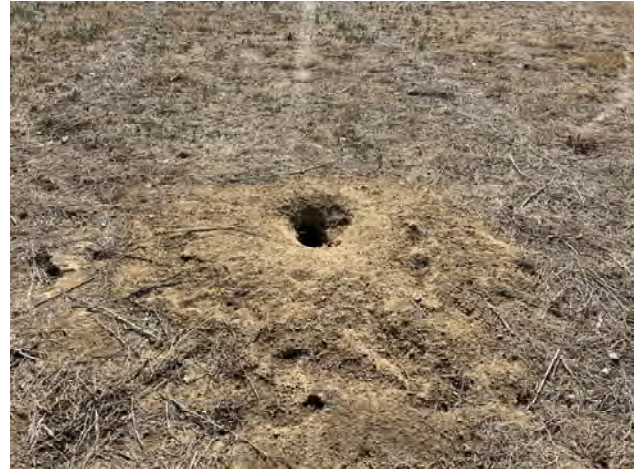
Prairie dog hole

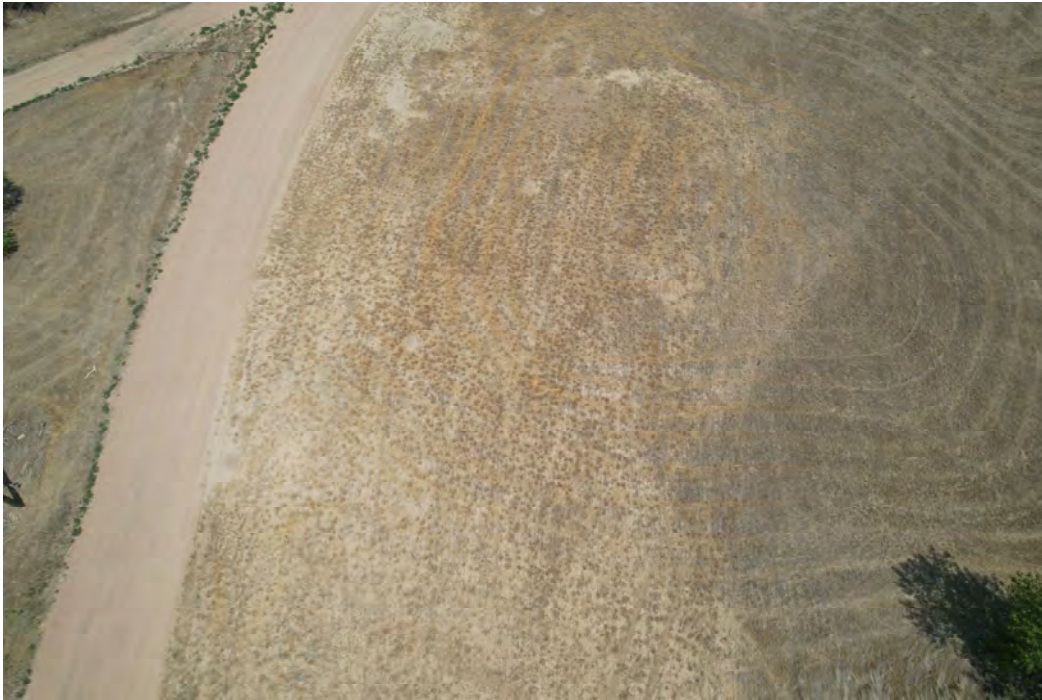
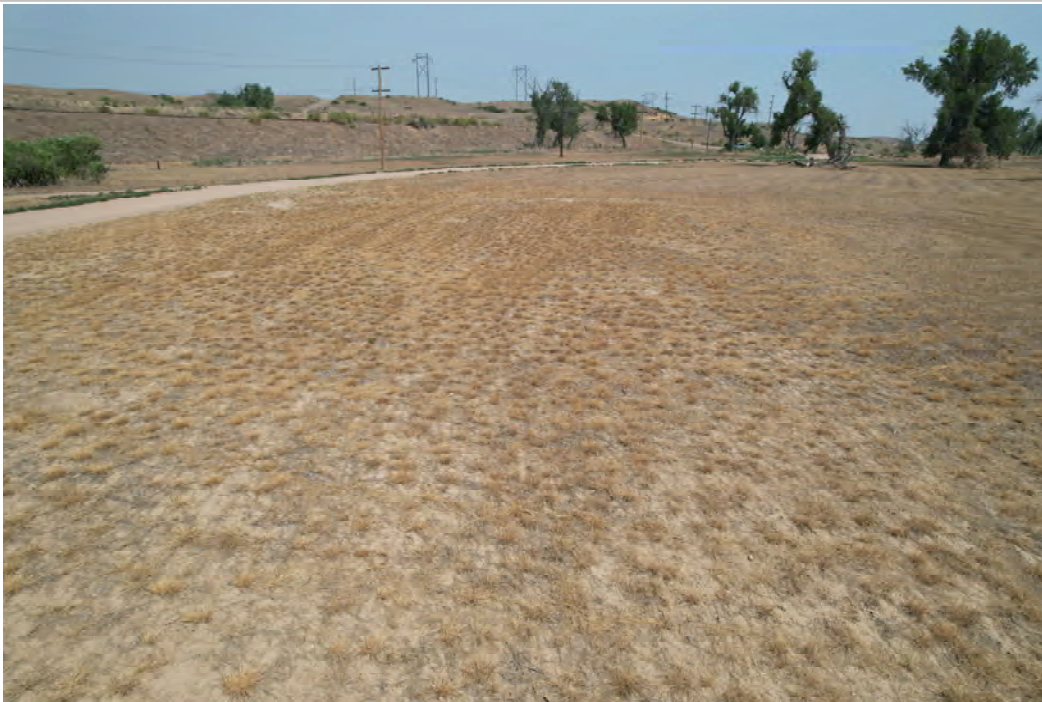
**PRIMARY SITE RECOMMENDATION: Quantitative Vegetation Survey**

Primary Recommendation:	Rationale:	Description:
Quantitative Vegetation Survey	Non-crop, perennial vegetation observed within reclaimed surface appears to be comparable to reference vegetation cover, composition, and vigor.	Reclaim surface appears to match surrounding reference area. Confluence recommends a QVS to further compare reclaim and reference areas.

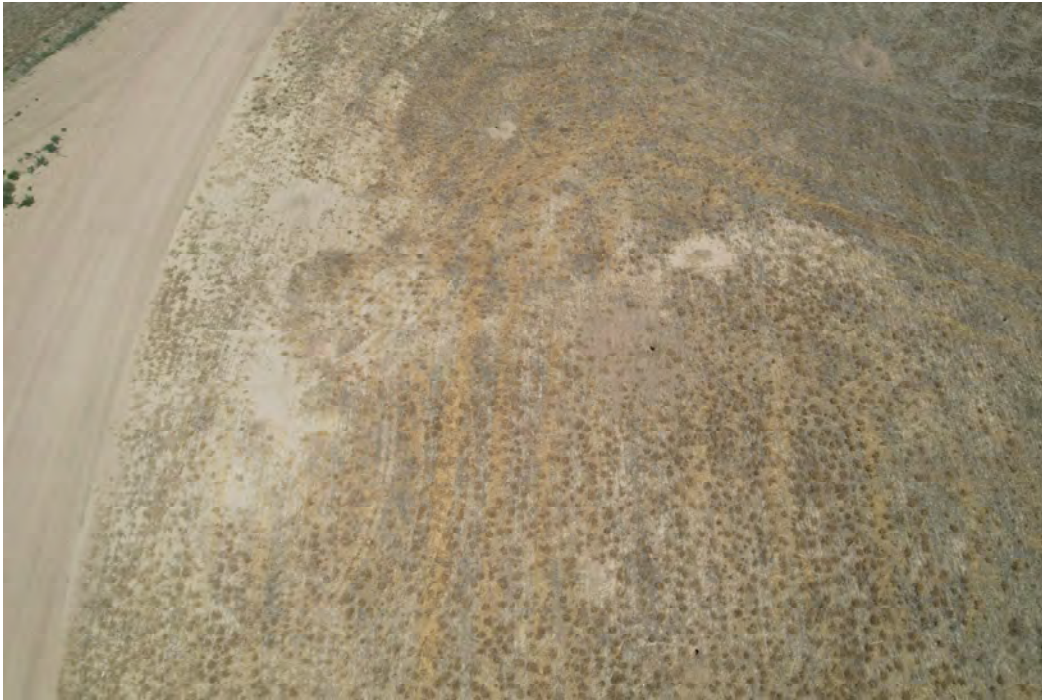
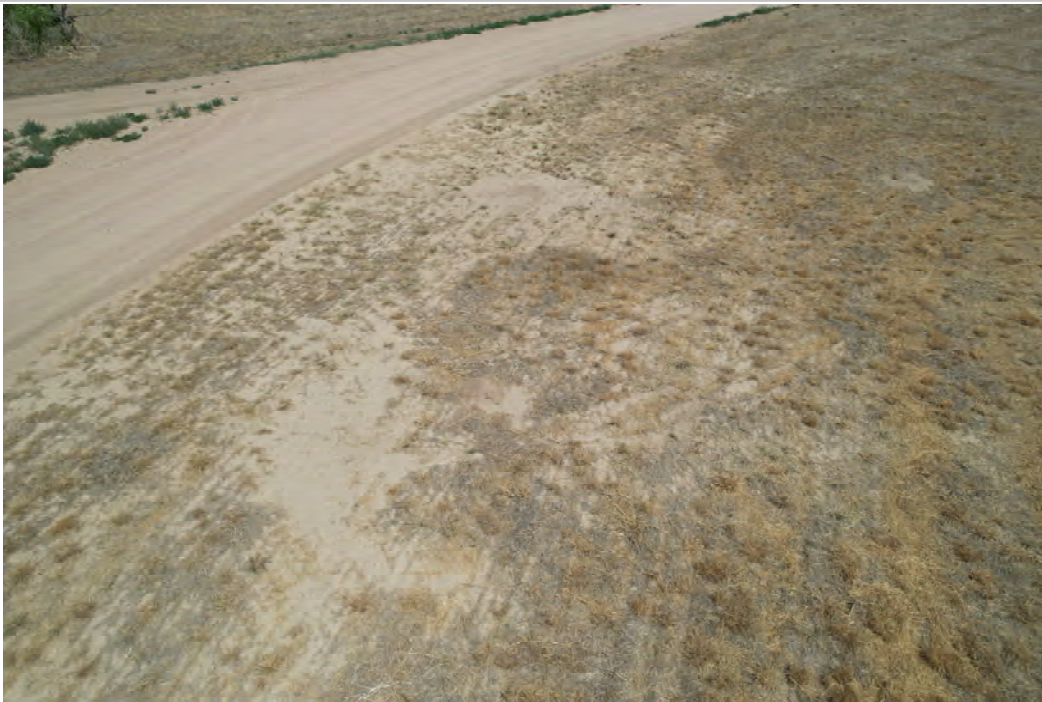
**SECONDARY SITE RECOMMENDATION: Maintenance**

<b>Secondary Recommendation:</b> Maintenance	<b>Rationale:</b> Vehicle damage to reclaim surface observed.	<b>Description:</b> Vehicle tracks from previous mowing operations are present within the reclaim. In addition, bare spots are present within the reclaim. Confluence recommends collecting agronomic focused soil samples in the reclaim and reference to identify soil suitability and nutrient availability. Sample results will guide soil amendment recommendations for a future application that can be combined with an interseeding effort at a seasonally appropriate time.
---	--	---

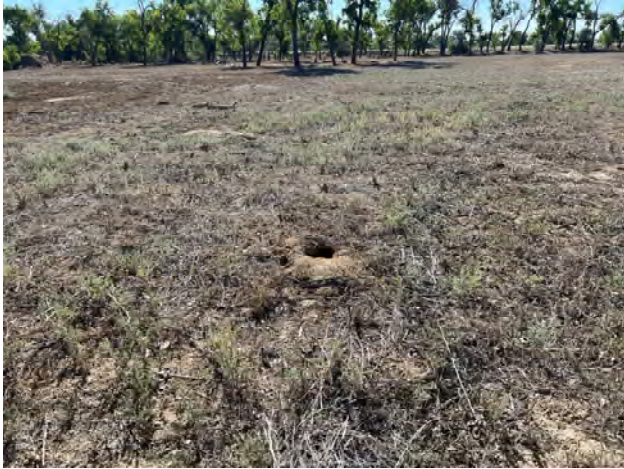
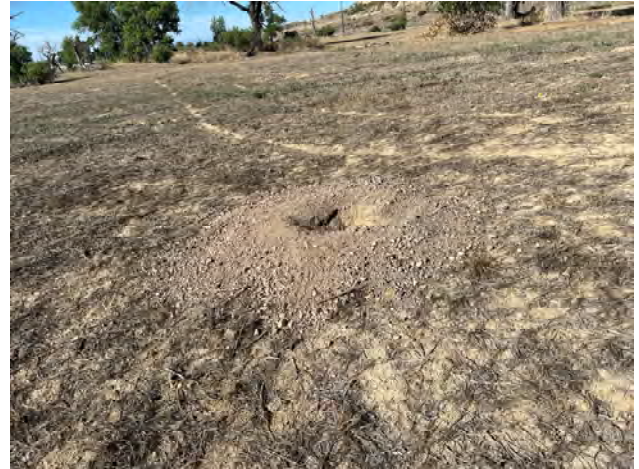
- Prairie dog holes are still present on site but do not appear to have expanded in the last month.  
 - Bull thistle appears to have been successfully treated. Two individuals observed and hand-pulled.

Prairie dog burrow

Prairie dog burrow and vehicle tracks

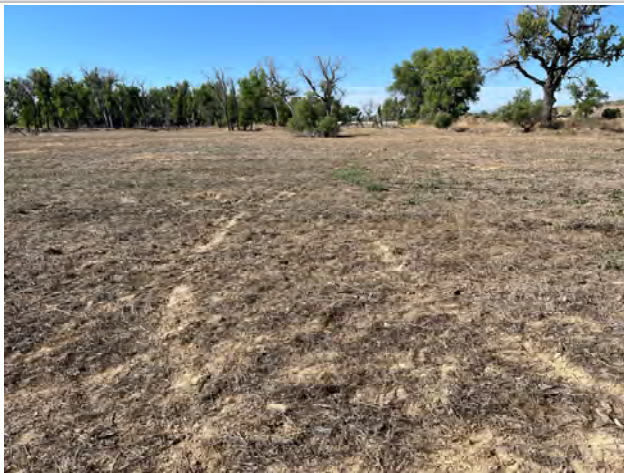
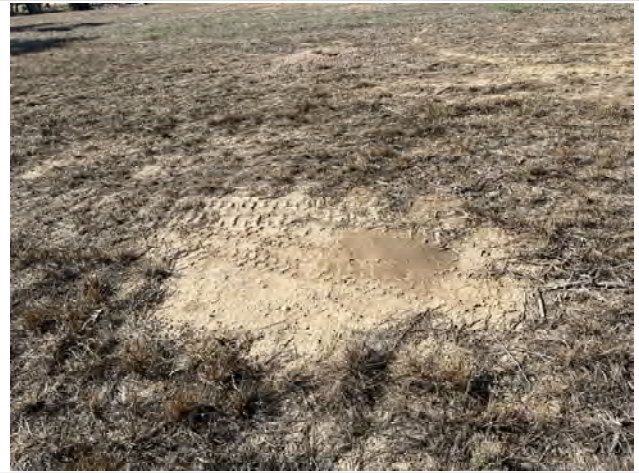
Vehicle tracks

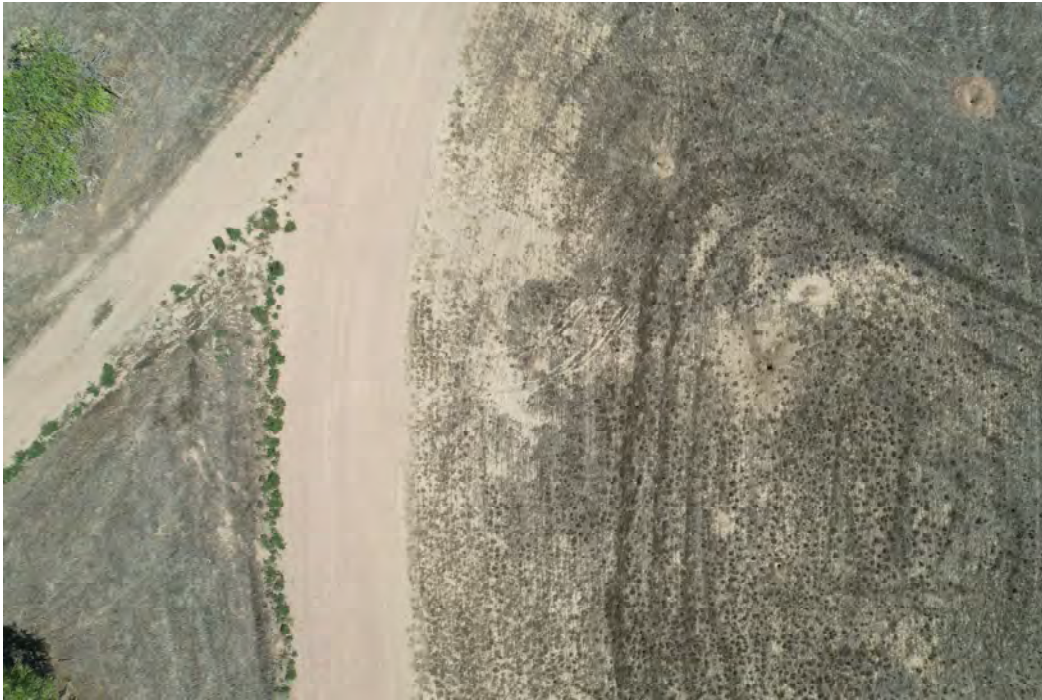
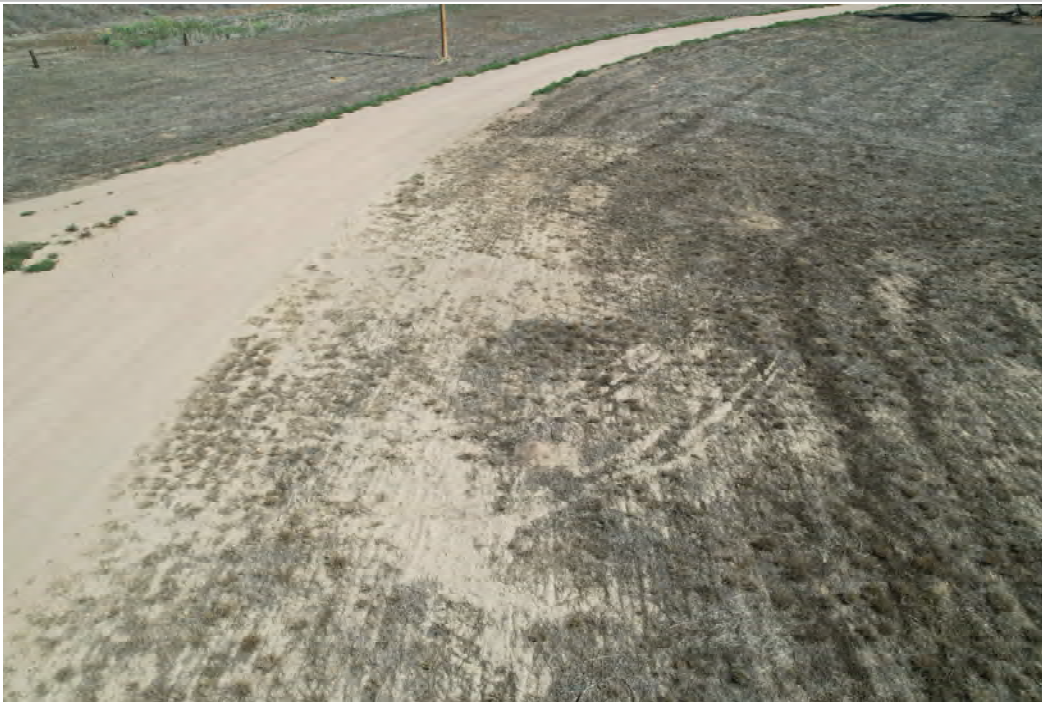
**PRIMARY SITE RECOMMENDATION: Maintenance**

Primary Recommendation:	Rationale:	Description:
Maintenance	Vehicle damage to reclaim surface observed.	Vehicle tracks from previous mowing operations are present within the reclaim. In addition, bare spots are present within the reclaim. Confluence recommends collecting agronomic focused soil samples in the reclaim and reference to identify soil suitability and nutrient availability. Sample results will guide soil amendment recommendations for a future application that can be combined with an Interseeding effort at a seasonally appropriate time.

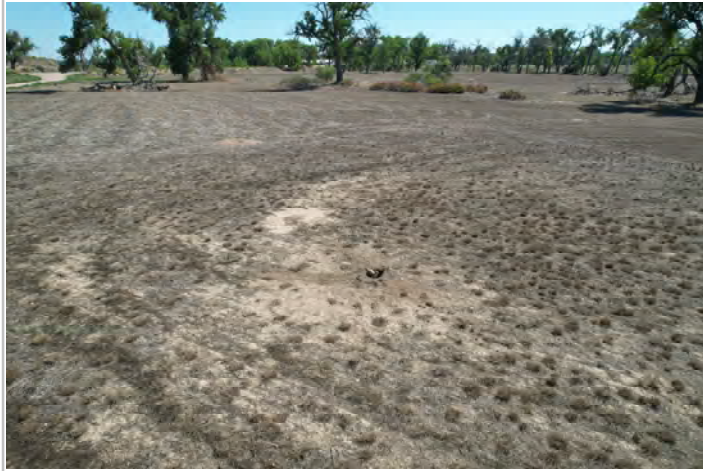
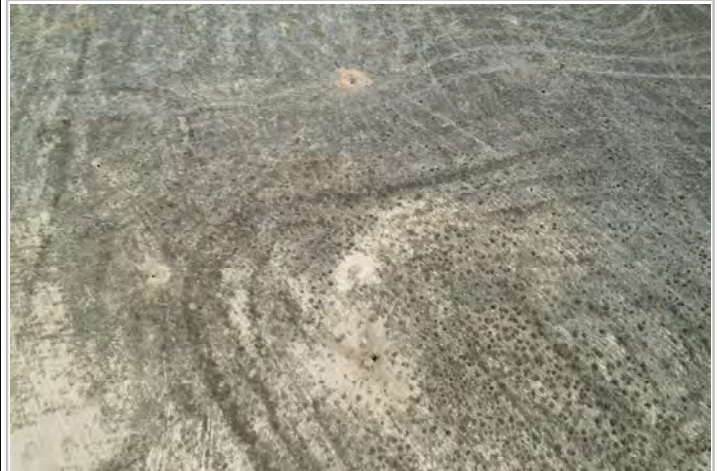
- Prairie dogs are active onsite and in the surrounding areas, two burrows observed at this time. They do not appear to have spread further in the last month.

Prairie dog burrow

Aerial view of prairie dog burrows

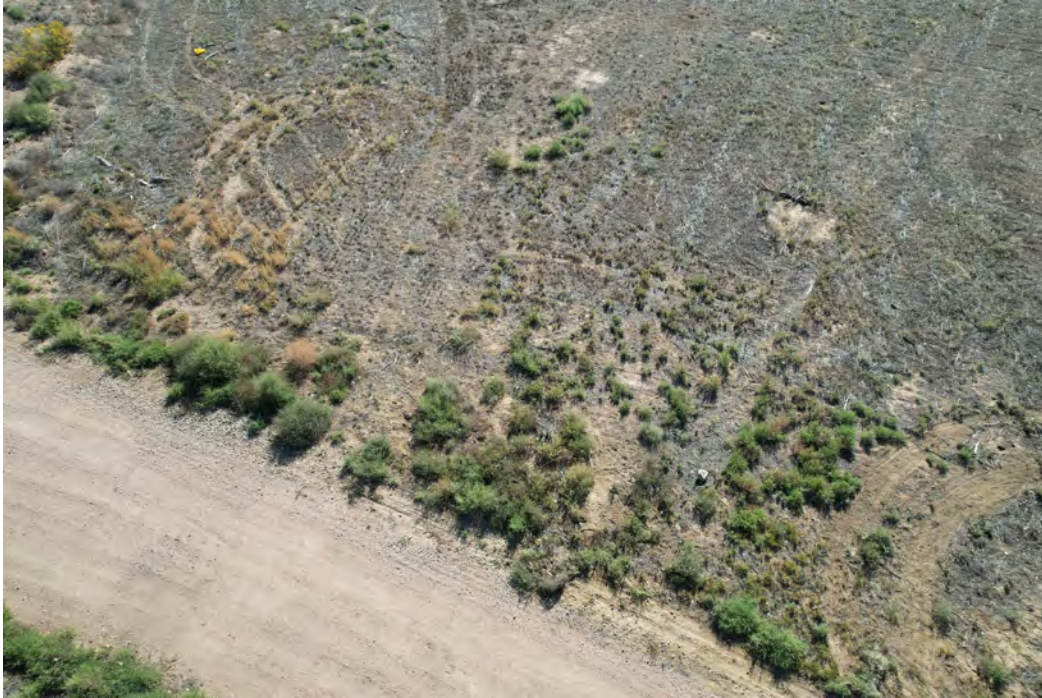
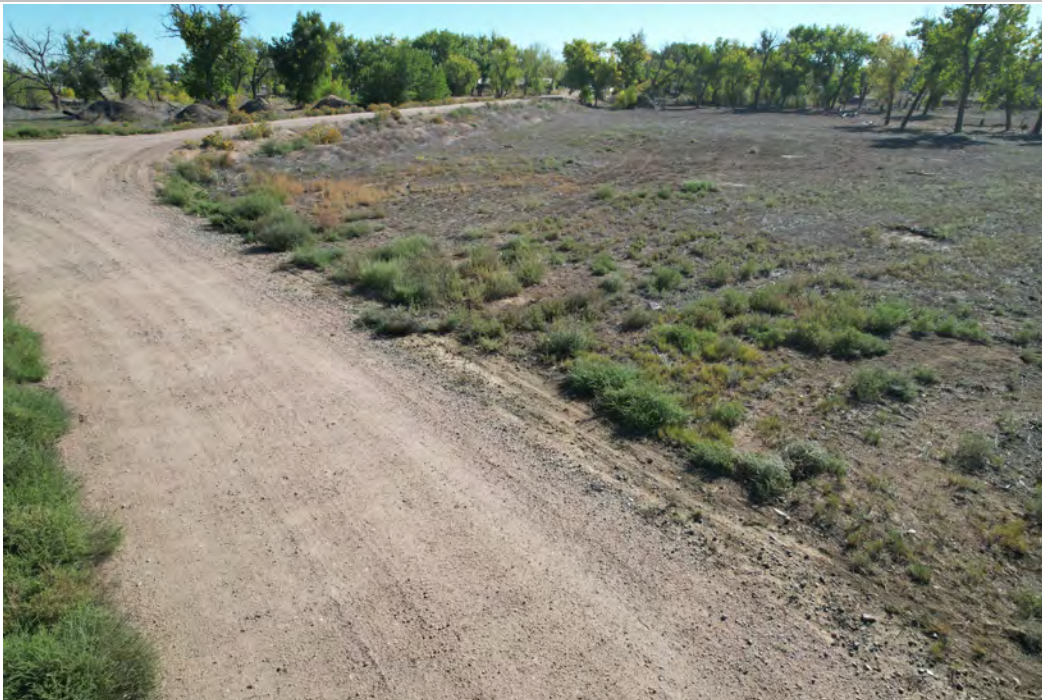
**PRIMARY SITE RECOMMENDATION: Maintenance**

Primary Recommendation:	Rationale:	Description:
Maintenance	Weeds are over-represented within the reclaim when compared to the reference.	Kochia and Russian thistle are dominant at the former access point along the western edge of the reclaim. Kochia is also present throughout the reclaim. Confluence recommends a herbicide treatment targeting remaining individuals. An integrated weed management plan and consistent mechanical and herbicidal treatments will be required to suppress these species.
