## Annual Reclamation Assessment Report (2024)

<b>ECMC Location Name (ID)</b>	MATT-64N67W /24NWSW (331001)
<b>Operator Location Name</b>	Matt 1 Well Pad & Facility
<b>ECMC Operator Name (ID)</b>	PDC ENERGY, INC (69175)
<b>Legal Description</b>	NWSW Sec. 24 T4N-R67W
<b>Well Pad Geographic Coordinates (WGS84)</b>	40.295627/ -104.846841
<b>Facility Pad Geographic Coordinates (WGS84)</b>	40.294865/-104.848239

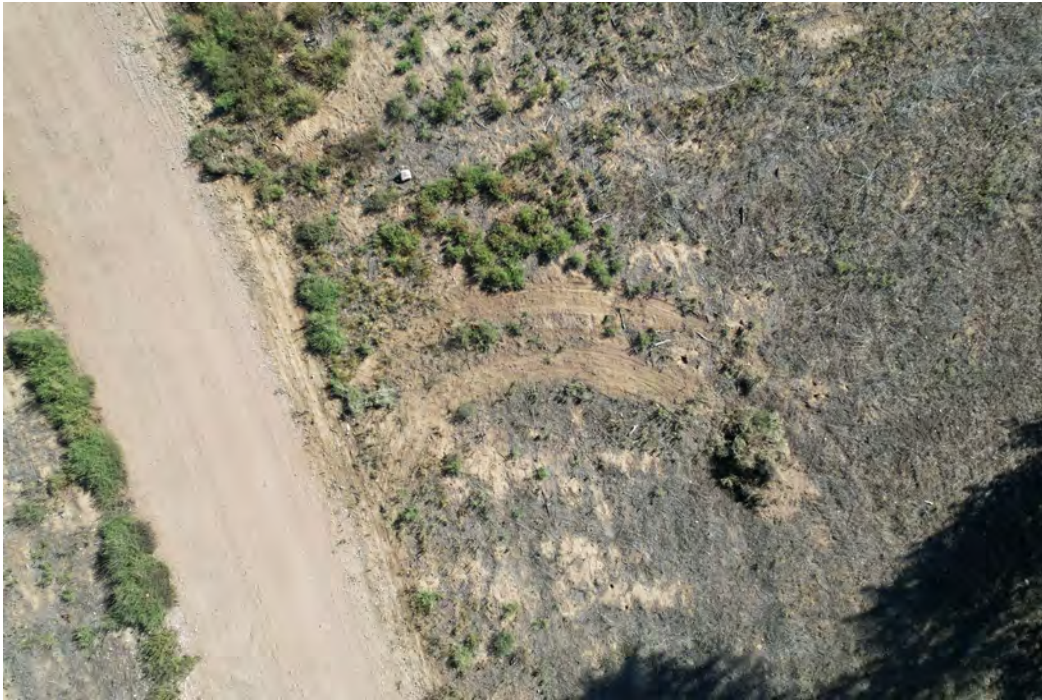
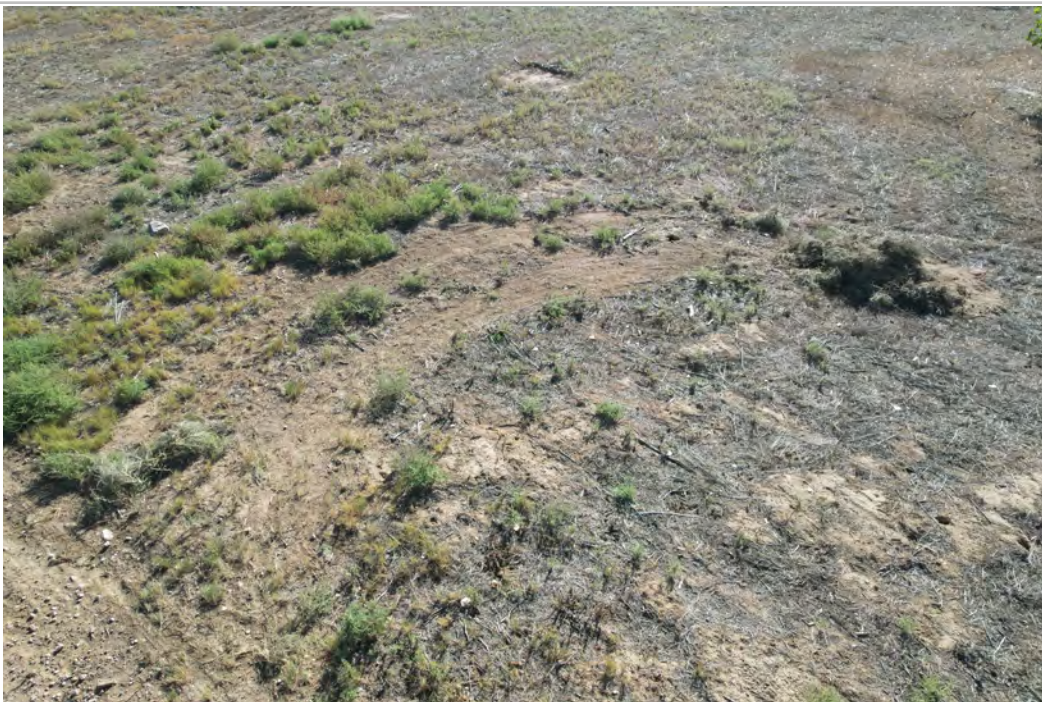
**SECONDARY SITE RECOMMENDATION: Maintenance**

Secondary Recommendation:	Rationale:	Description:
Maintenance	Vehicle damage to reclaim surface observed.	Vehicle tracks and a small debris pile were observed on the reclaim on the western edge that were not seen in previous inspections. Vehicle tracks from previous mowing operations are also present throughout the reclaim. Confluence recommends collecting agronomic focused soil samples in the reclaim and reference to identify soil suitability and nutrient availability. Sample results will guide soil amendment recommendations for a future application that can be combined with an interseeding effort at a seasonally appropriate time.

Maintenance Contract Type: Level 2 - Verbal Authorization. (Use for jobs that cost ~ \$500 - \$1,500, seeding, soil sampling, and/or erosion repair)  
 Square Foot Estimate: NA

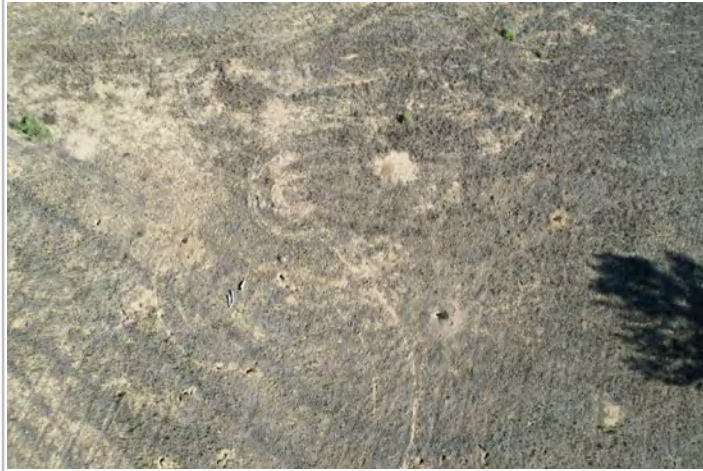
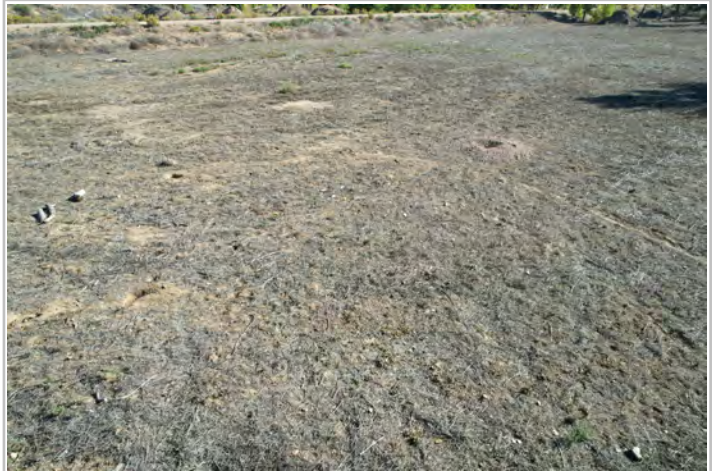
Prairie dog overview

Prairie dog context

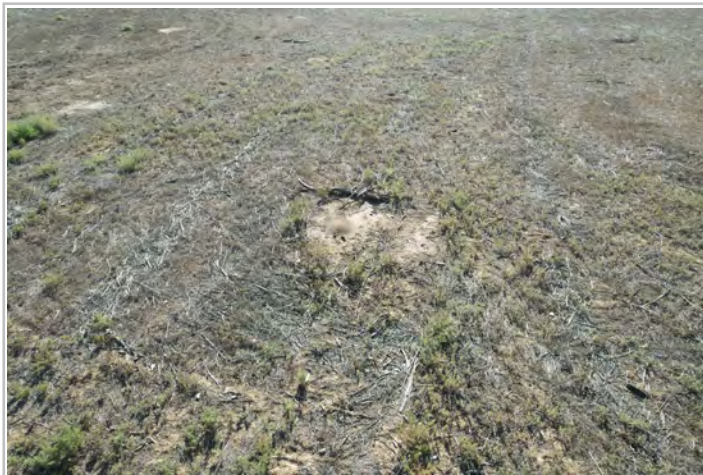
Bare spot

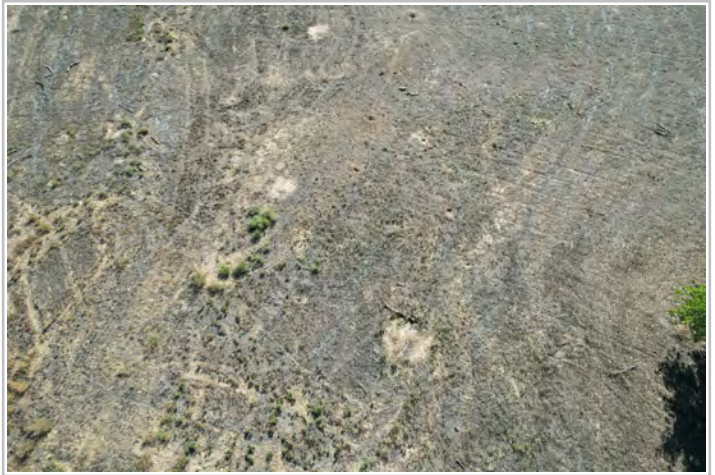
Additional context for bare areas

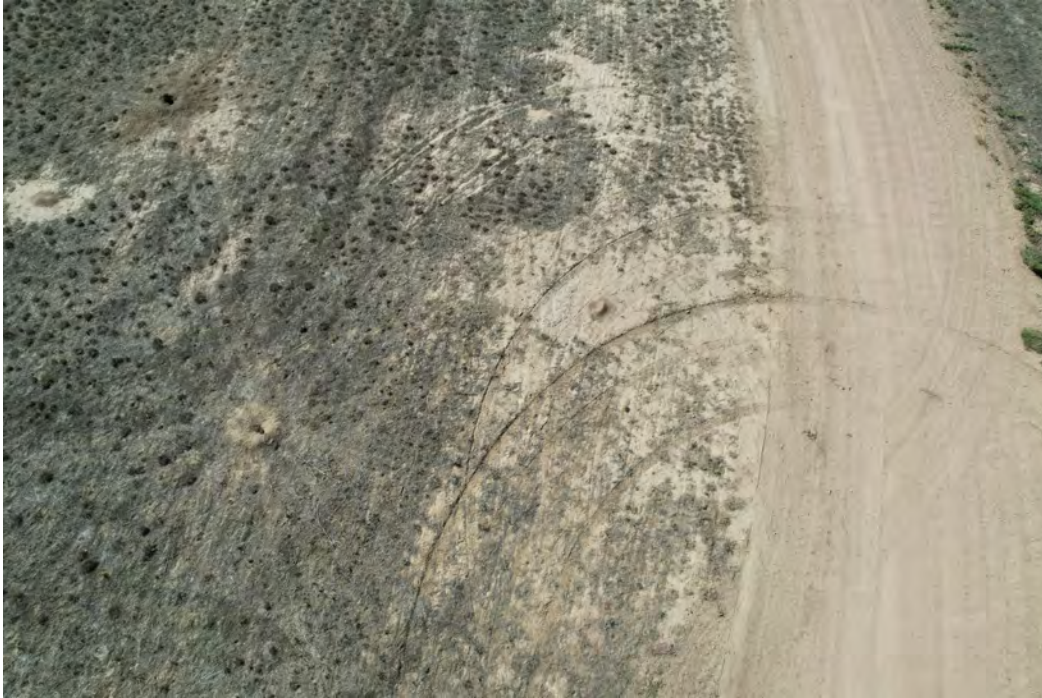
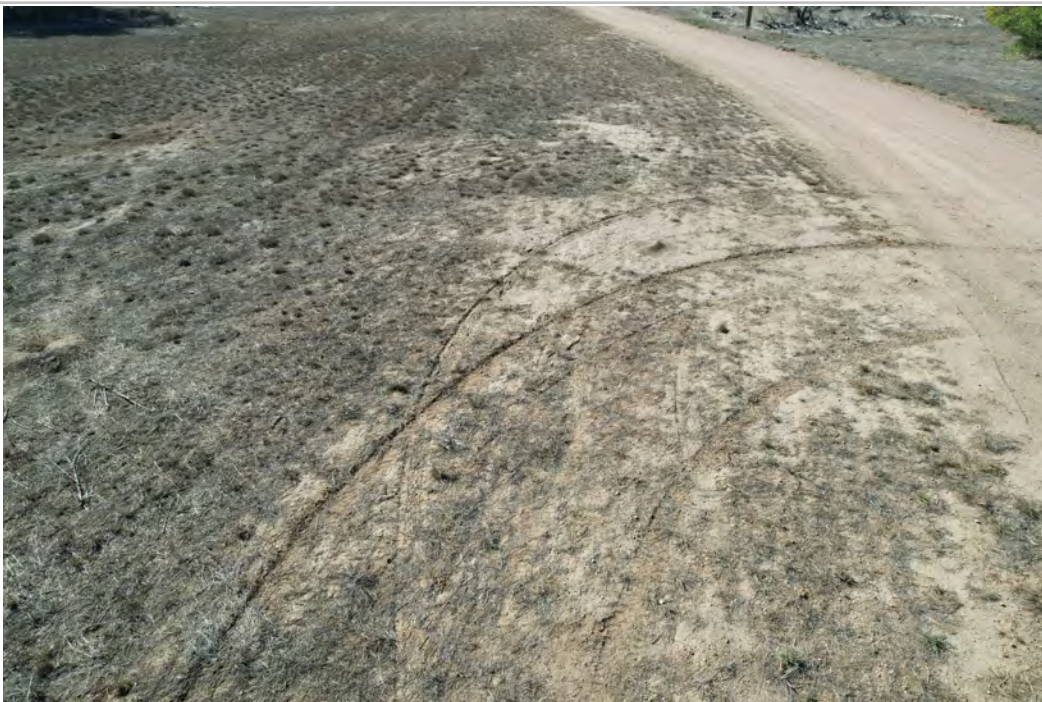
**PRIMARY SITE RECOMMENDATION: Maintenance**

Primary Recommendation:	Rationale:	Description:
Maintenance	Vehicle damage to reclaim surface observed.	Additional vehicle tracks are present that were not seen in previous inspections. Also, vehicle tracks from previous mowing operations are still present. Confluence recommends collecting agronomic focused soil samples in the reclaim and reference to identify soil suitability and nutrient availability. Sample results will guide soil amendment recommendations for a future application that can be combined with an interseeding effort at a seasonally appropriate time.

Maintenance Contract Type: Level 2 - Verbal Authorization. (Use for jobs that cost ~ \$500 - \$1,500, seeding, soil sampling, and/or erosion repair)  
 Square Foot Estimate: NA

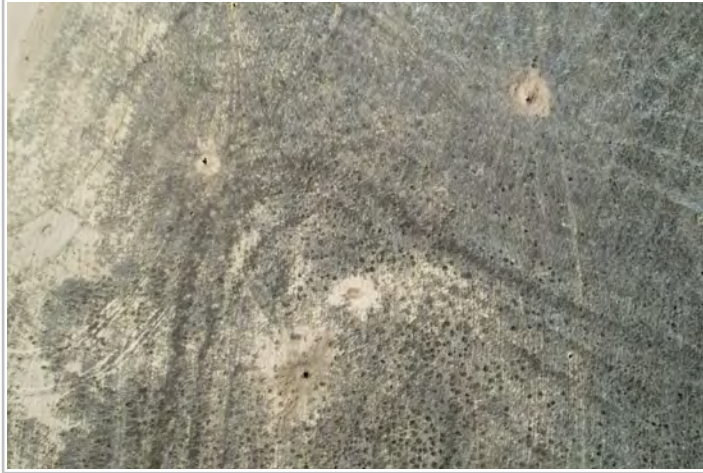
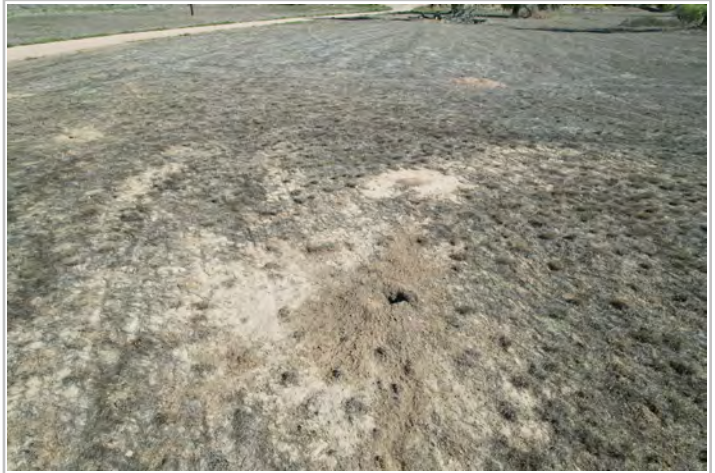
Prairie dog overview

Prairie dog context

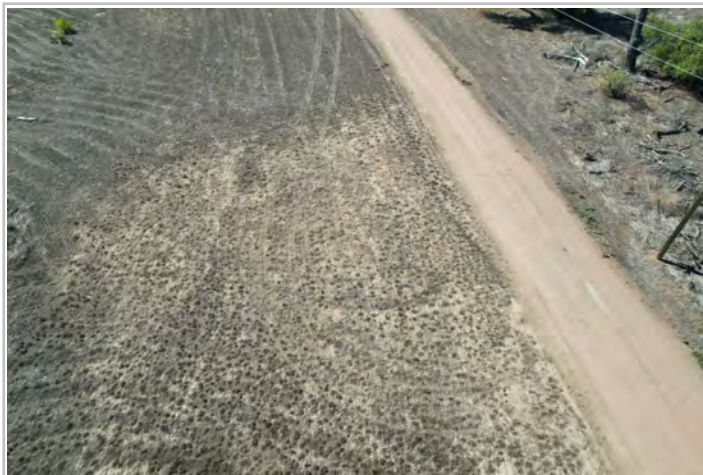
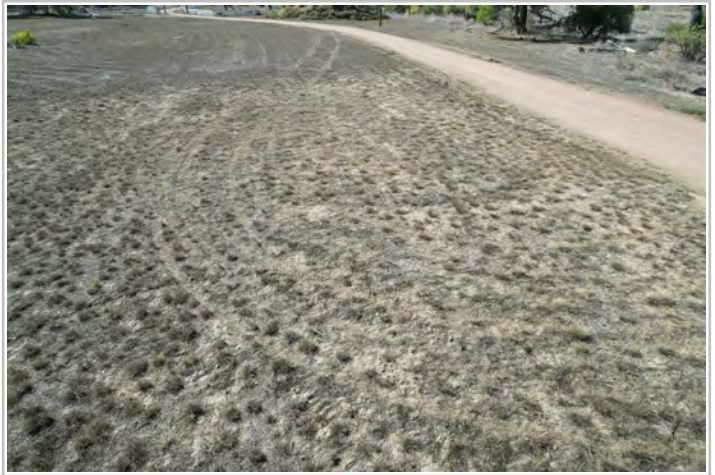
Additional vehicle tracks overview

Additional vehicle tracks context
