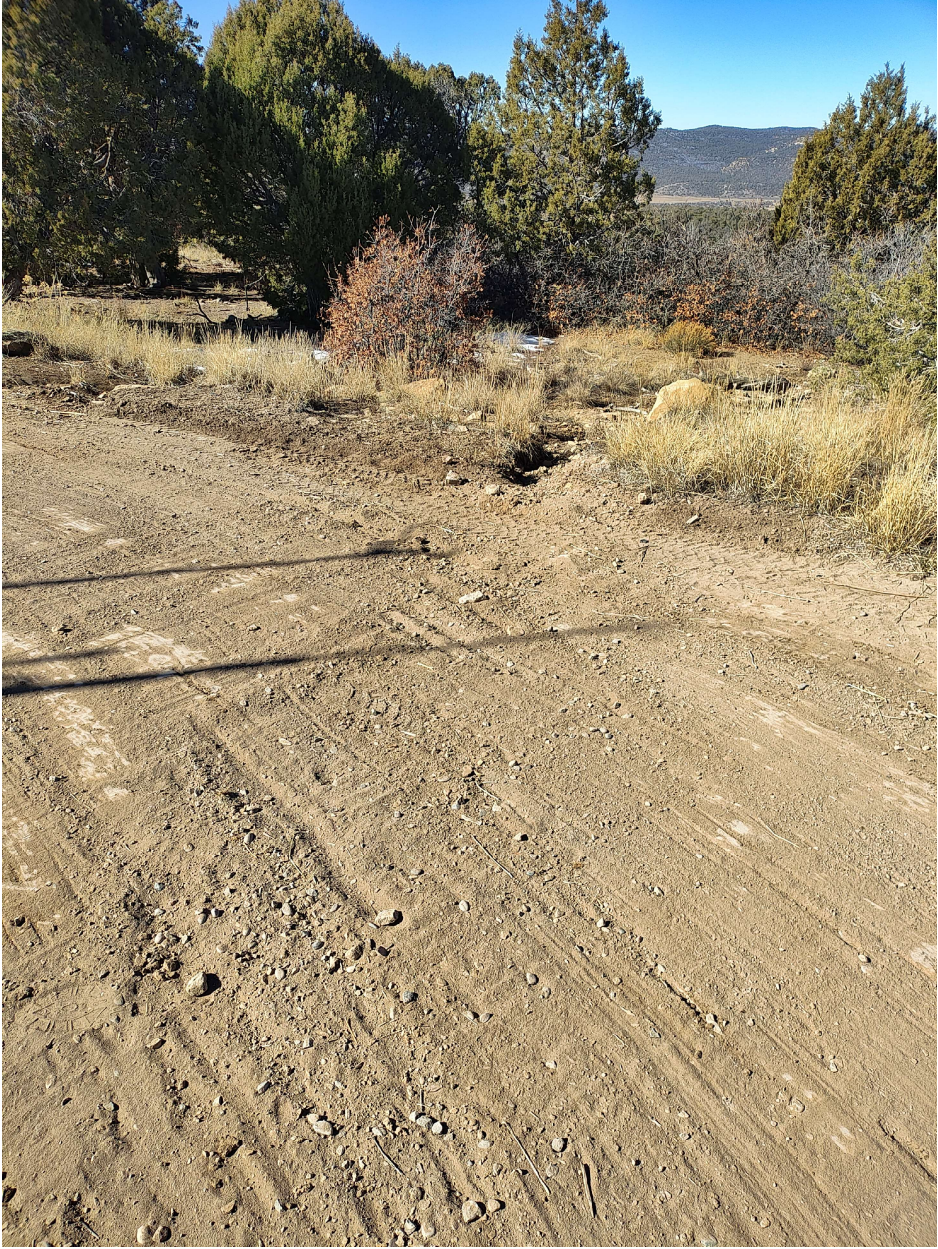
Comment: Erosion observed on the western edge of the pad.

Corrective Action: Comply with rule 1002f. Install or repair required BMPs.
