Hilcorp Energy Company
ALLISON UNIT 147
FORMATION FRC
LATITUDE N 37.00248
LONGITUDE W 107.56014
SE/SW, 800' FSL & 1849' FWL
SEC.24 T032N R007W
LEASE NO. FEE
API NO. 05-067-DR350
LA PLATA COUNTY, COLORADO
EMERGENCY CONTACT (505) 324-5170 OR 911
NO SMOKING NO TRESPASSING

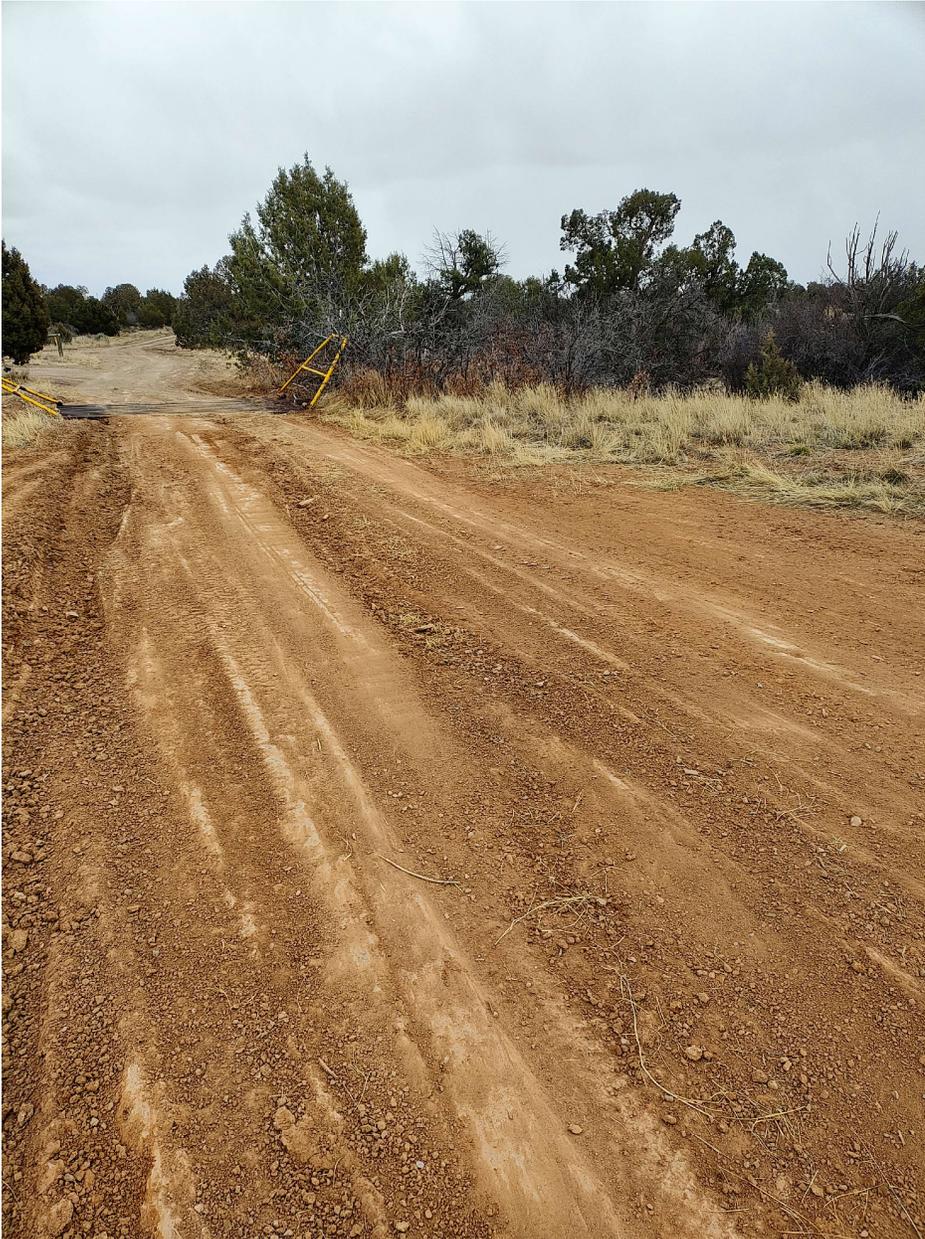
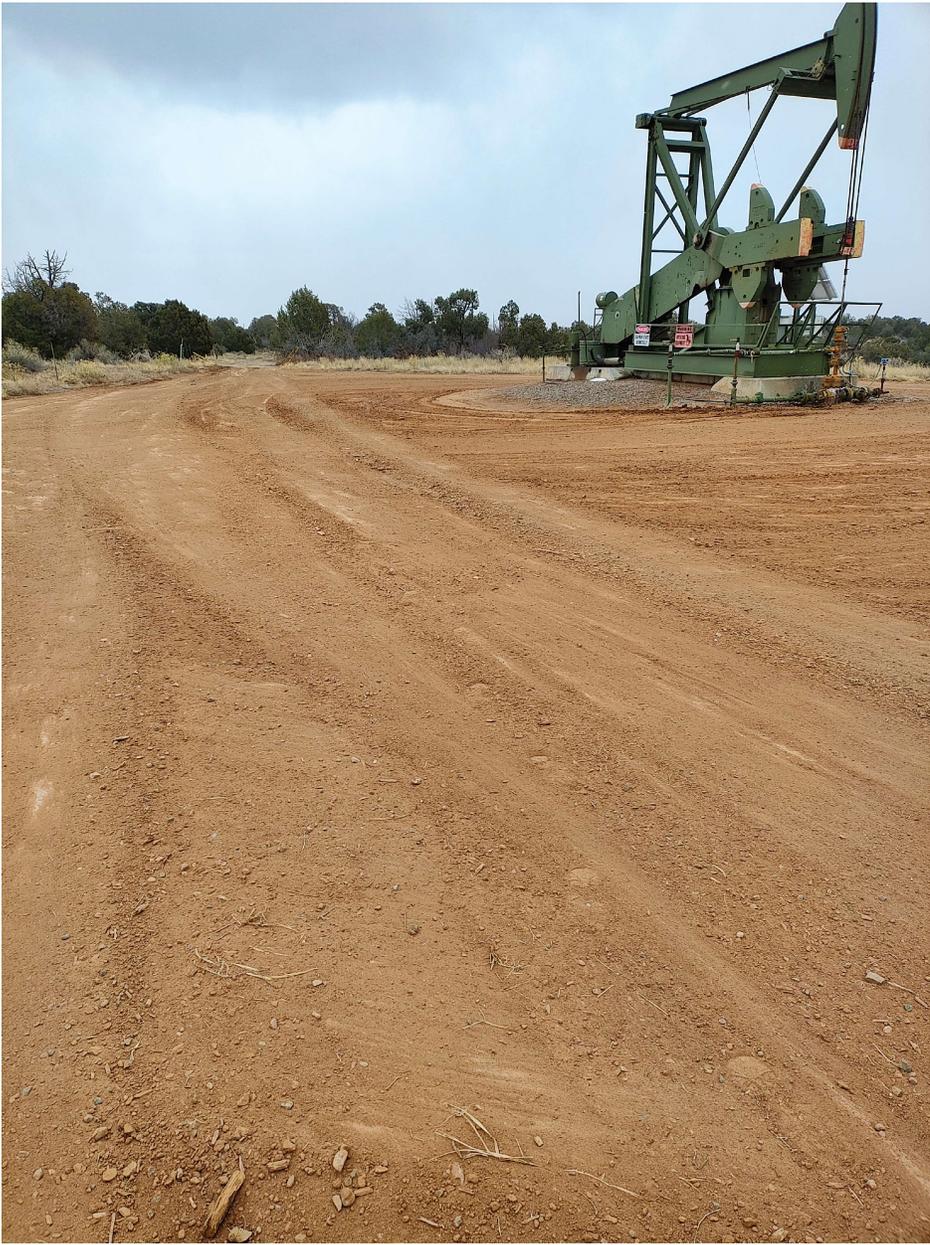
Comment: Rutting occurring at access road and active pad. Additional stabilization/grading efforts are needed to minimize degradation to the active pad.

Corrective Action: Comply with rule 1002f. Install or repair required BMPs.
