# Inspection Photos

**Operator:** BLACK HILLS PLATEAU

**Location ID:** 312407

**Inspection Doc:** 718100535

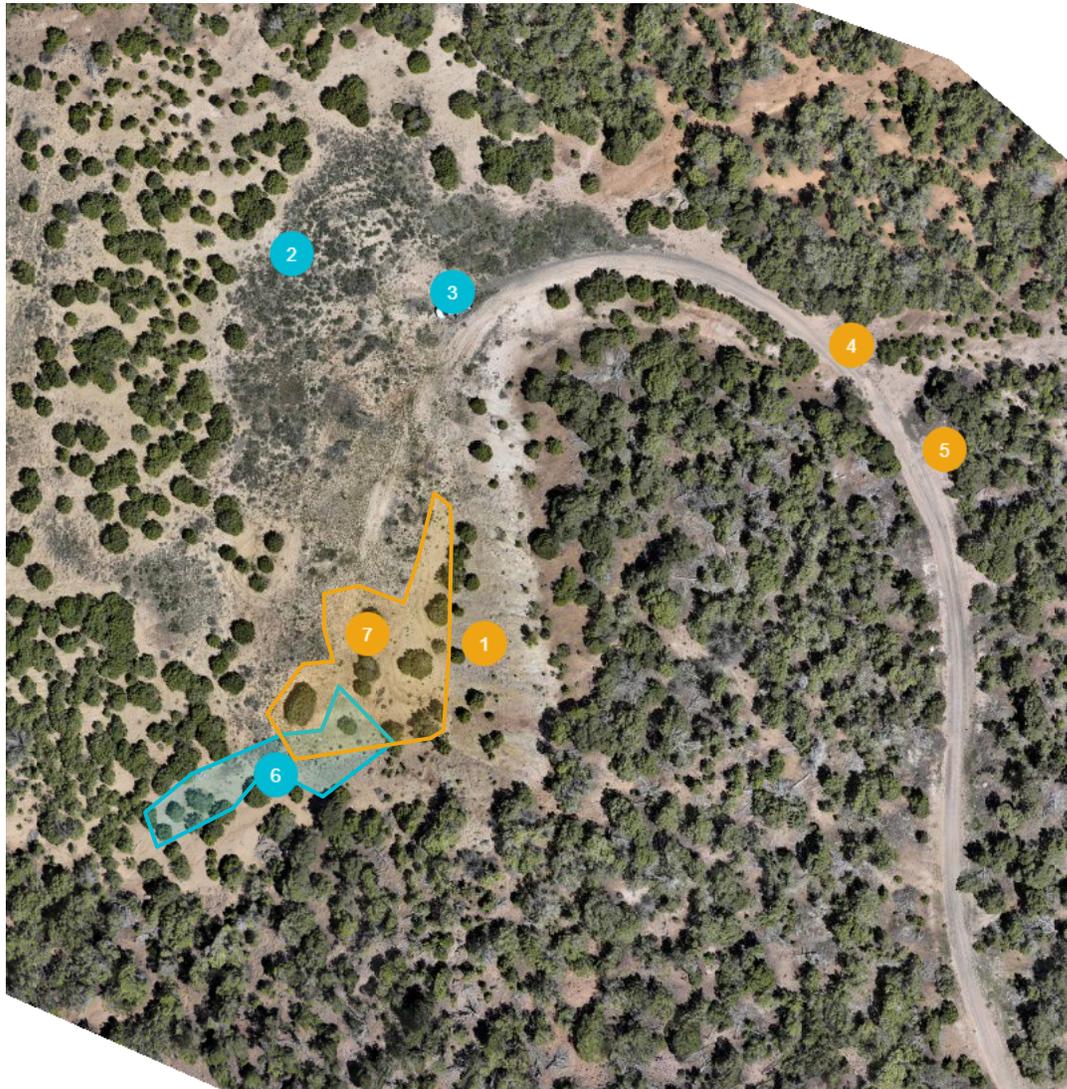
Cut slopes	2.15 US ft	39.1856608, -107.9754894	1502072.9 US ft, 2298422.5 US ft
2

Pipe equipment	-8.11 US ft	39.1862704, -107.9758788	1502297.8 US ft, 2298318.2 US ft
3

Unused gate/pipe	-8.68 US ft	39.1862109, -107.9755544	1502273.6 US ft, 2298409.5 US ft
4

Access road	-23.54 US ft	39.1861286, -107.9747447	1502237.4 US ft, 2298638.1 US ft
5

Access Road	-20.52 US ft	39.1859630, -107.9745594	1502175.7 US ft, 2298689.0 US ft

Wildlife carcasses	--	--	4016.65 ft <sup>2</sup>	5234.25 ft <sup>2</sup>
7

Sediment deposition	--	--	8277.09 ft <sup>2</sup>	0.26 acres

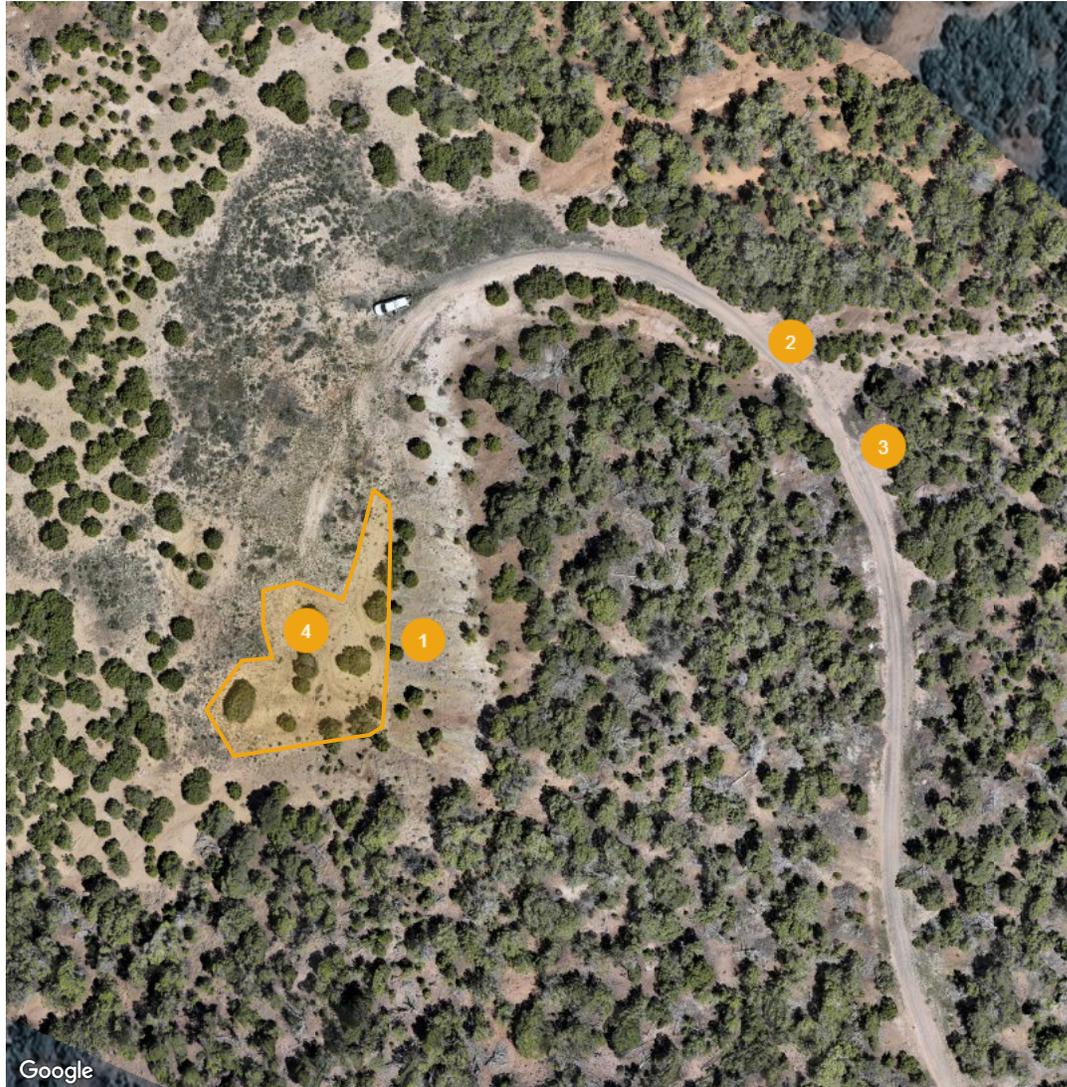
Summary:	Polygon represents areas of sediment deposition over time due to unstabilized cut slopes.
Created:	May 29, 2025, 2:38pm by Aaron Trujillo
Cost of Repair:	—
Lat/Long:	39.18566, -107.97568
Area:	8277.09 ft <sup>2</sup>
Surface area:	0.26 acres
