DOVER ATWOOD CORP/ENVEX BACA, LLC  
20165 N. 67th Ave. • Glendale, AZ 85308

ECMC  
Environmental  
Field Inspection

Hancock M-631S43W (321046)  
© 04-Jun-25 12:45:02

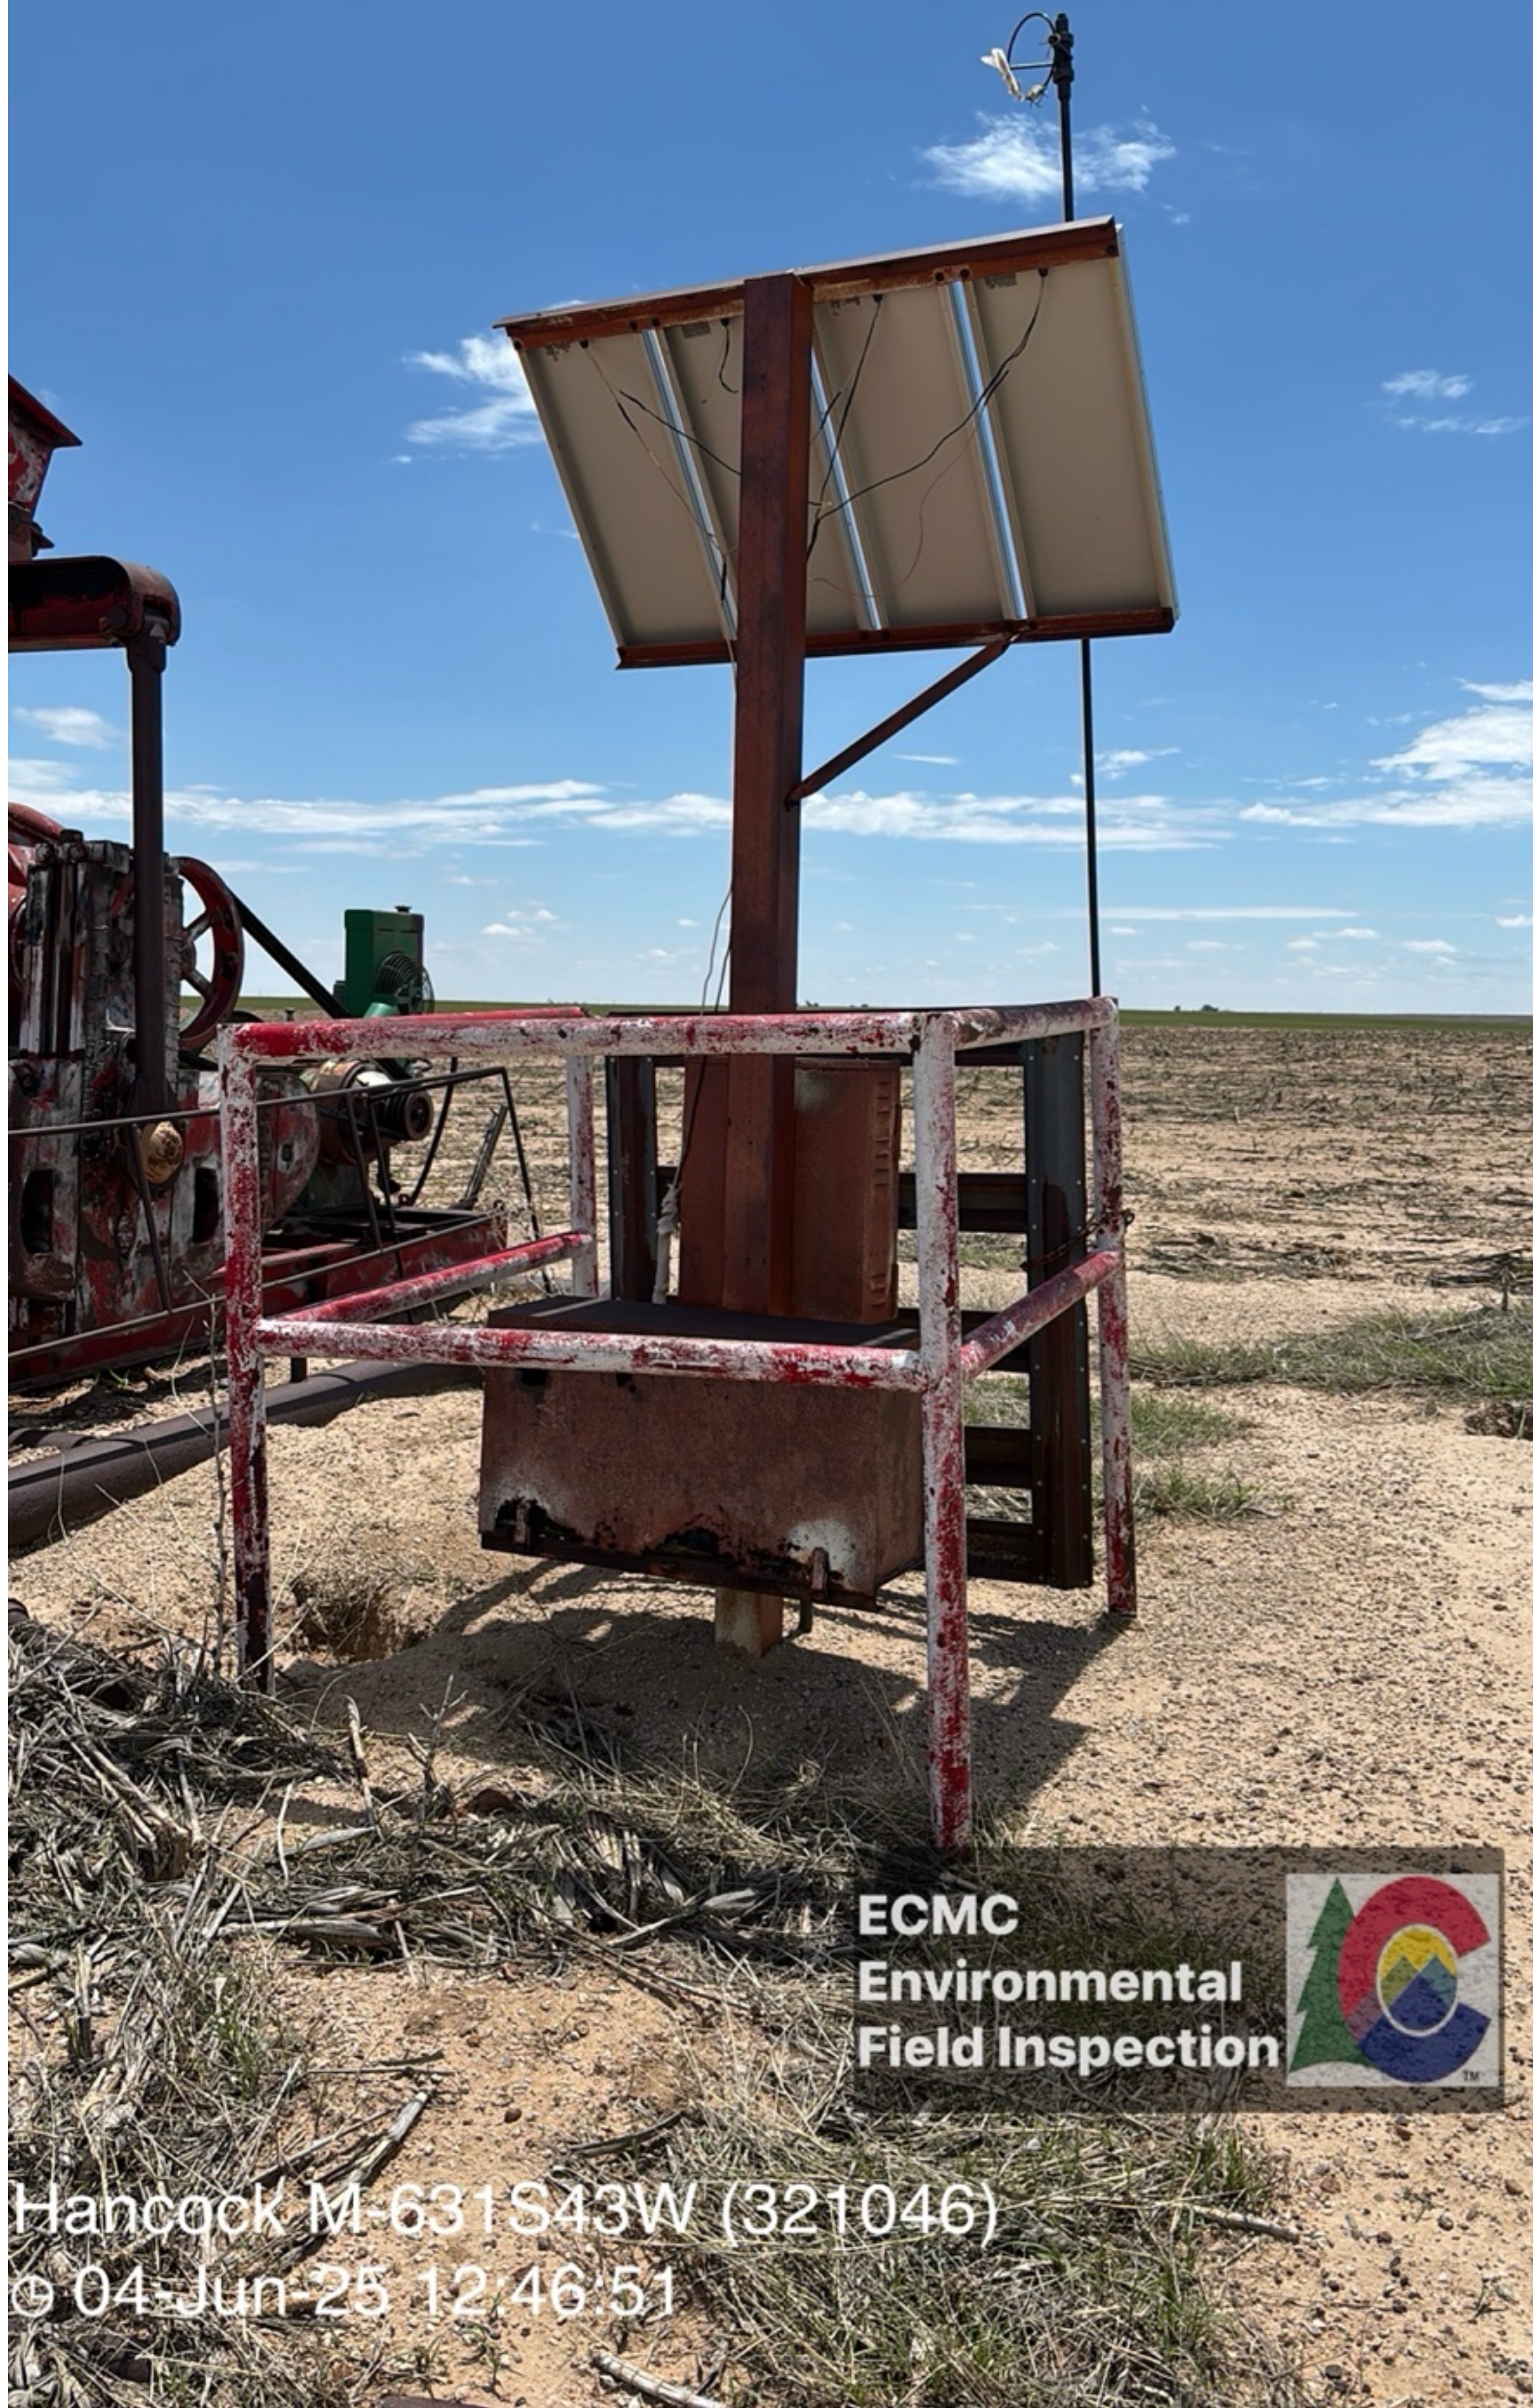
Stained soil observed beneath the bung installed on outlet/drain port on the ~100-bbl open top fiberglass produced water storage tank.
