Jilson 1 Wellhead  
© 20-May-25 17:19:23

Jilson 1 Wellhead excavation

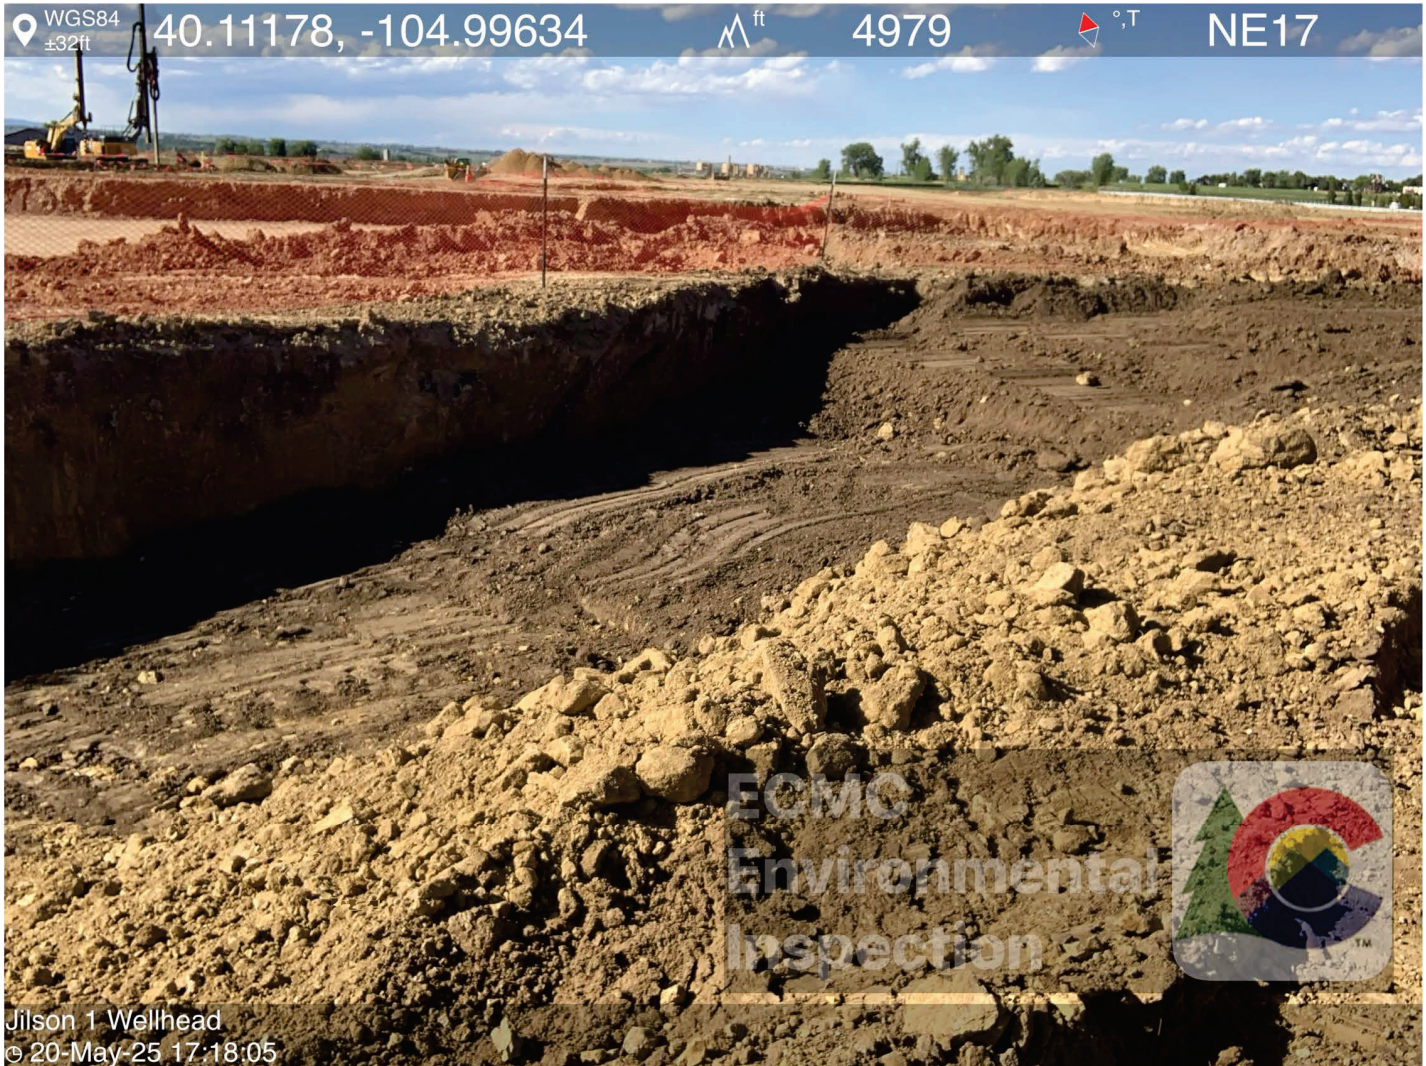
Jilson 1 Wellhead excavation - Shallow groundwater (~5' BGS). Date on cap: 2/5/2025

-Inadequate fencing - Orange construction fencing has been installed around portions of the open excavations; However, fencing has been installed too close to unstable sidewalls and is sagging/falling into the open excavation.

-Weeds observed within the open excavation
