# Final Reclamation Inspection

Operator: NOBLE ENERGY INC - 100322

Location ID: 328767

Inspection Photos  
Location Name: DUNCAN D #20-15  
Location ID: 328767

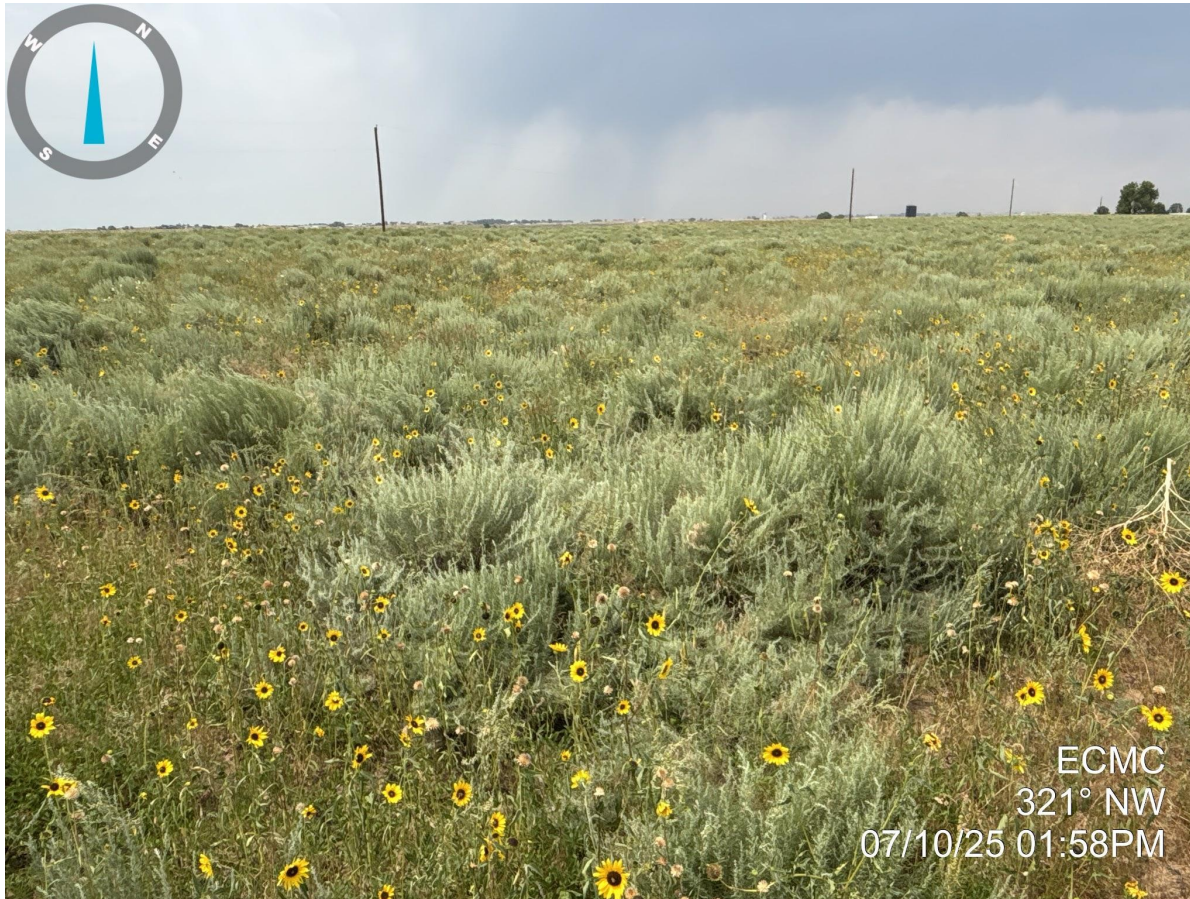
**Photo 11.** Photo taken of the reference area for the location, west of the location, facing northwest. Photo illustrates sand sagebrush (*Artemisia filifolia*) and prairie sunflower (*Helianthus petiolaris*).
