Final Reclamation and Stormwater Inspection

Location ID: 316929

Well Name: LINKER #1

Inspection Document #: 718601099

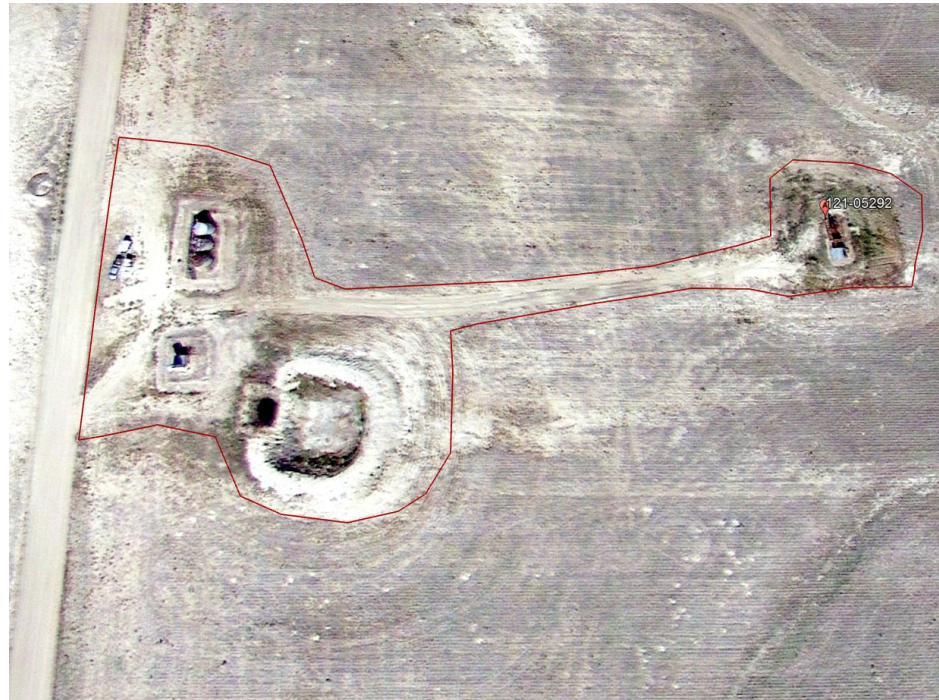
Photo 12. Google earth aerial imagery taken 09/17/2012. Illustrating footprint of the tank battery, access road and well location while active.
