# Final Reclamation Inspection

Operator: Kerr McGee Oil & Gas Onshore - 47120

Location ID: 329455

Inspection Photos  
Location Name: LDS T 13-5  
Location ID: 329455

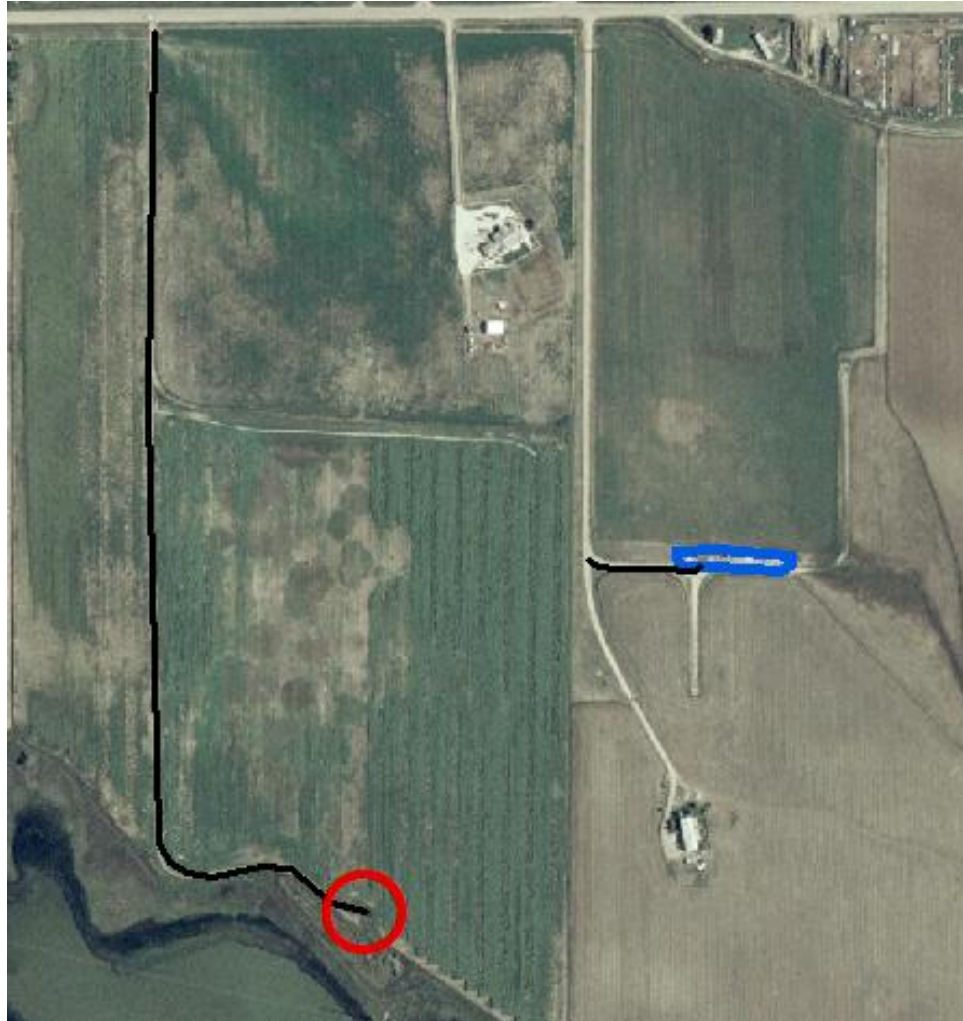
**Photo 1.** NAIP aerial imagery (2019) illustrating the well location (red circle), associated tank battery location (blue polygon), and well and tank battery access roads (black lines). The tank battery is associated with the Temple 22-13 well API #123-18380 under location ID #330089.

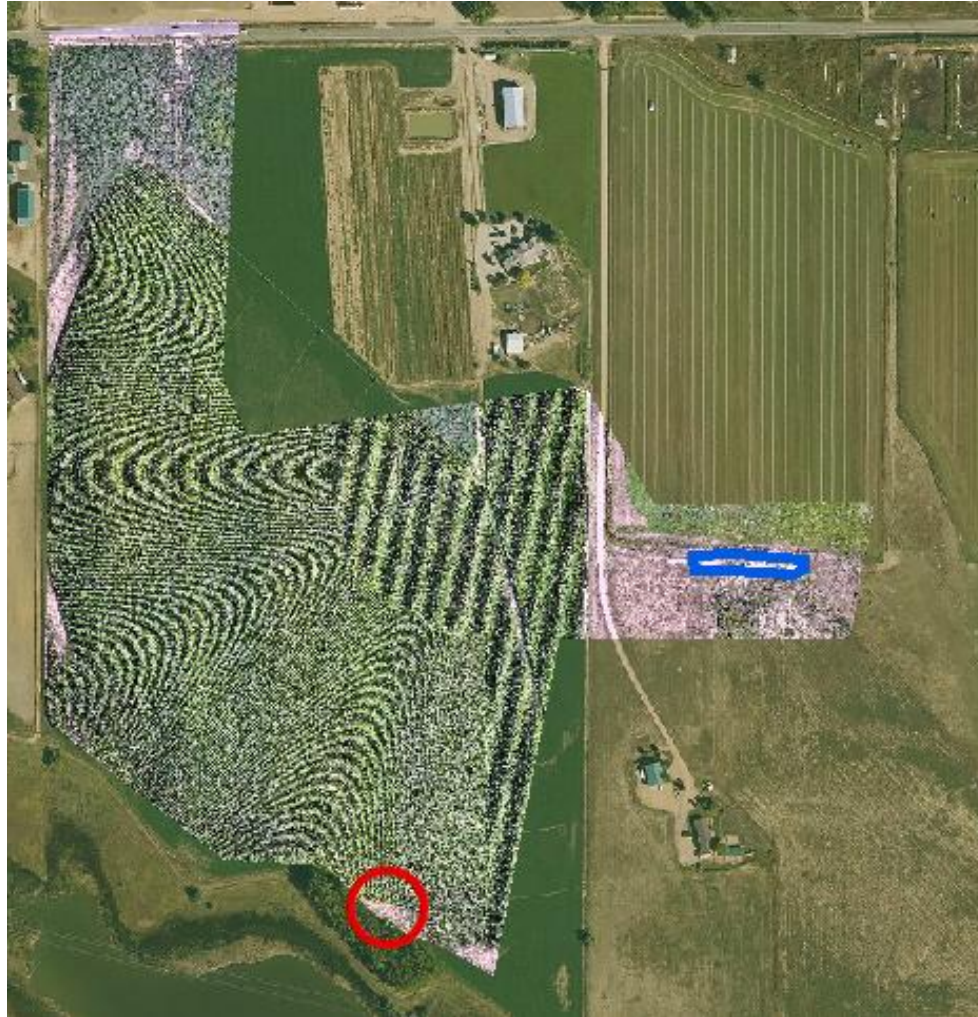
**Photo 2.** Orthomosaic (drone) imagery taken 8/12/2025 and NAIP aerial imagery (2023) illustrating the well location (red circle) and associated tank battery (blue polygon).
