Inspection Photos

Operator: QB ENERGY OPERATING LLC

Location ID: 335577

Inspection Doc: 718100962

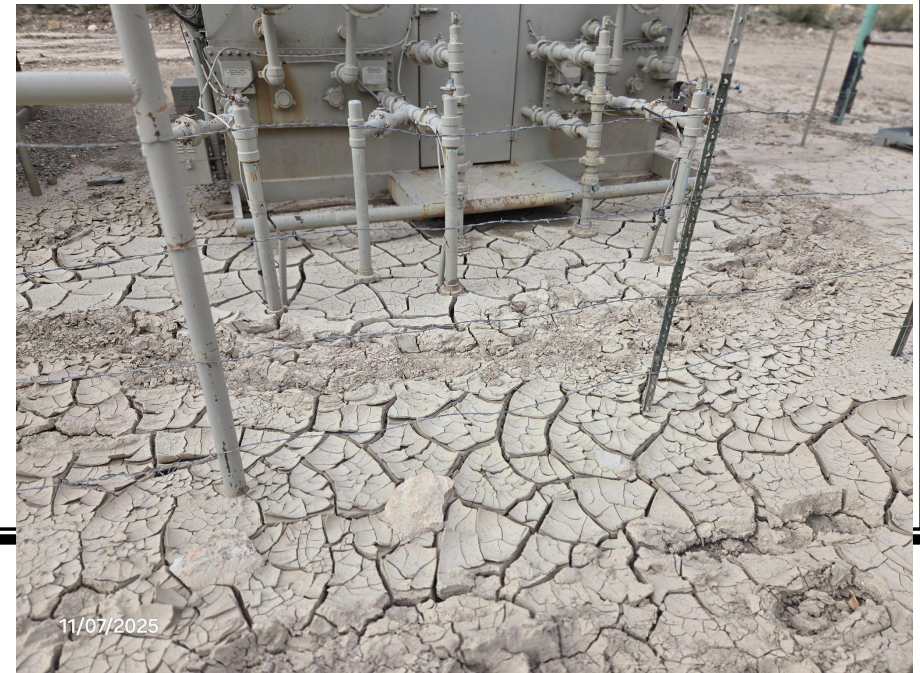
Photo 5: Photos taken from the east end of the Location. Photo shows point where stormwater runoff is discharging from the Location. No engineered outlet or other BMPs to allow for proper and controlled stormwater discharge observed.
