Site Specific Final Reclamation Completion Notice – Cropland Drone Imagery

Permit Closure Report – Cropland

Location ID: 323264

Location Name: BUDERUS-65N65W/23NENE

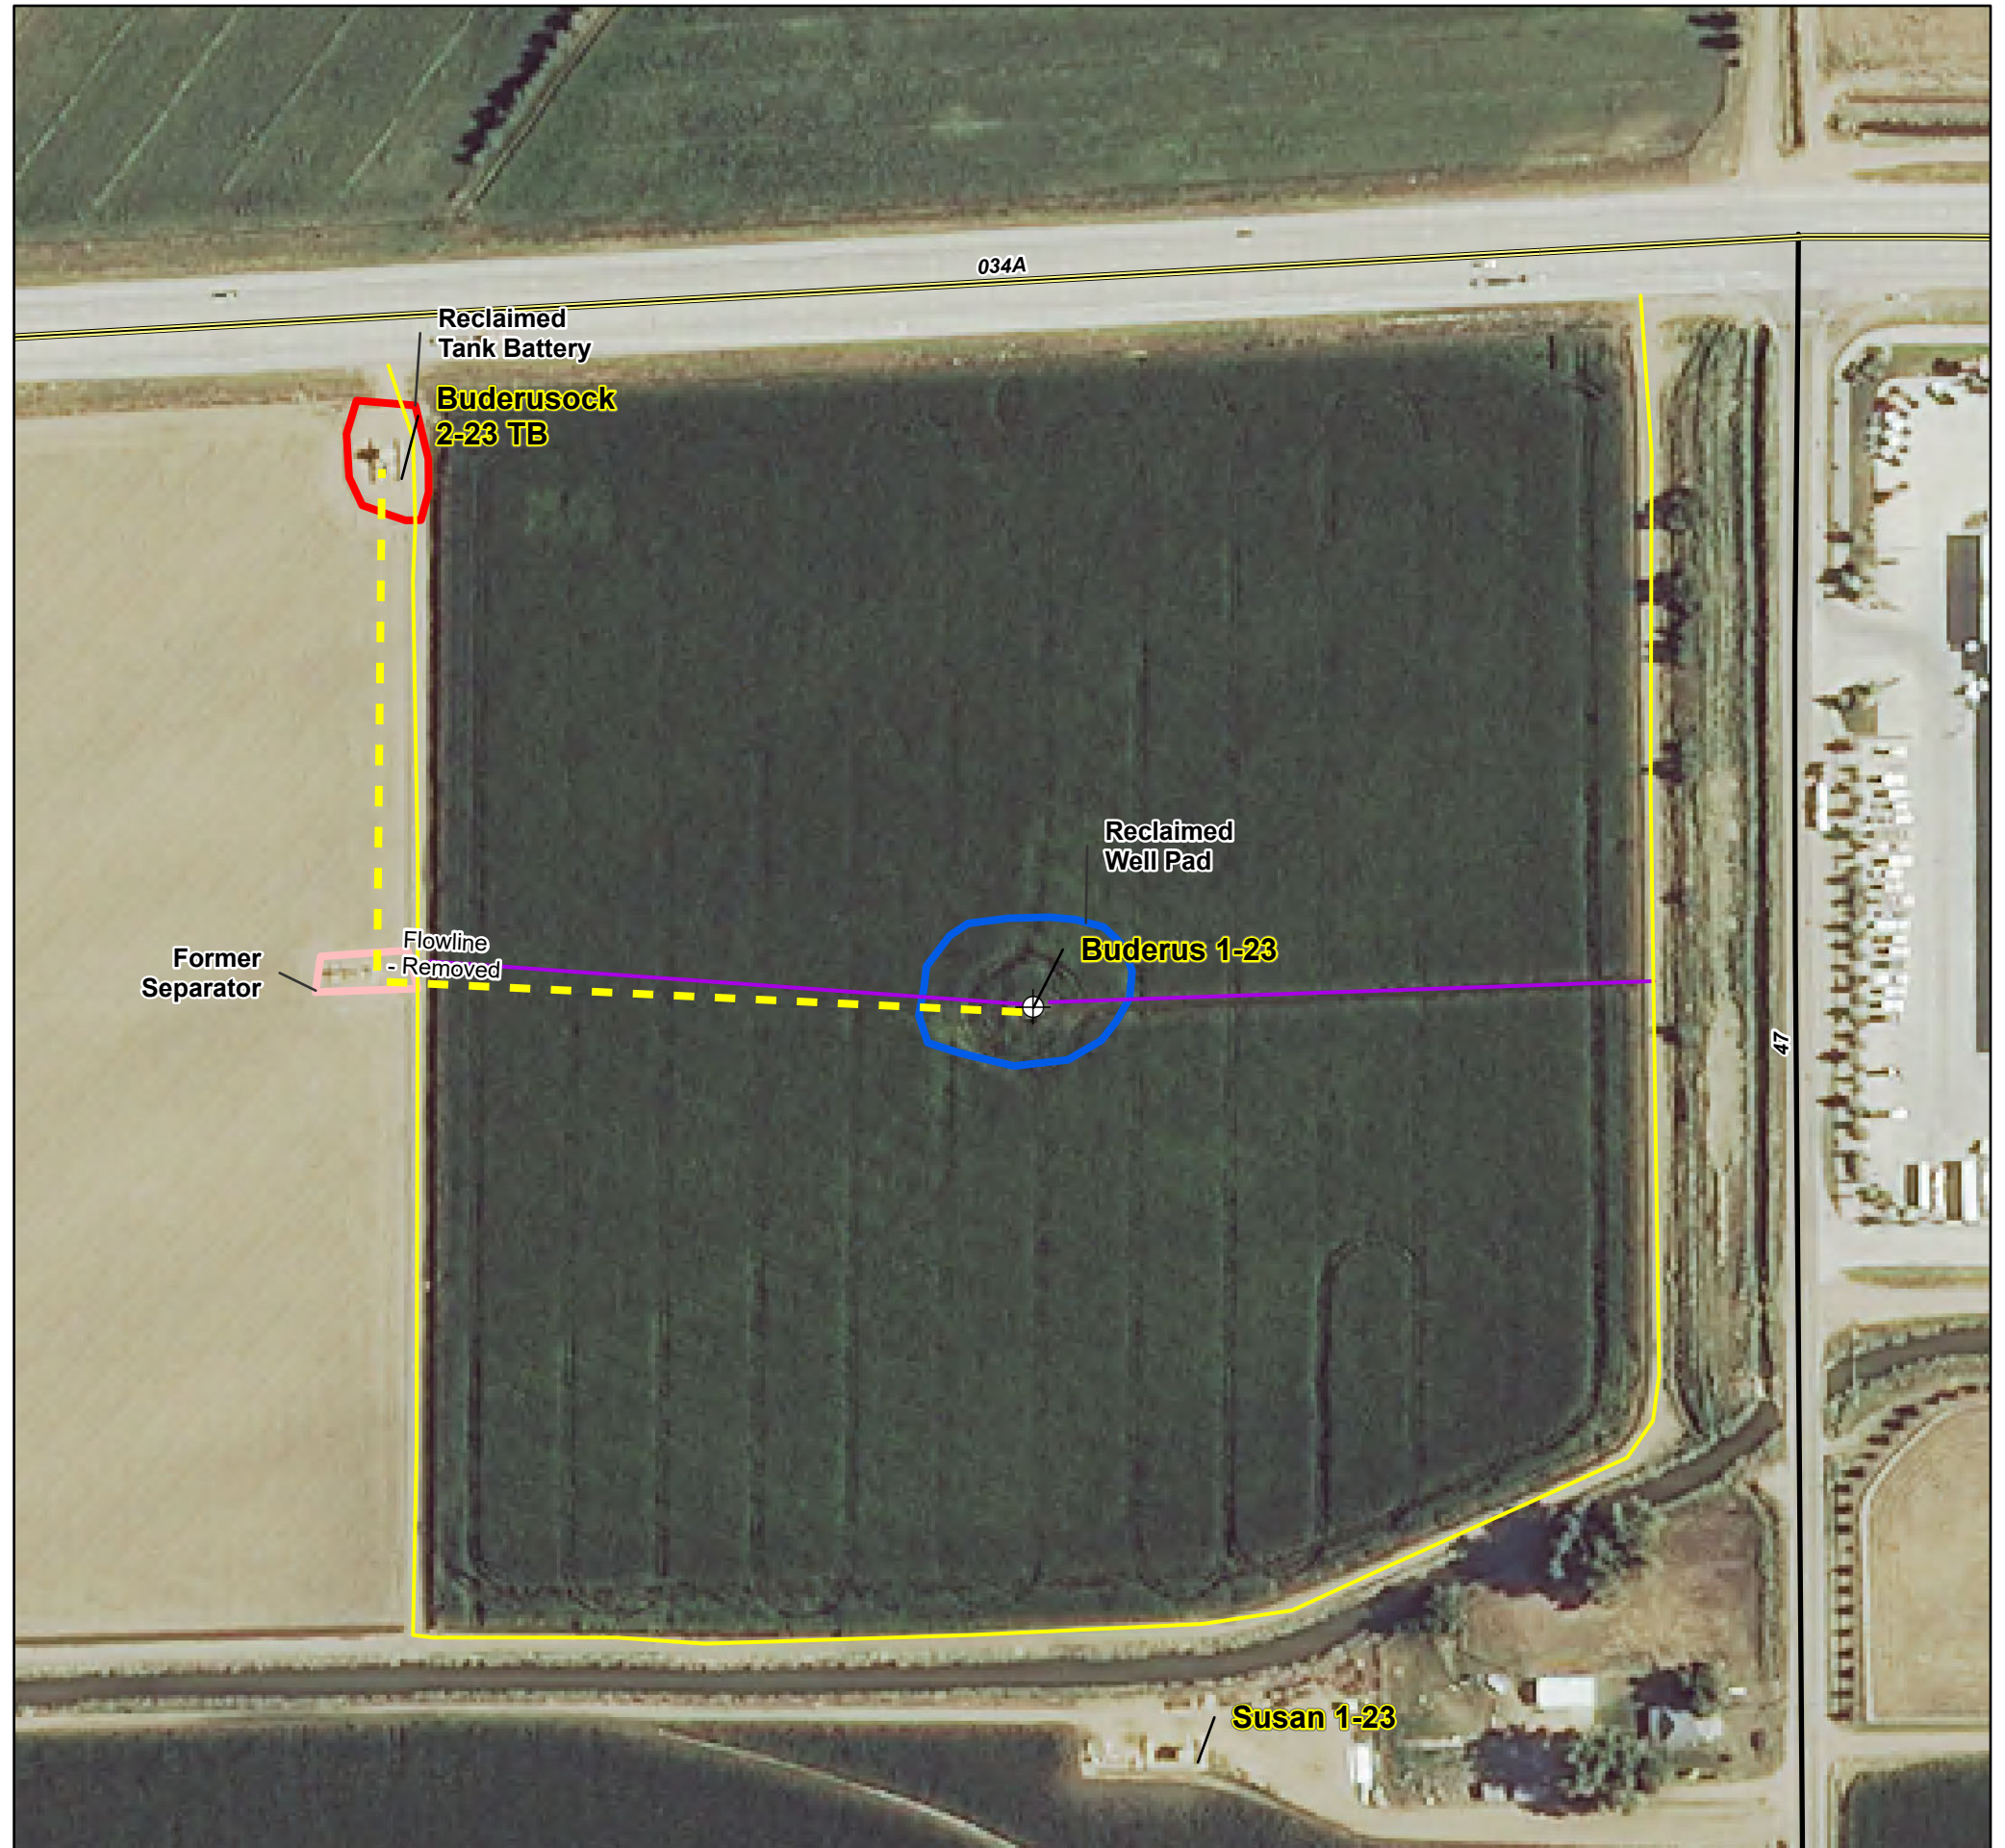
PDC Form 4 Final Reclamation - Pre Plugging Overview

- Well Head
- Flowline - Removed
- Access Road - Reclaimed
- Pre-Existing Access Road
- Former Separator
- Reclaimed Tank Battery
- Reclaimed Well Pad
- Highway
- County/Local Road

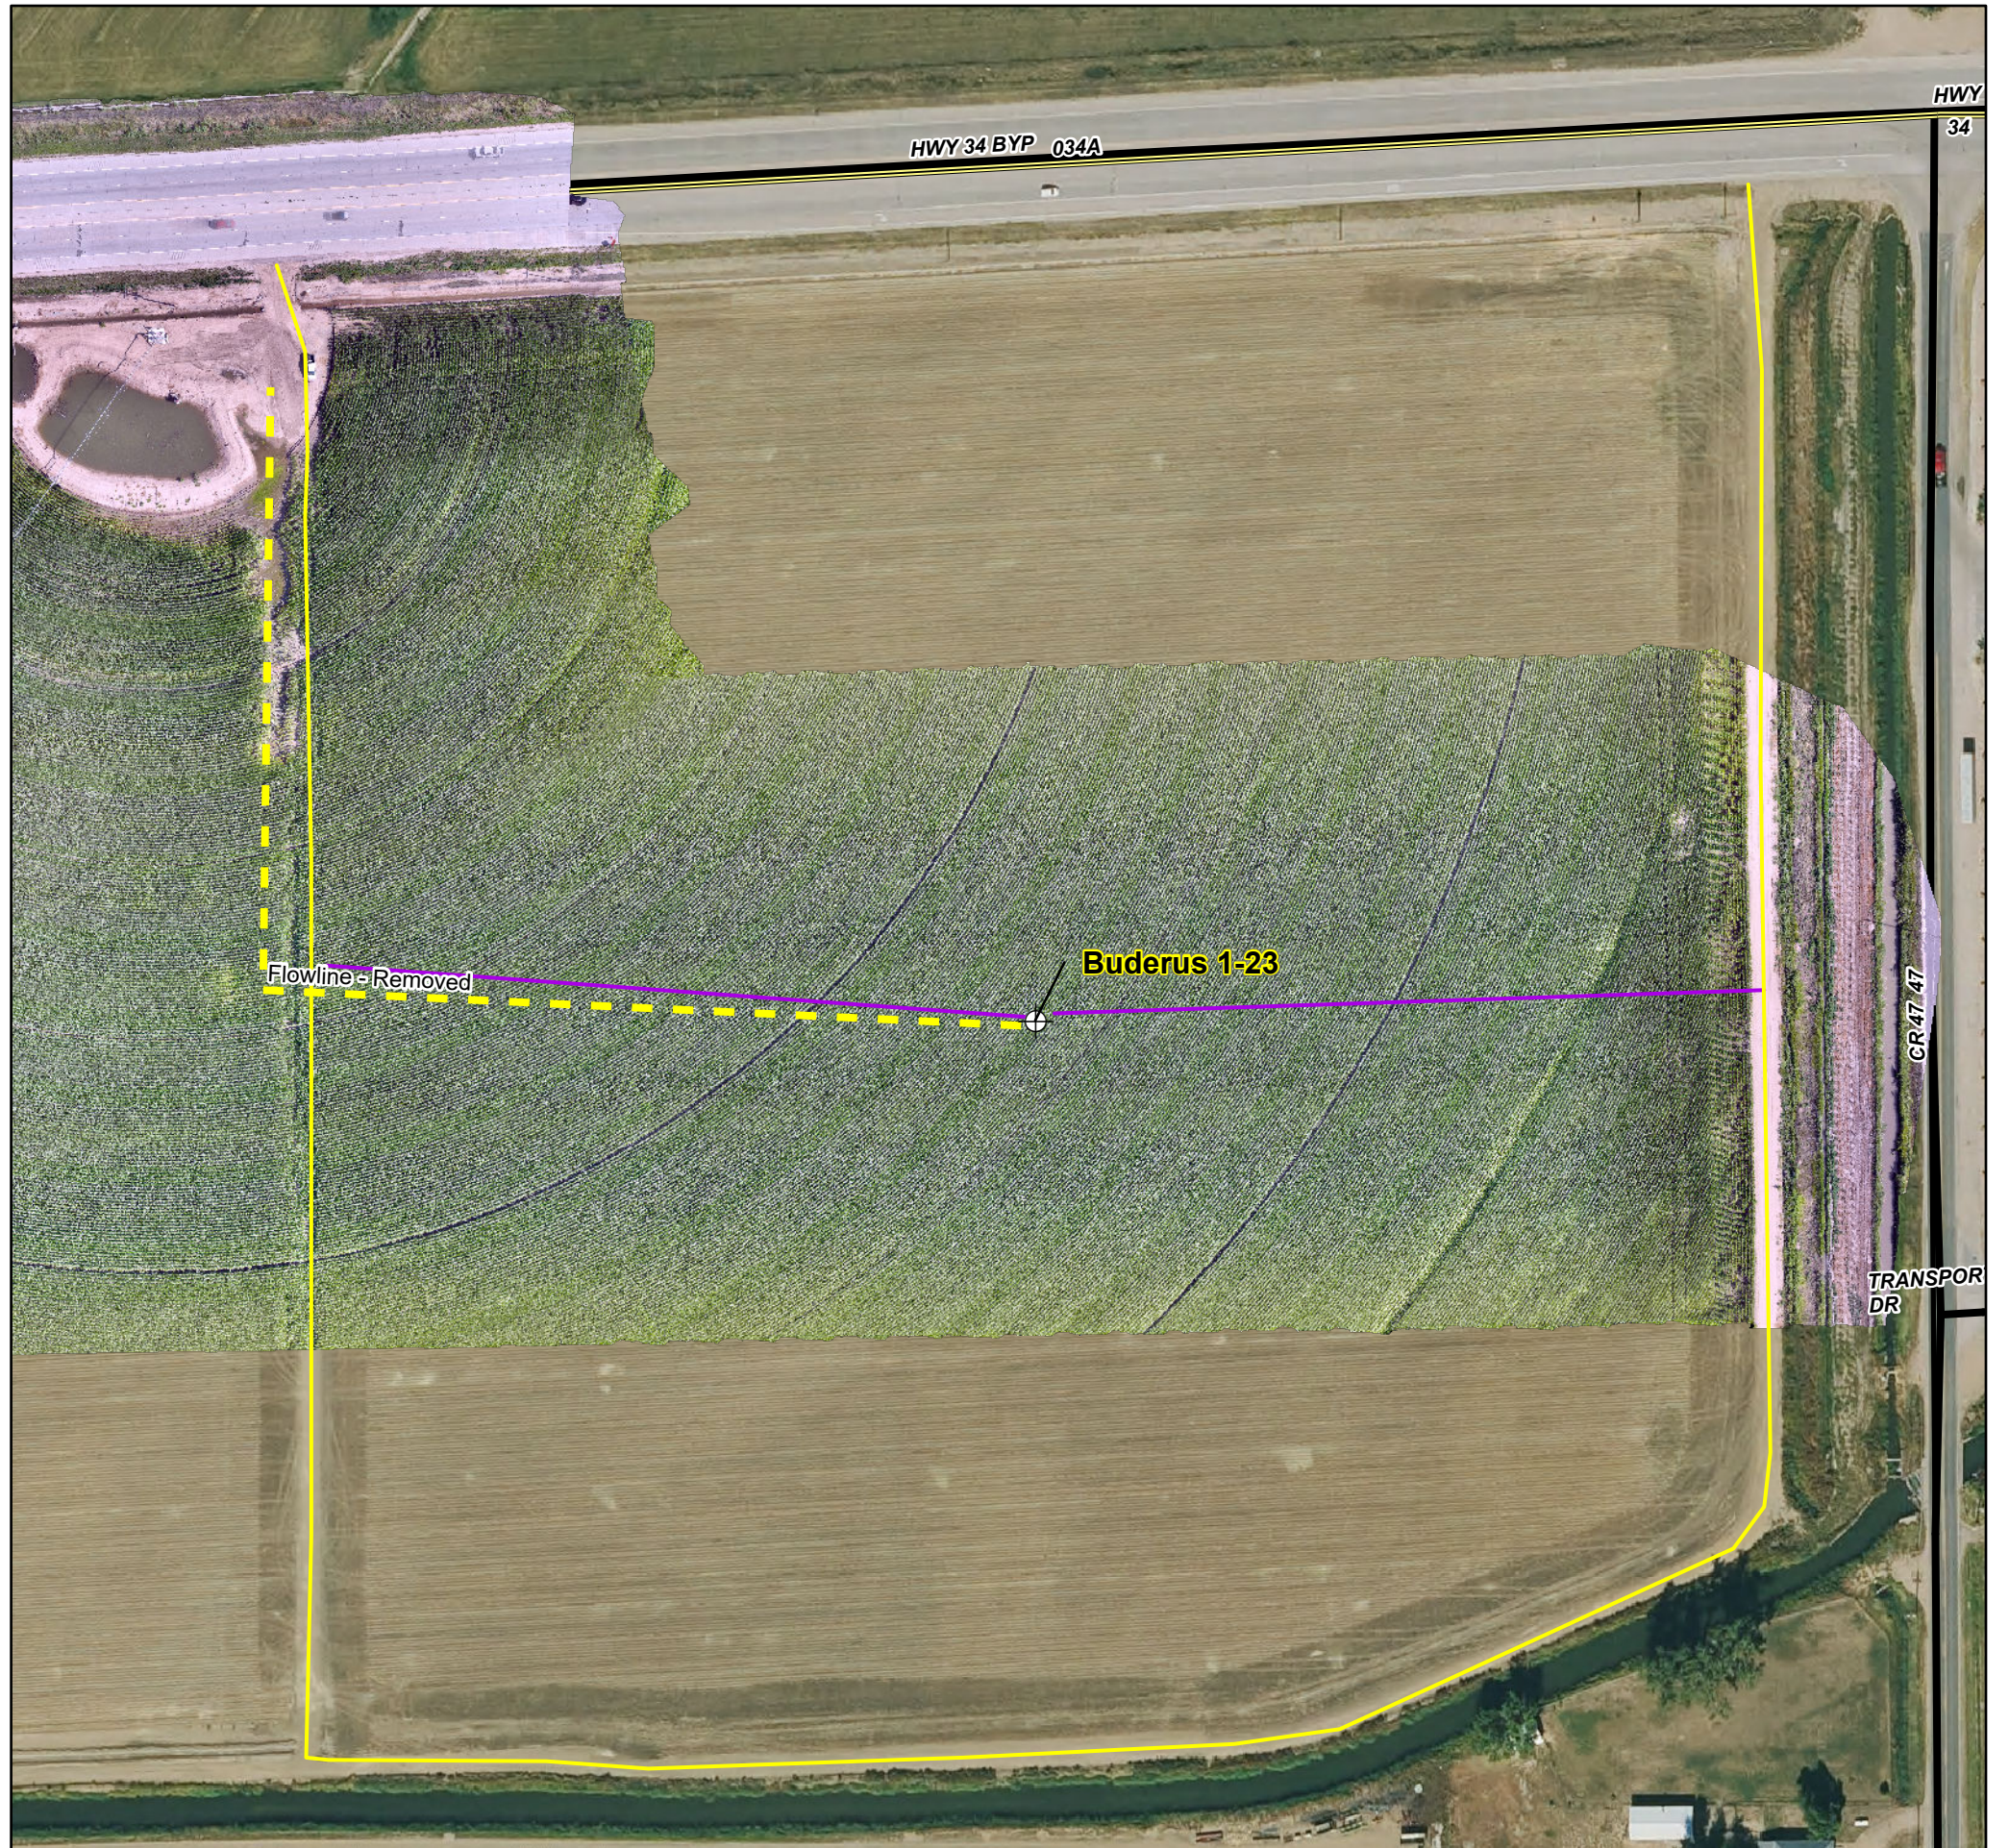
PDC Energy Form 4 Final Reclamation - Post Plugging Overview

Post-Plugging and Abandonment Location Overview
