Final Reclamation Inspection

Operator: Kerr McGee Oil & Gas Onshore - 47120

Location ID: 317894

Inspection Document #: 714002799

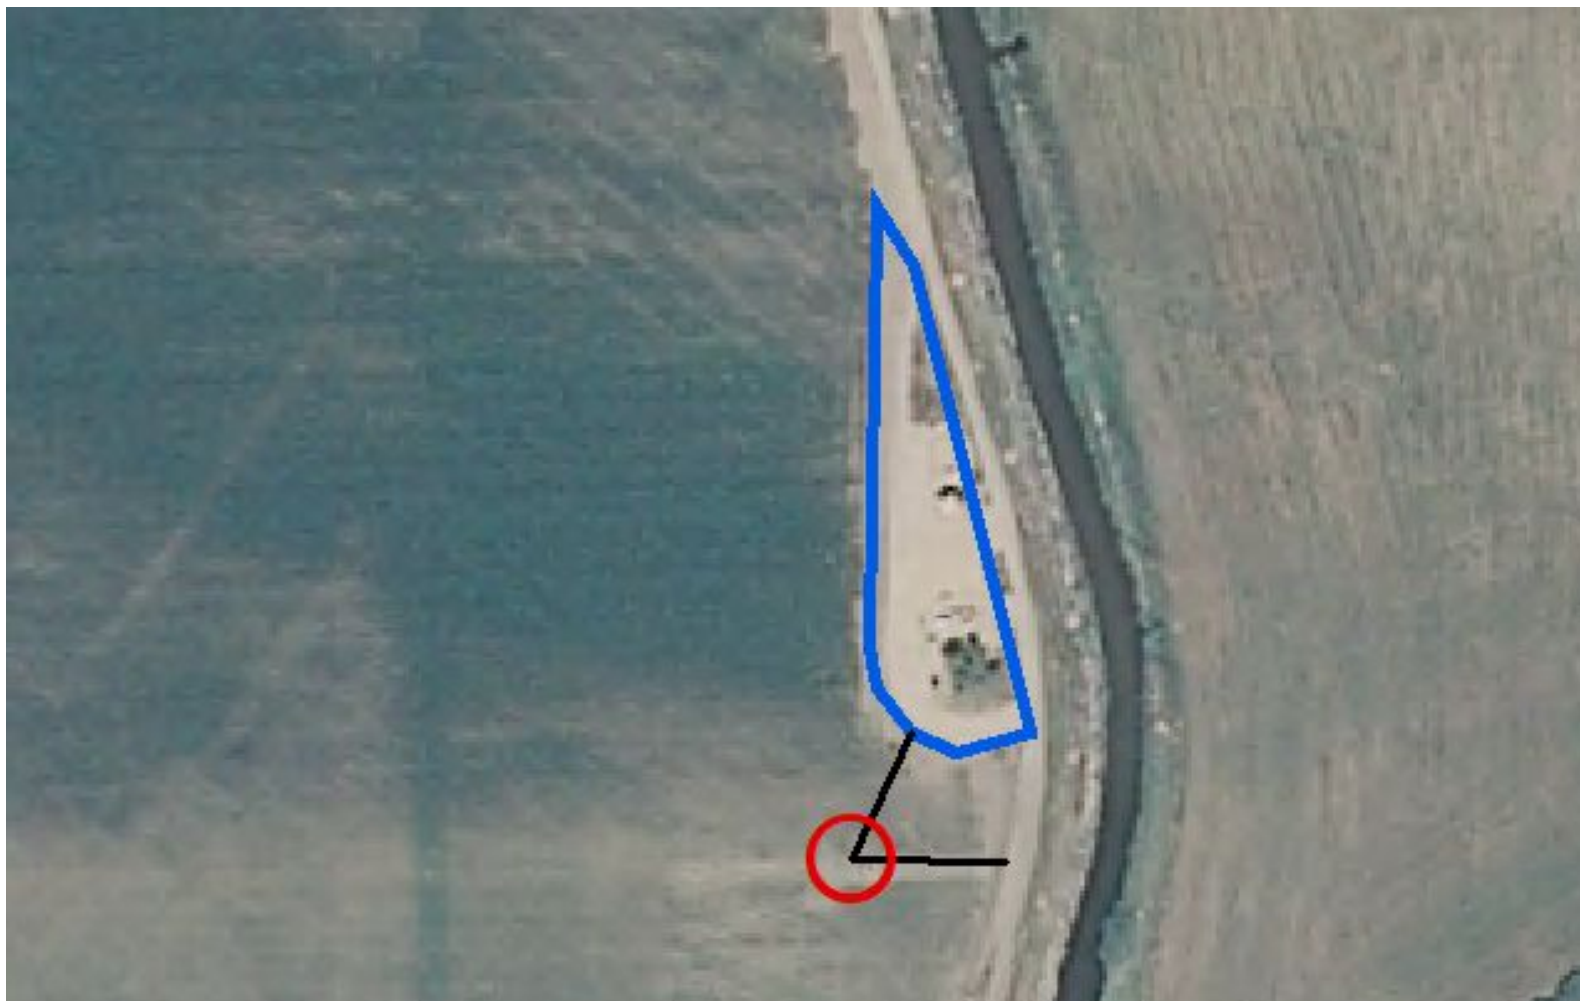
Photo 1. NAIP aerial imagery (2009) illustrating the well location (red circle), associated tank battery location (blue polygon), and well access roads (black lines).
