Looking south along the Flowline Facility ID 478291 from the State #6 well. Orange construction fencing has been installed along an area of the trench adjacent to the well, but does not continue. A rope with orange ribbons has been installed on both sides of the remaining length of the trench.

ECMC : Environmental Inspection

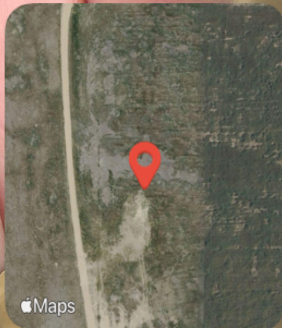
Looking at a piece of black soil. The material was friable; no odor was observed. Further characterization is necessary.
