Final Reclamation Inspection

Operator: Kerr McGee Oil & Gas Onshore - 47120

Location ID: 332613

Location Name: Morning 24-10 and Morning 25-10

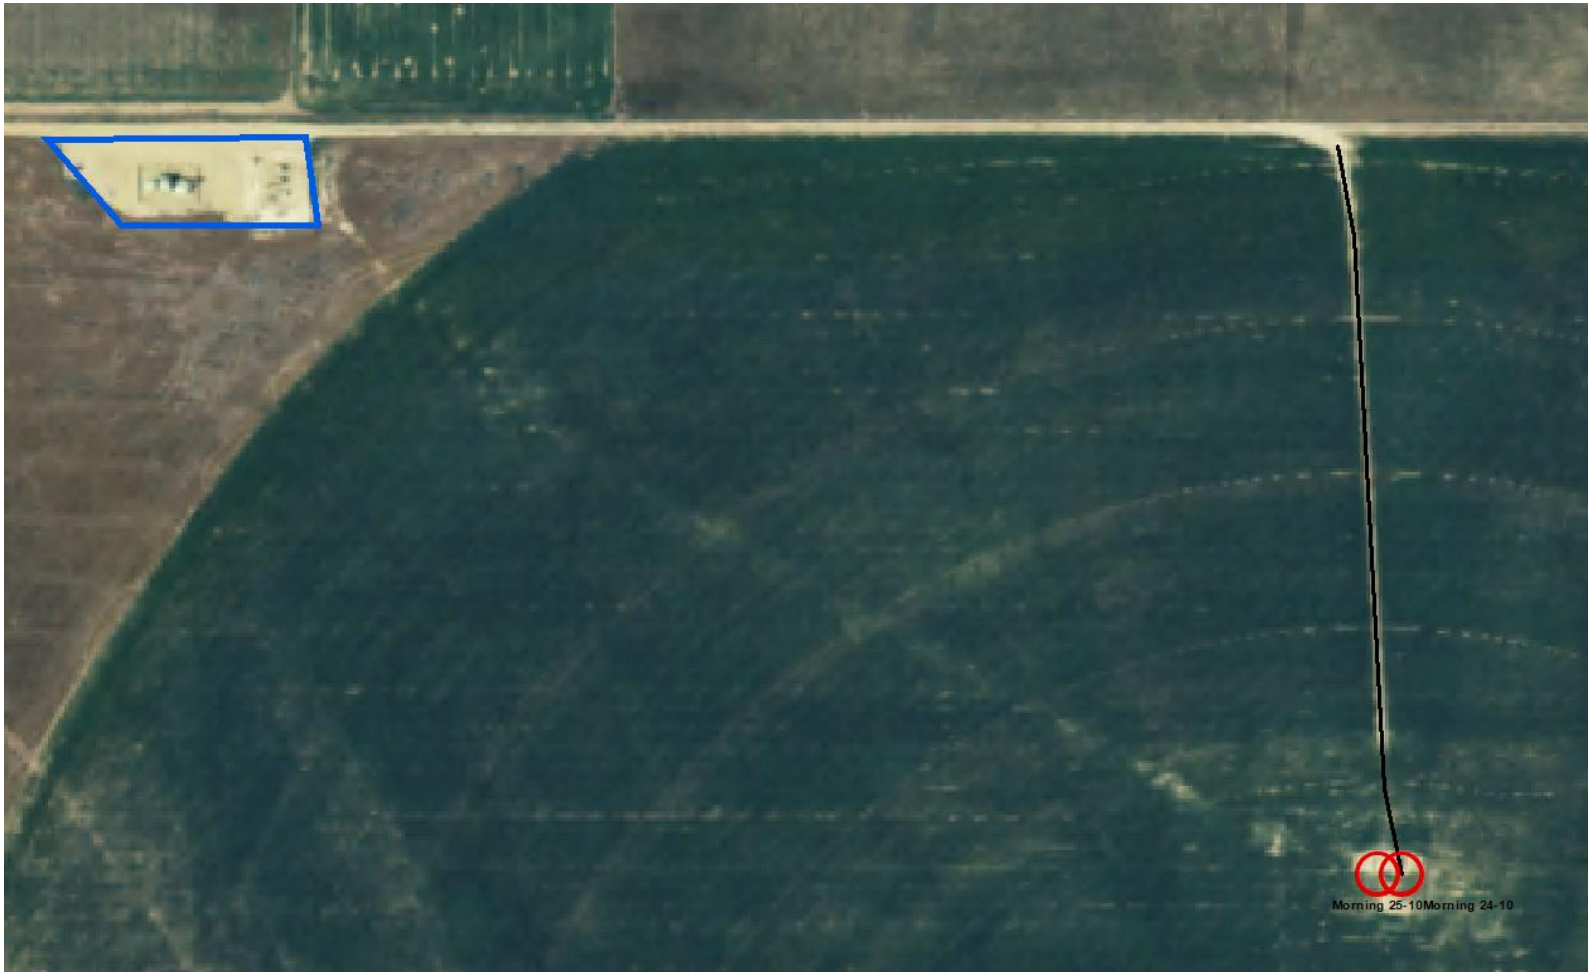
Photo 1. NAIP aerial imagery (2011) illustrating the well locations (red circles), associated tank battery location (blue polygon), and well access road (black line).

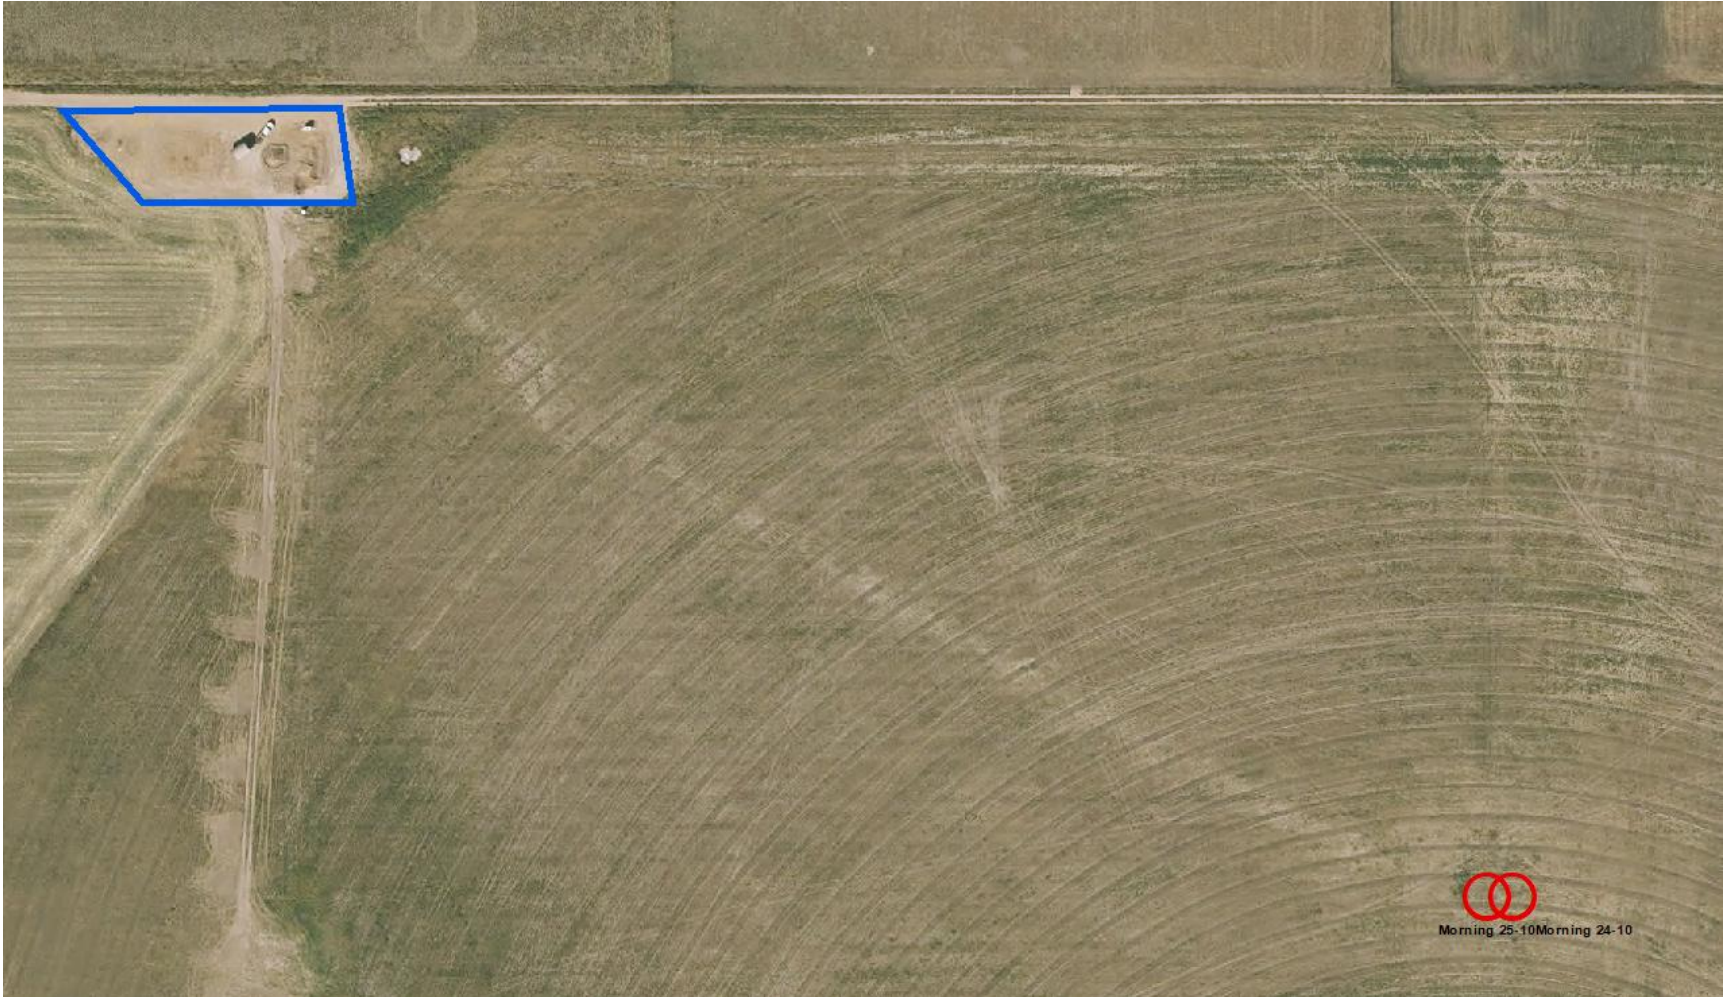
Photo 2. NAIP aerial imagery (2023) illustrating the well locations (red circles) and associated tank battery (blue polygon).

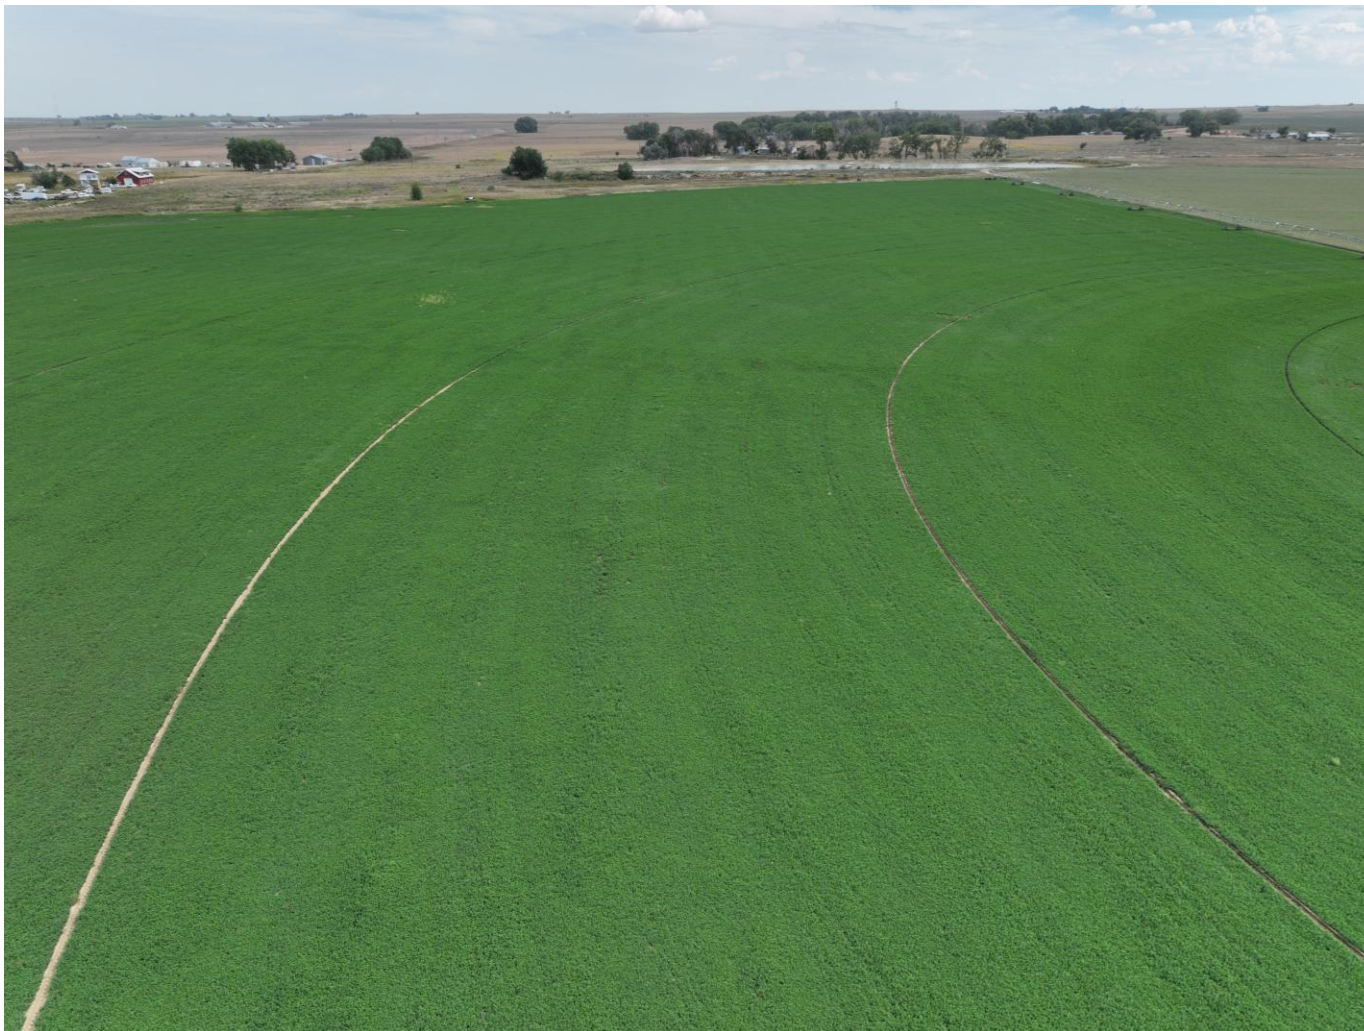
Photo 4. Drone aerial imagery taken west of well locations, facing east (displaying the wells).

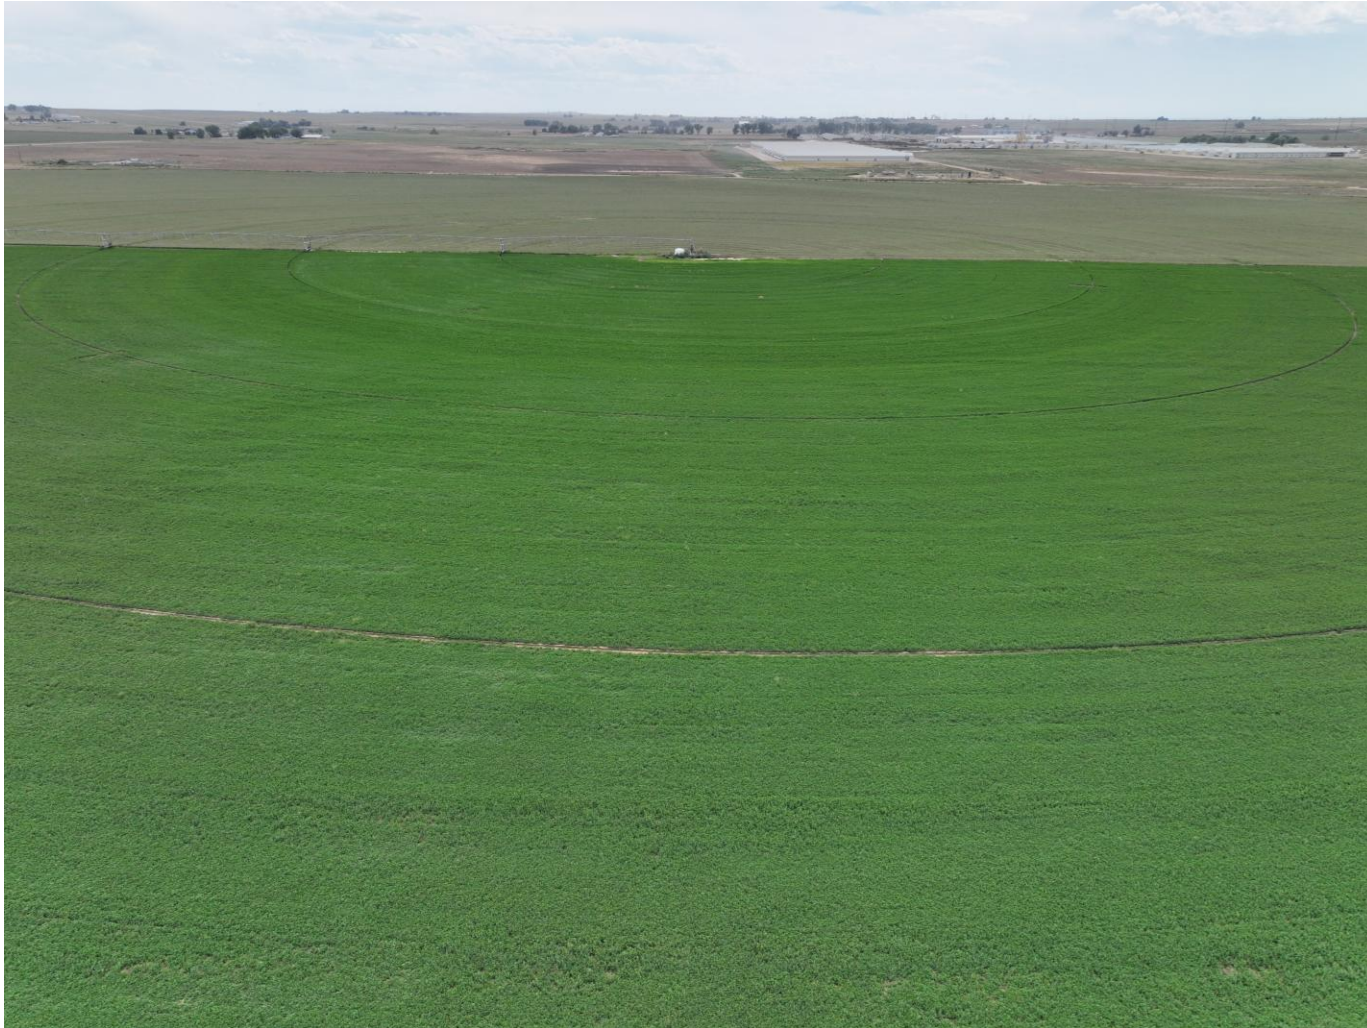
Photo 5. Drone aerial imagery taken north of well locations, facing south (displaying the wells).

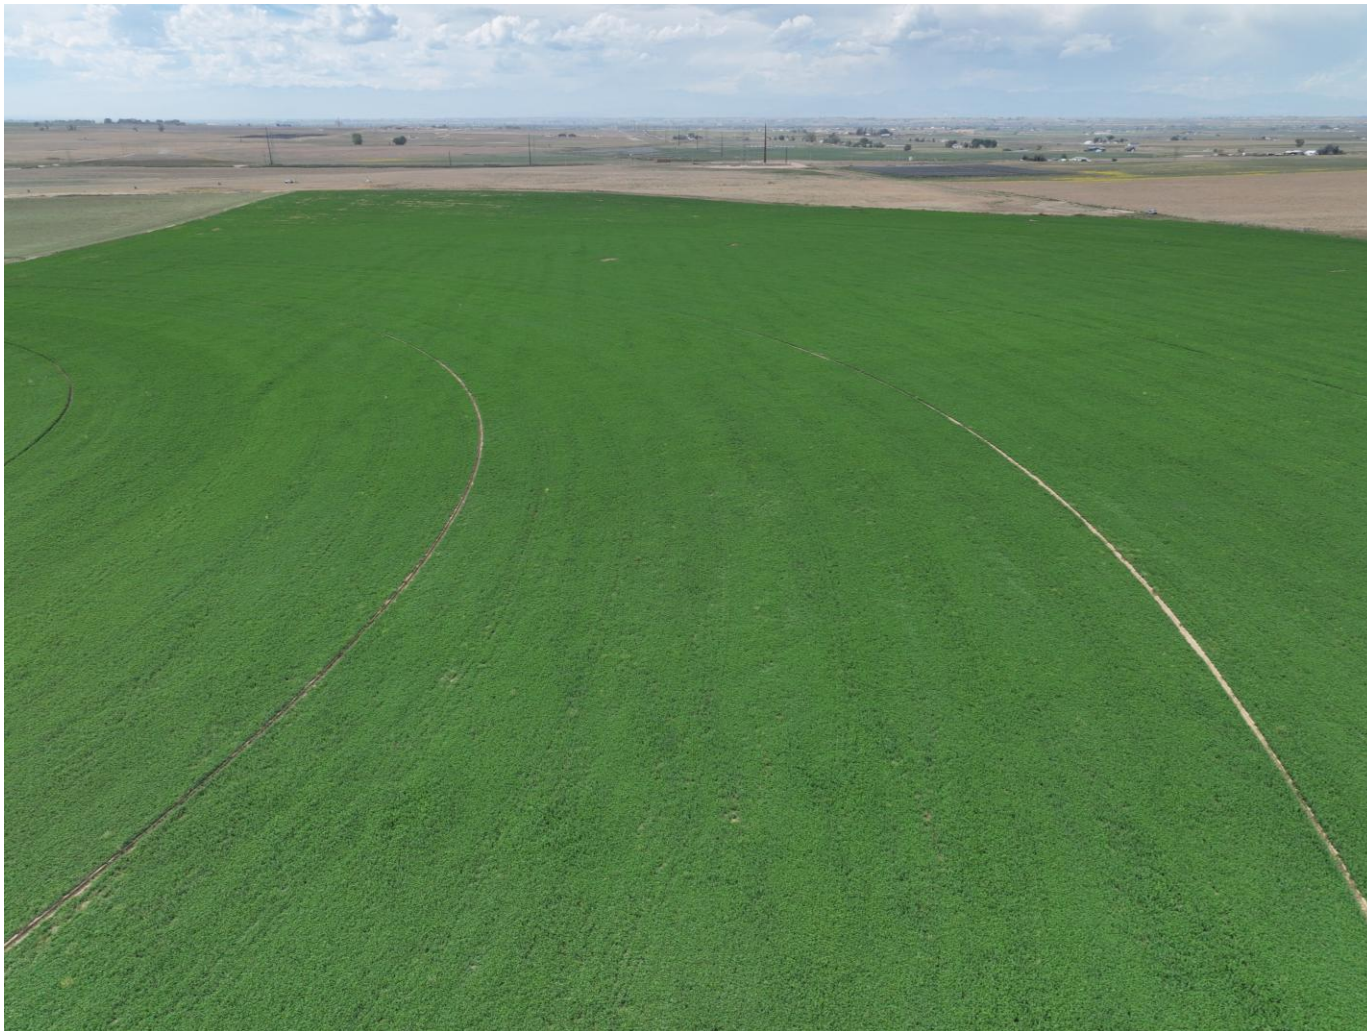
Photo 6. Drone aerial imagery taken east of well locations, facing west (displaying the wells).

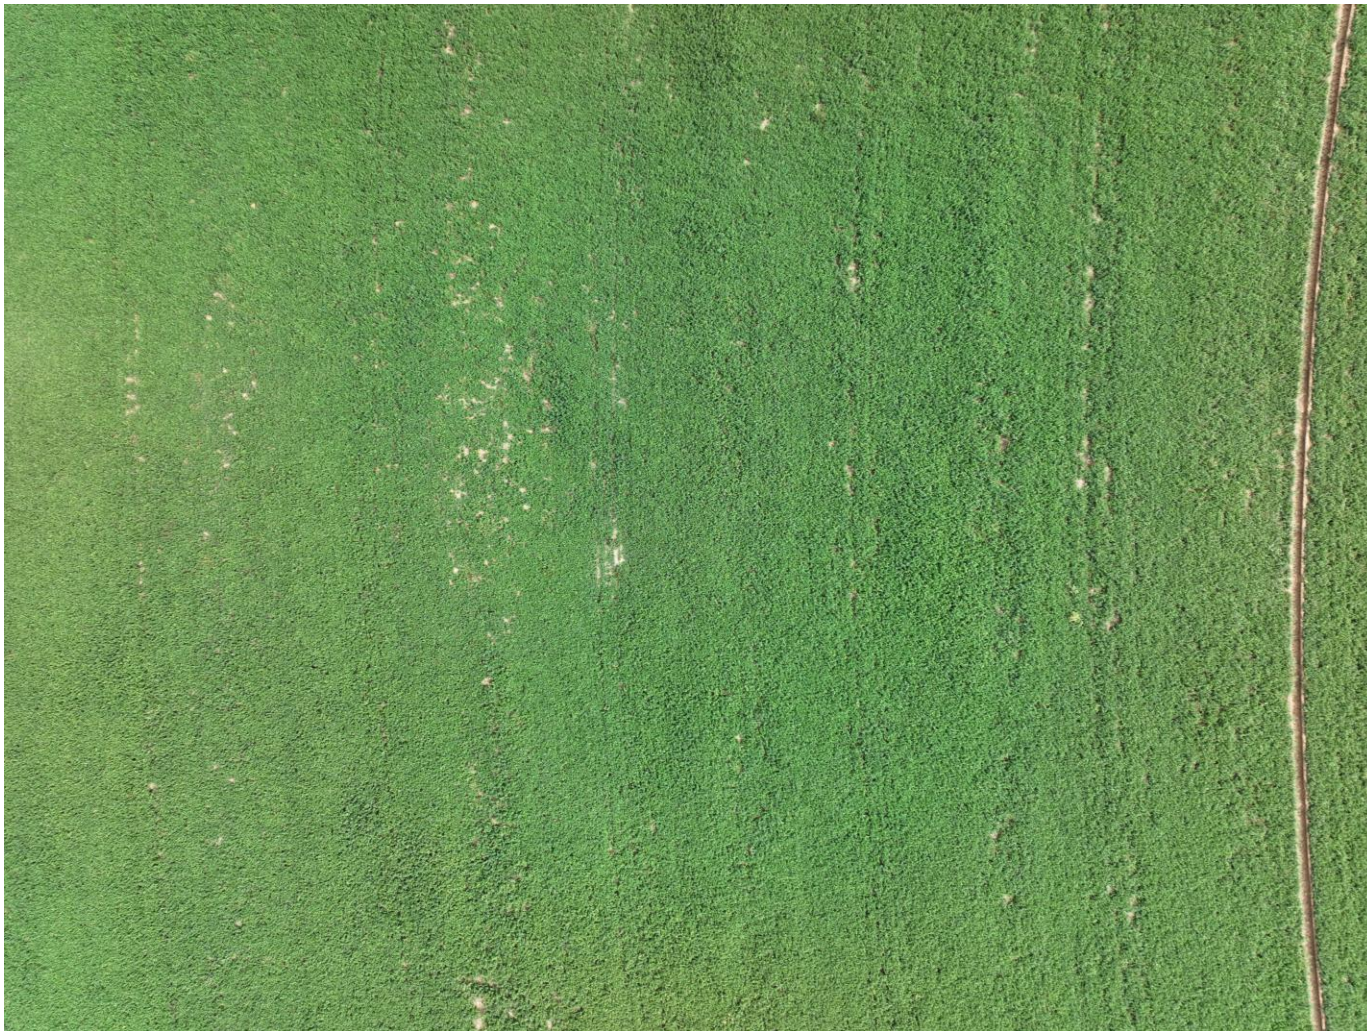
Photo 7. Drone aerial imagery taken directly above the well locations, facing downward (displaying the wells).

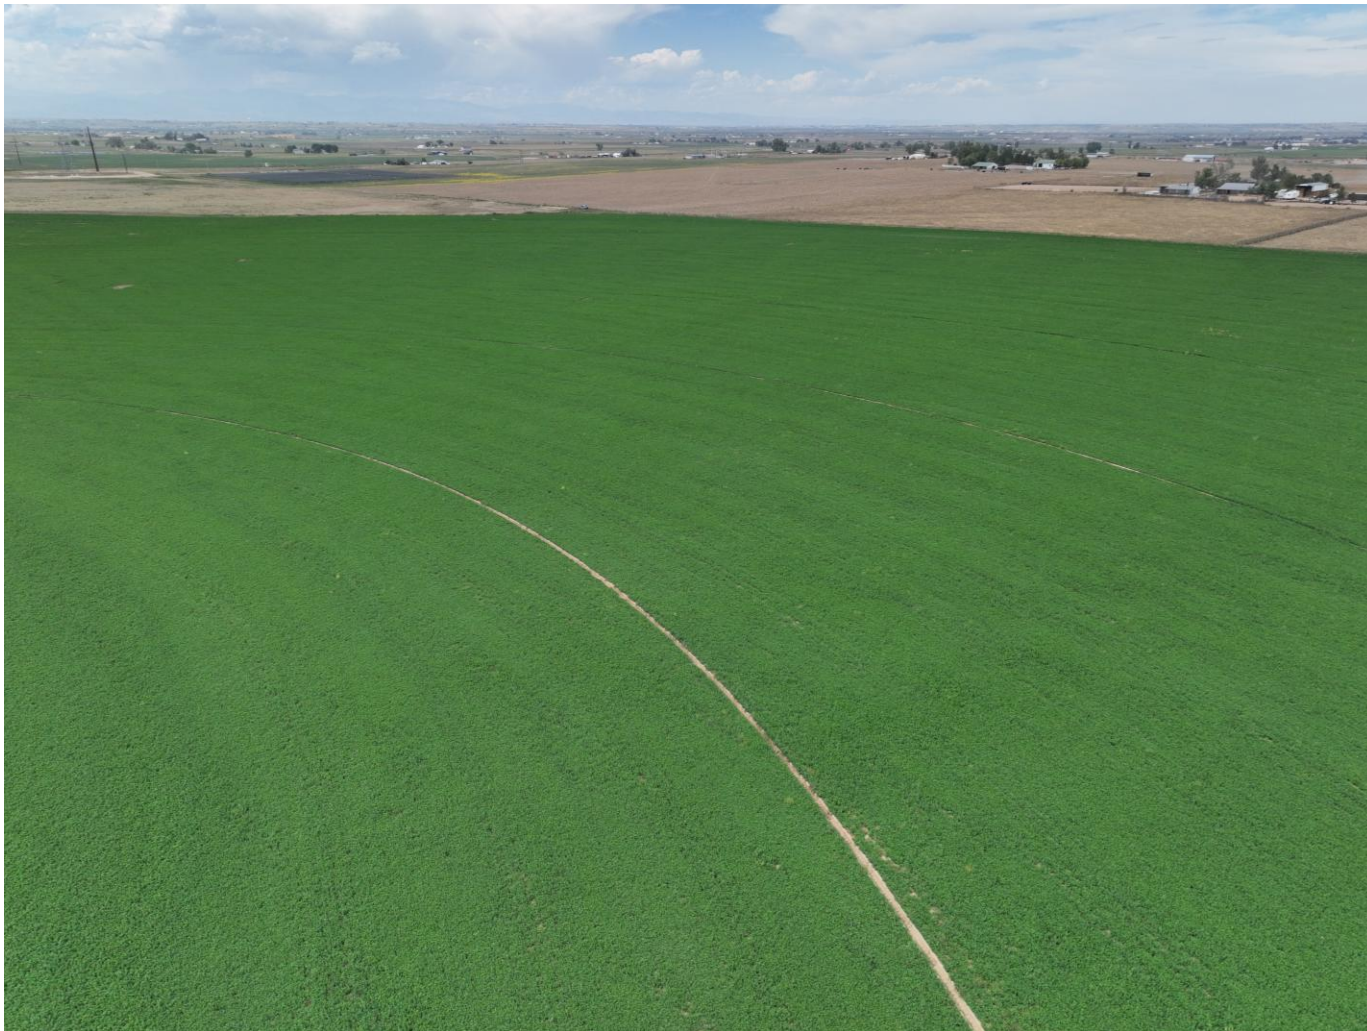
Photo 8. Drone aerial imagery taken southeast of well locations, facing northwest (displaying the wells and presumed flowline).

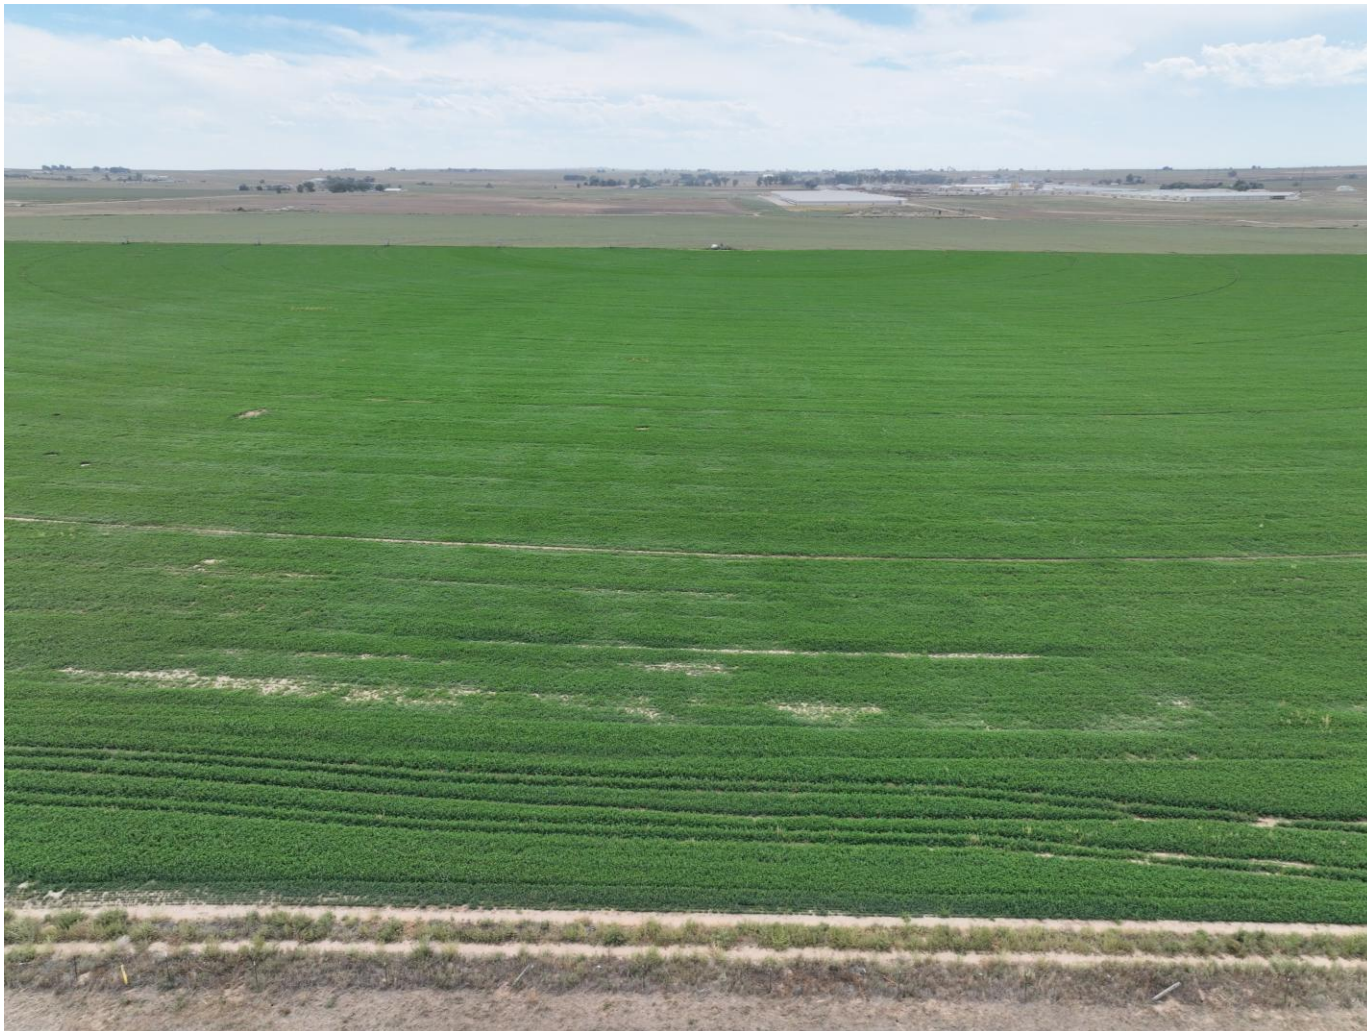
Photo 9. Drone aerial imagery taken north of well access road takeoff, facing south (displaying the well access road and wells).

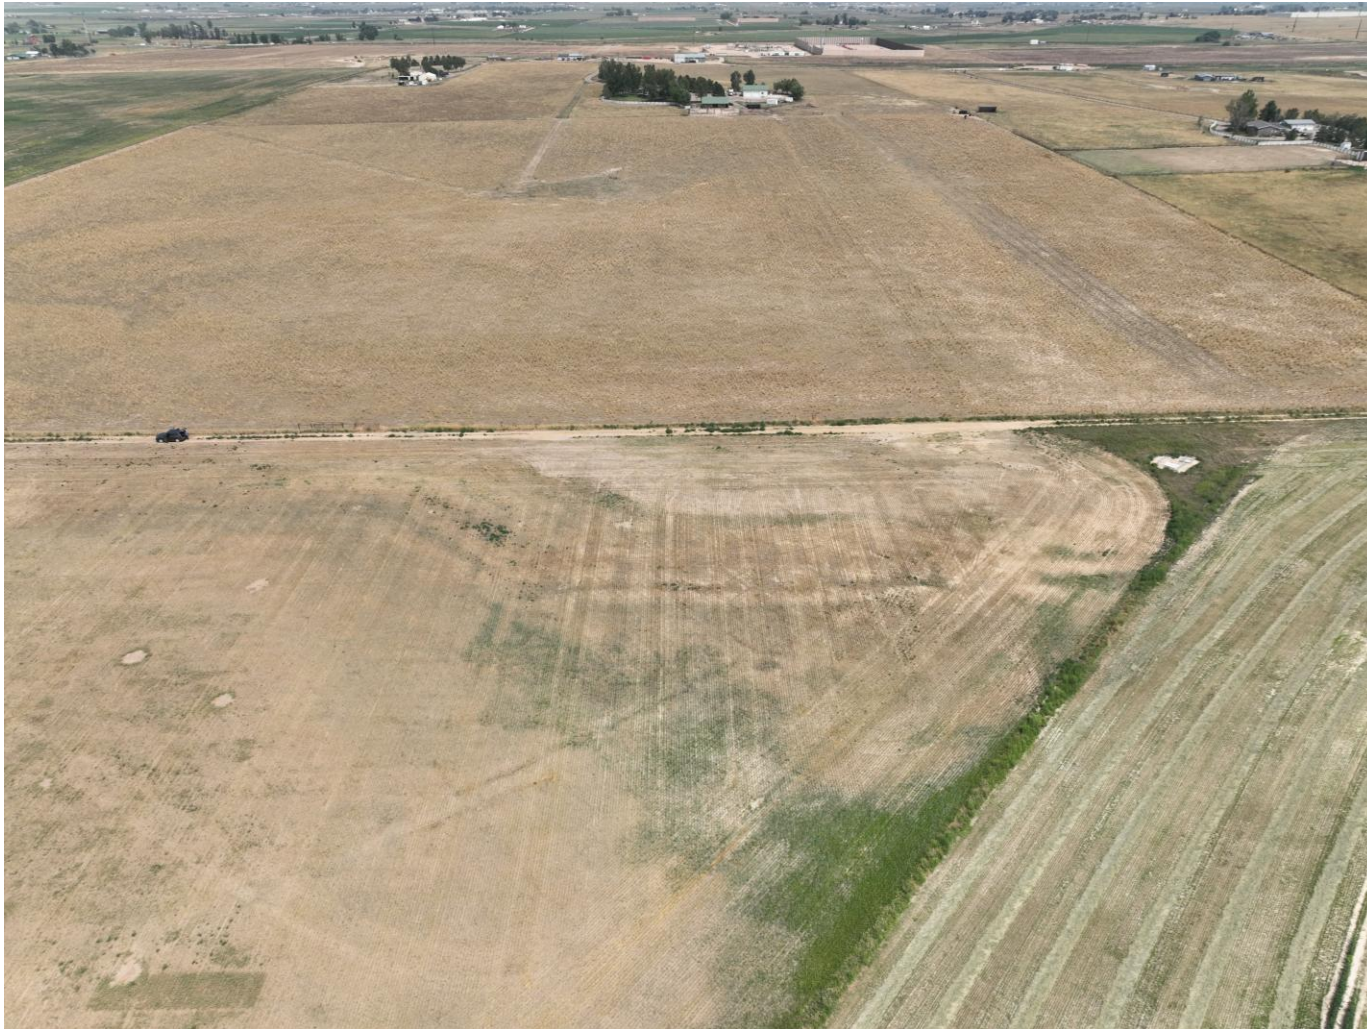
Photo 10. Drone aerial imagery taken south of the tank battery location, facing north (displaying the TB, access road, and wells).

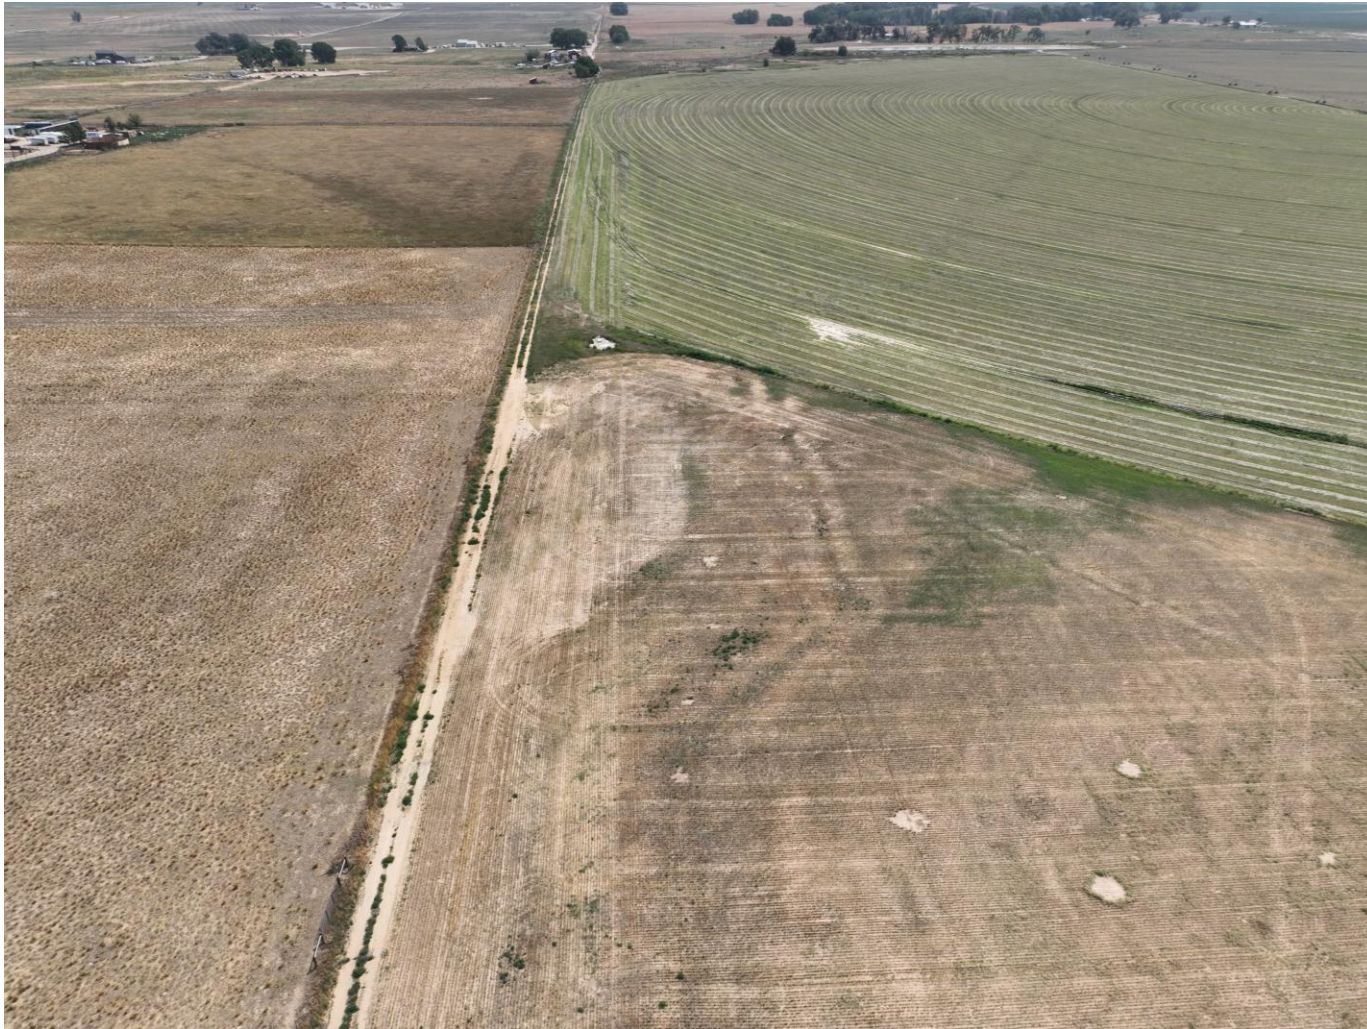
Photo 11. Drone aerial imagery taken west of the tank battery location, facing east (displaying TB).

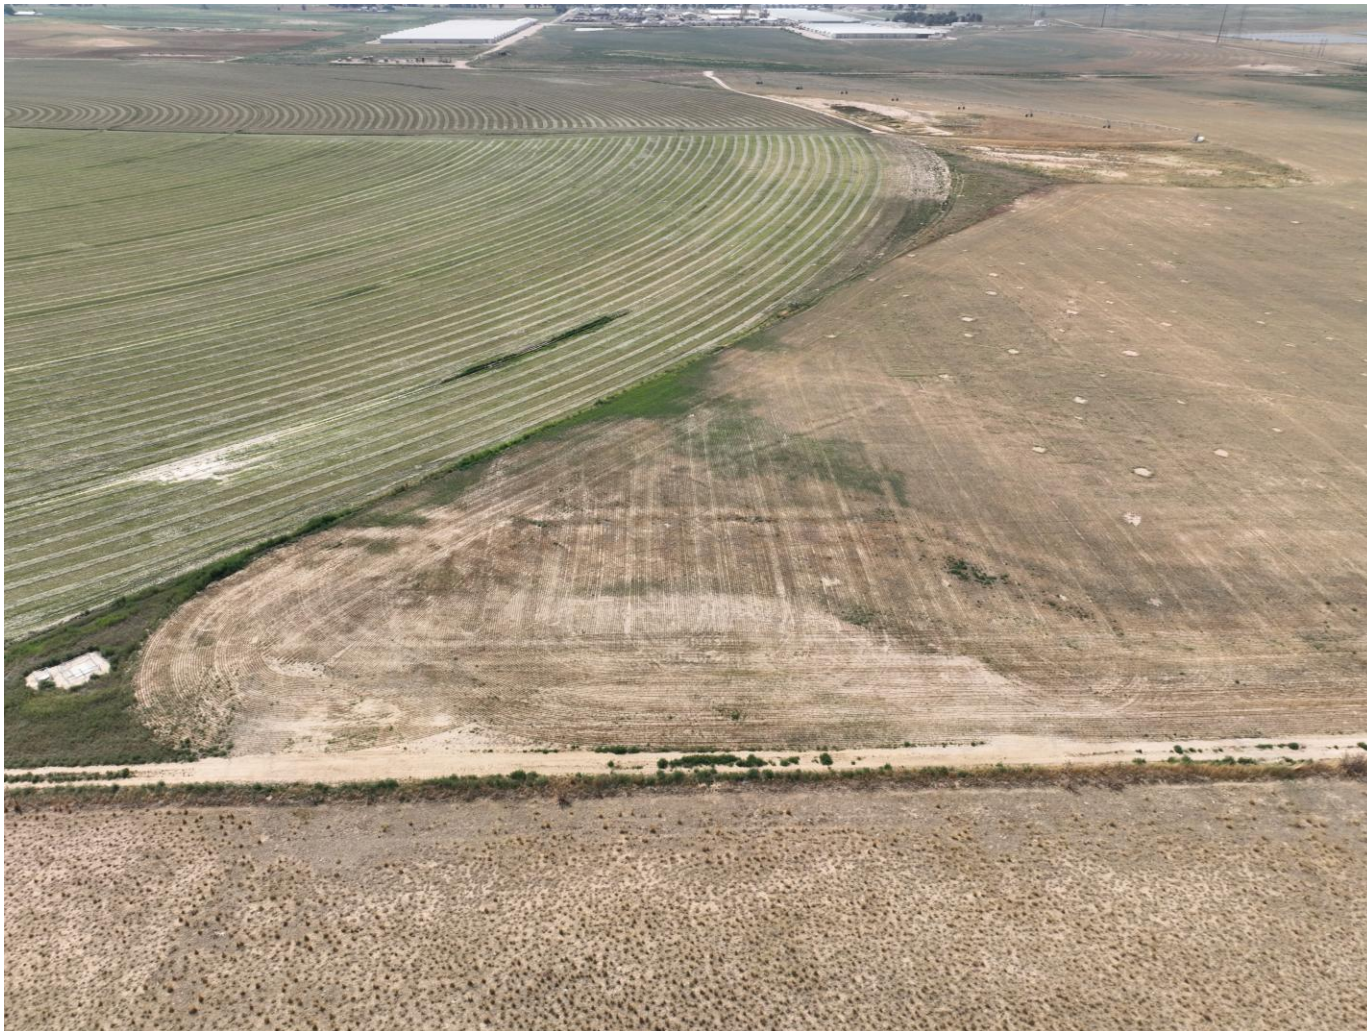
Photo 12. Drone aerial imagery taken north of the tank battery location, facing south (displaying the TB).

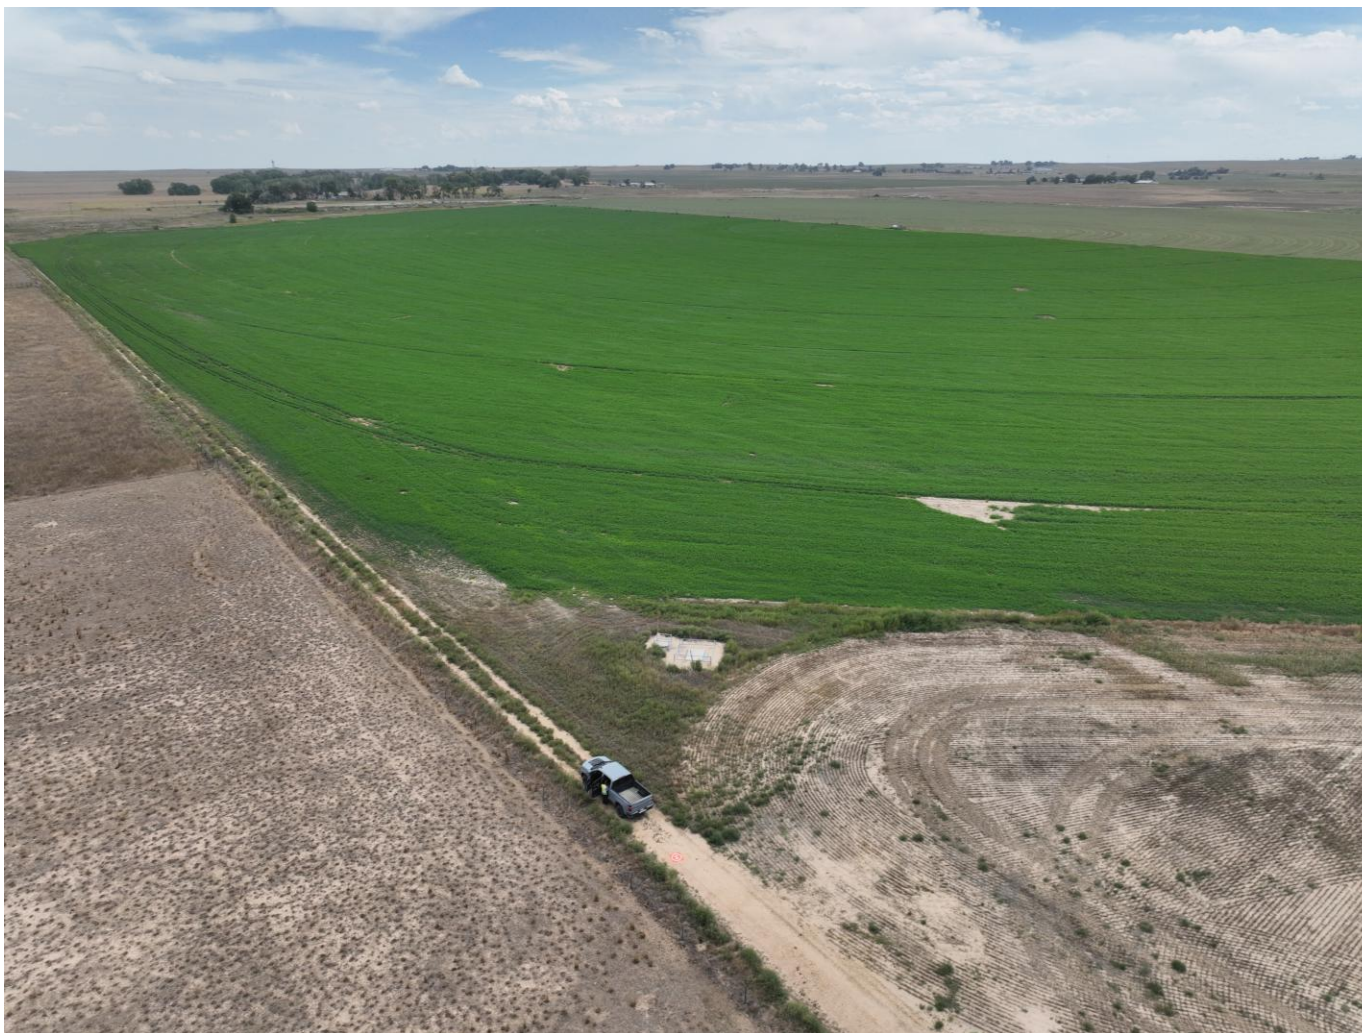
Photo 14. Drone aerial imagery taken northwest of the tank battery location, facing southeast (displaying part of the TB and presumed flowline).
