# Final Reclamation Inspection

Operator: RITCHIE EXPLORATION INC

Location ID: 313860

Inspection Document #: 720300150

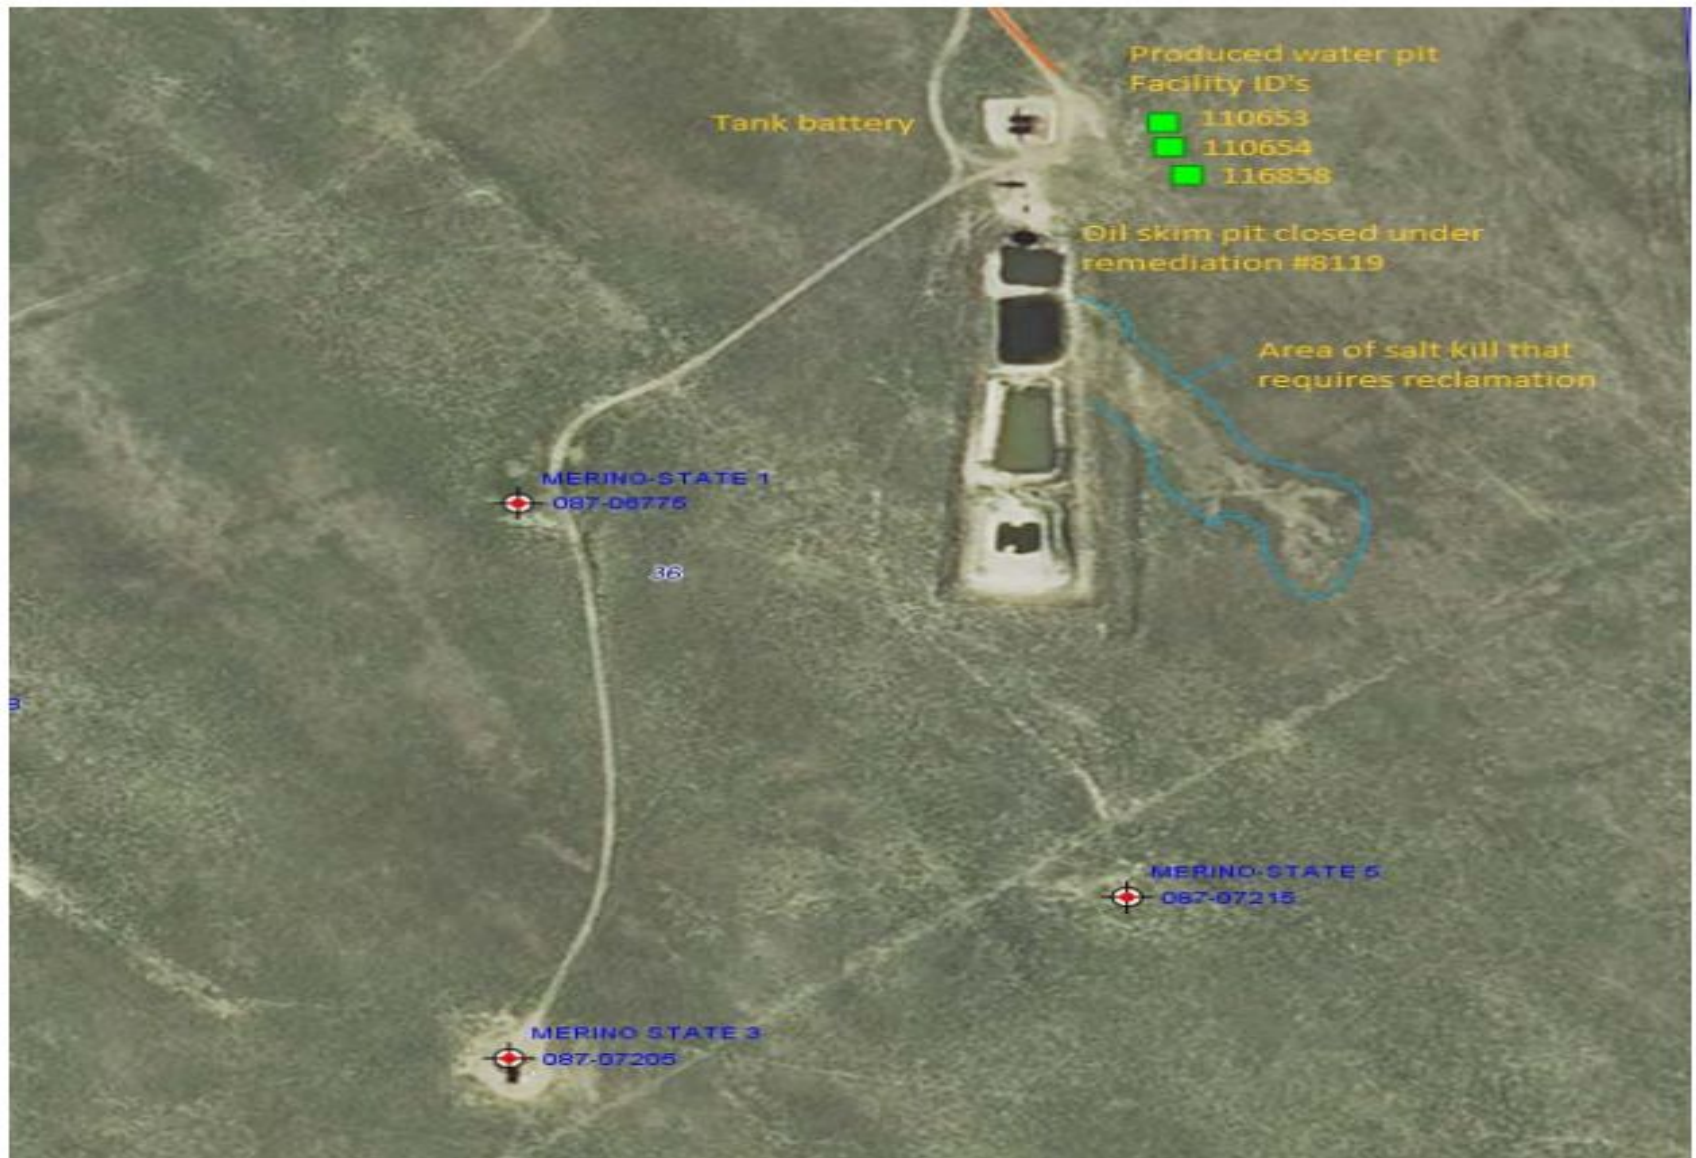
**Photo 12.** Historical satellite imagery of the three wells, tank battery and pit complex provided by operator consultant.
